Enea Mustafaraj¹

STRUCTURAL ASSESSMENT AND RETROFITTING OF HISTORICAL CONSTRUCTIONS: A CASE STUDY FROM ALBANIA

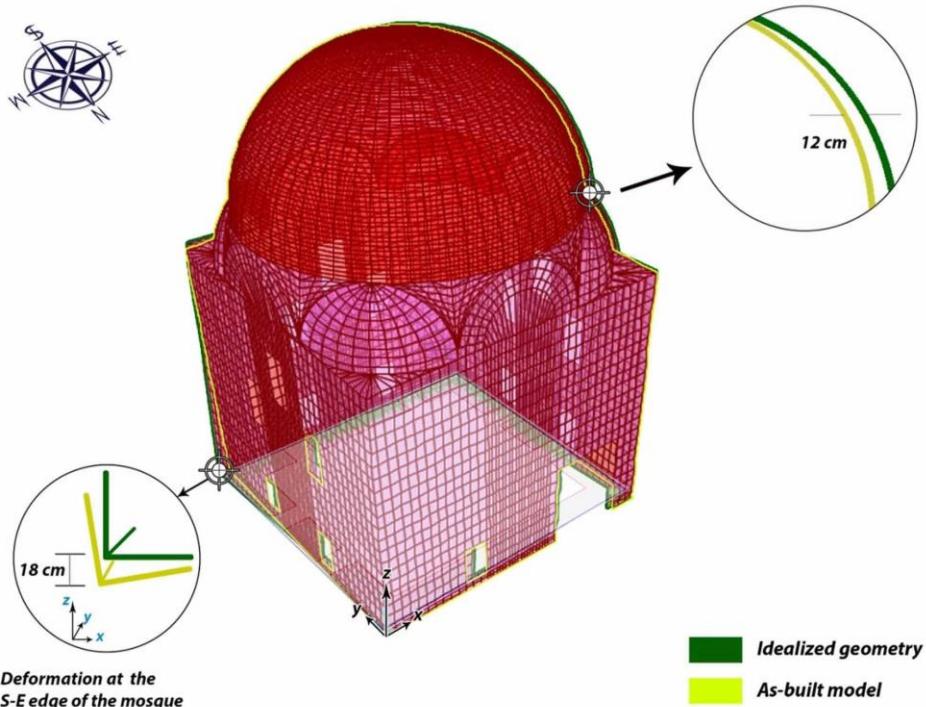
Figure 2 - FEM model of Naziresha's mosque.

As expected, stress concentrations were recorded at the corners of openings and wall connection locations. This model output can be easily verified by observing the cracks on the existing structure.

The FEM results of the model with assumed perfect geometry showed that the stresses under dead load are seen to be below the ultimate resistive capacity of materials. The distribution of the compression stresses in the dome is seen to be distributed at the middle part, whereas the tensile stresses are observed in a circumferential direction. The maximum value of principal stress (SMAX) and minimum principal stress (SMIN) are seen at the connection of the main dome with the supporting arches having a maximum value of 0.361 MPa and -0.525 MPa for tensile and compressive stresses, respectively.

In the load bearing walls hoop stress (S11) varies from -0.177 to 0.148 MPa. Comparing the corresponding models under static and earthquake load, the maximum tensile stress that occurs in the structure is 0.361 MPa under static, 0.801 MPa under seismic load and 0.144 s for the first mode. On the other hand, the actual geometric model gives 0.774 MPa under static load, 1.4 MPa under seismic load and 0.174 s for the first mode.

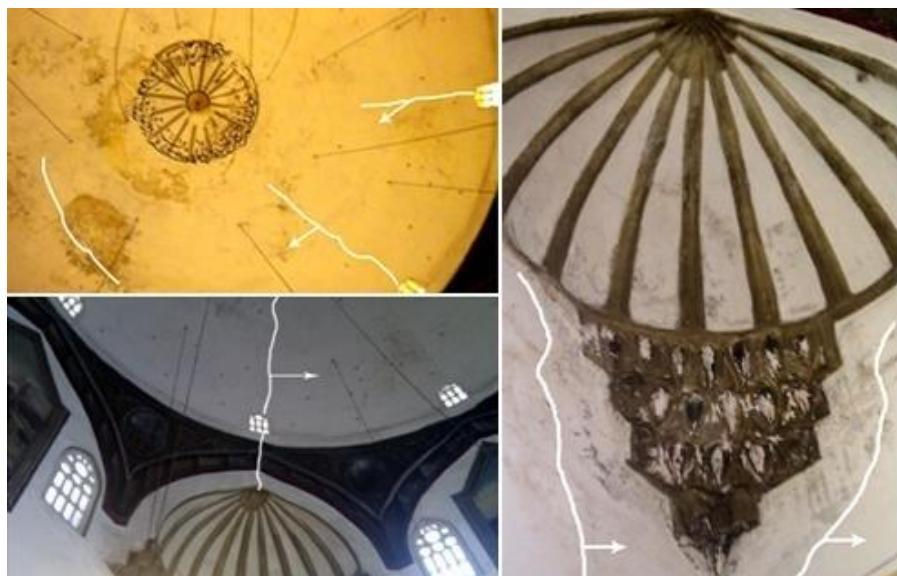
Structural conditions of the roof system of Mirahor Ilyas Beg Mosque in Korça seem adequate to carry static loads. However, there are found many structural cracks. Improper connection of the lanterns hanged at the top of the ceiling, in a later time after the dome was built, has caused extra local stress concentrations causing cracks around the connections (Figure 3).

Spall of plaster can be seen in some zones. There are also found cracks related to the old age of the building and amortization during time. Pendentives and arches suffer from the same problems. Thrust transferred from the dome loads may have exceeded their load carrying capacity.

Figure 3 - Cracks in the interior of the dome and pendentives in Mirahor Ilyas Beg Mosque.

In the domes, the main concern is to repair the structural cracks and keep them under control, as well as protect the interior from atmospheric agents like rain and snow. In order to achieve this, the roofing system should be improved. The leaden layer of the cap should be checked for possible misalignment of the layers and repaired where damaged. The rainwater runoff system should be improved as it is seen to be inappropriate.

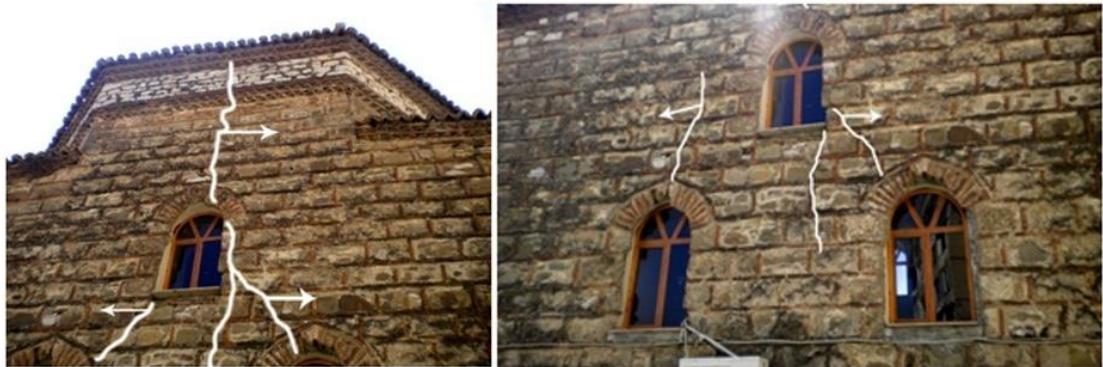
In the load bearing walls of the Naziresha's Mosque serious cracks are present in all façades. Most of the cracks inferred from the damage survey presented a diagonal and vertical trend. Creep of the masonry units is believed to be the cause of vertical parallel cracks which eventually may lead to collapse of the wall. This phenomenon is accompanied by occurrence of chipping and possible local failure. This is very obvious in the north façade where there are massive cracks whose cause is believed to be improper modification of the entrance. Vegetation growth can be seen where masonry units are missing. At the bottom of the walls, due to consequent flooding, sanding phenomenon is seen. There are found voids that grow bigger in time. Crack propagation from pendentives to the load bearing walls is observed in all four facades. In the places where openings are present, a different crack pattern can be seen. Tensile and shear stresses are concentrated close to the edges of these openings possibly due to local concentration of loadings. As a result, every window is cracked at the bottom corners of its frames (Figure 4).

Furthermore, cracks due to differential settlement and suffusion (migration of soil particles through soil skeleton) phenomenon are observed. Hair cracks (small cracks) are seen in the interior of the walls. Further cracks cannot be seen due to local works of rebuilding in the interior of the mosque. However traces of the mentioned cracks of the exterior can be spotted

if carefully checked. Based on the problems mentioned above, there is a very concerning situation about structural stability of this mosque.

Figure 4 - Propagation of cracks in the load bearing walls, west façade of Naziresha's Mosque

As seen from the damage survey, the load-bearing walls suffer the most from structural problems. They exhibit both visible surface degradation as well as structural cracks. The proposed intervention procedure consists of reducing the shear and tensile stresses on the walls by adding additional tensile and shear resisting elements where

The areas where sanding phenomenon and loss of masonry units is seen should be repaired using the local “cucci scucci” reconstruction technique. The substituting units must have the same architectural features and should be compatible with original facades. This technique should be used to repair the north and south facades (Figure 4).
