STRUCTURAL ASSESSMENT OF HISTORICAL CONSTRUCTIONS AND SELECTED RETROFITTING TECHNIQUES

Dr. ENEA MUSTAFARAJ

*Department of Civil Engineering
Epoka University*

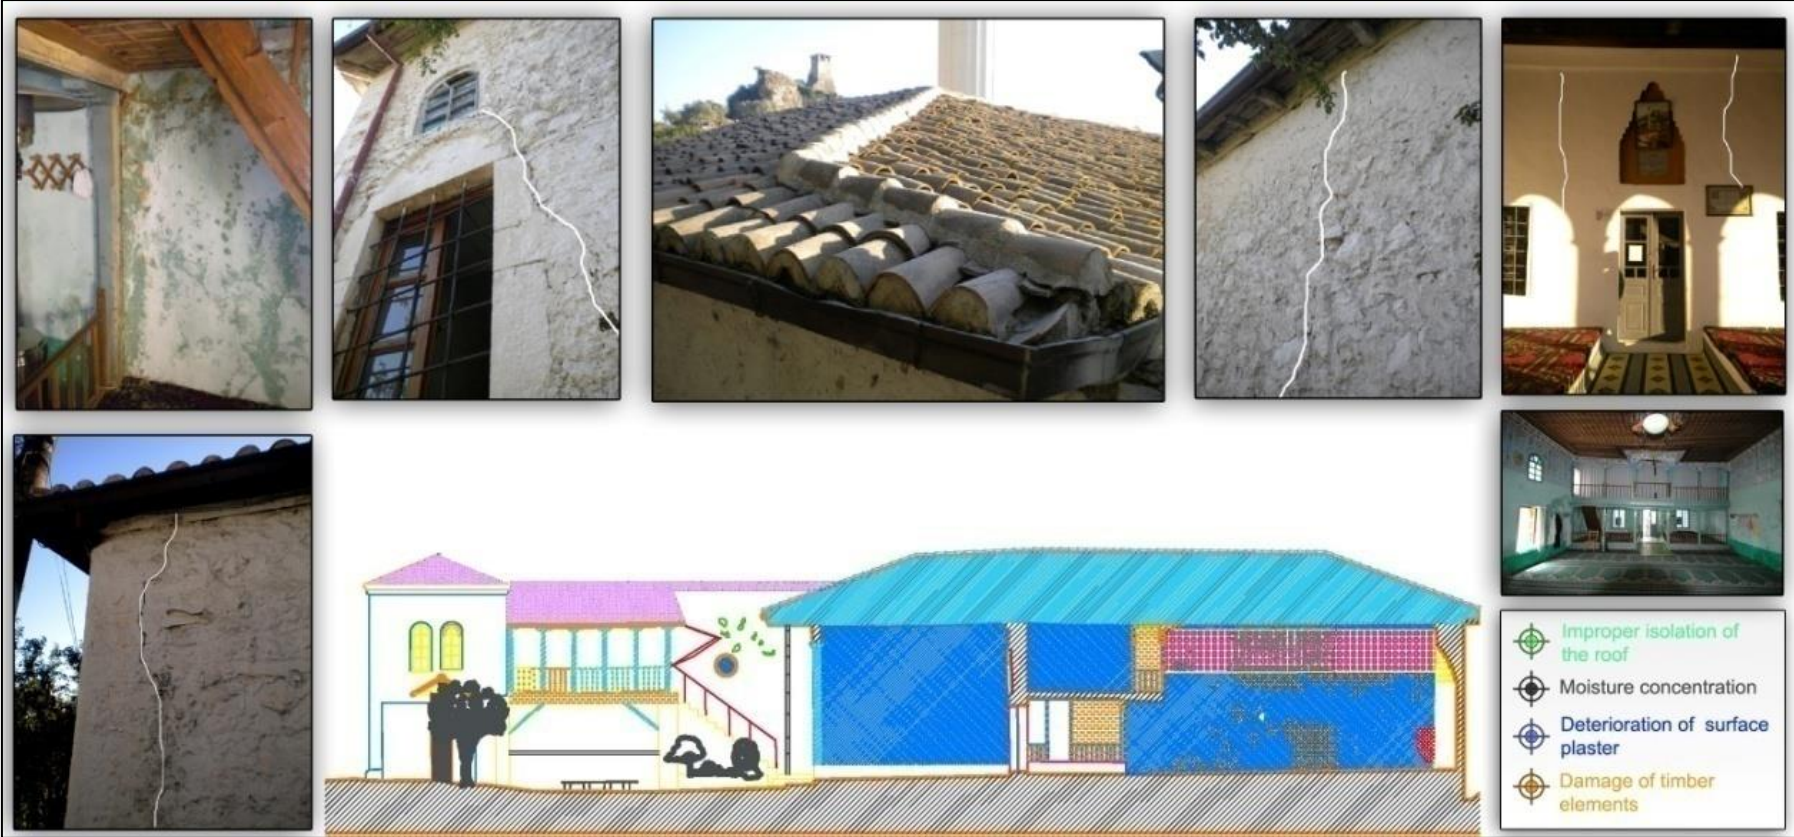
Assessment Results - Mirahor I. Beg's Mosque

⊕ Broken windows
⊕ Unnecessary metal clamp
⊕ Moisture concentration
⊕ Local loss of stone units
⊕ Deterioration of surface plaster

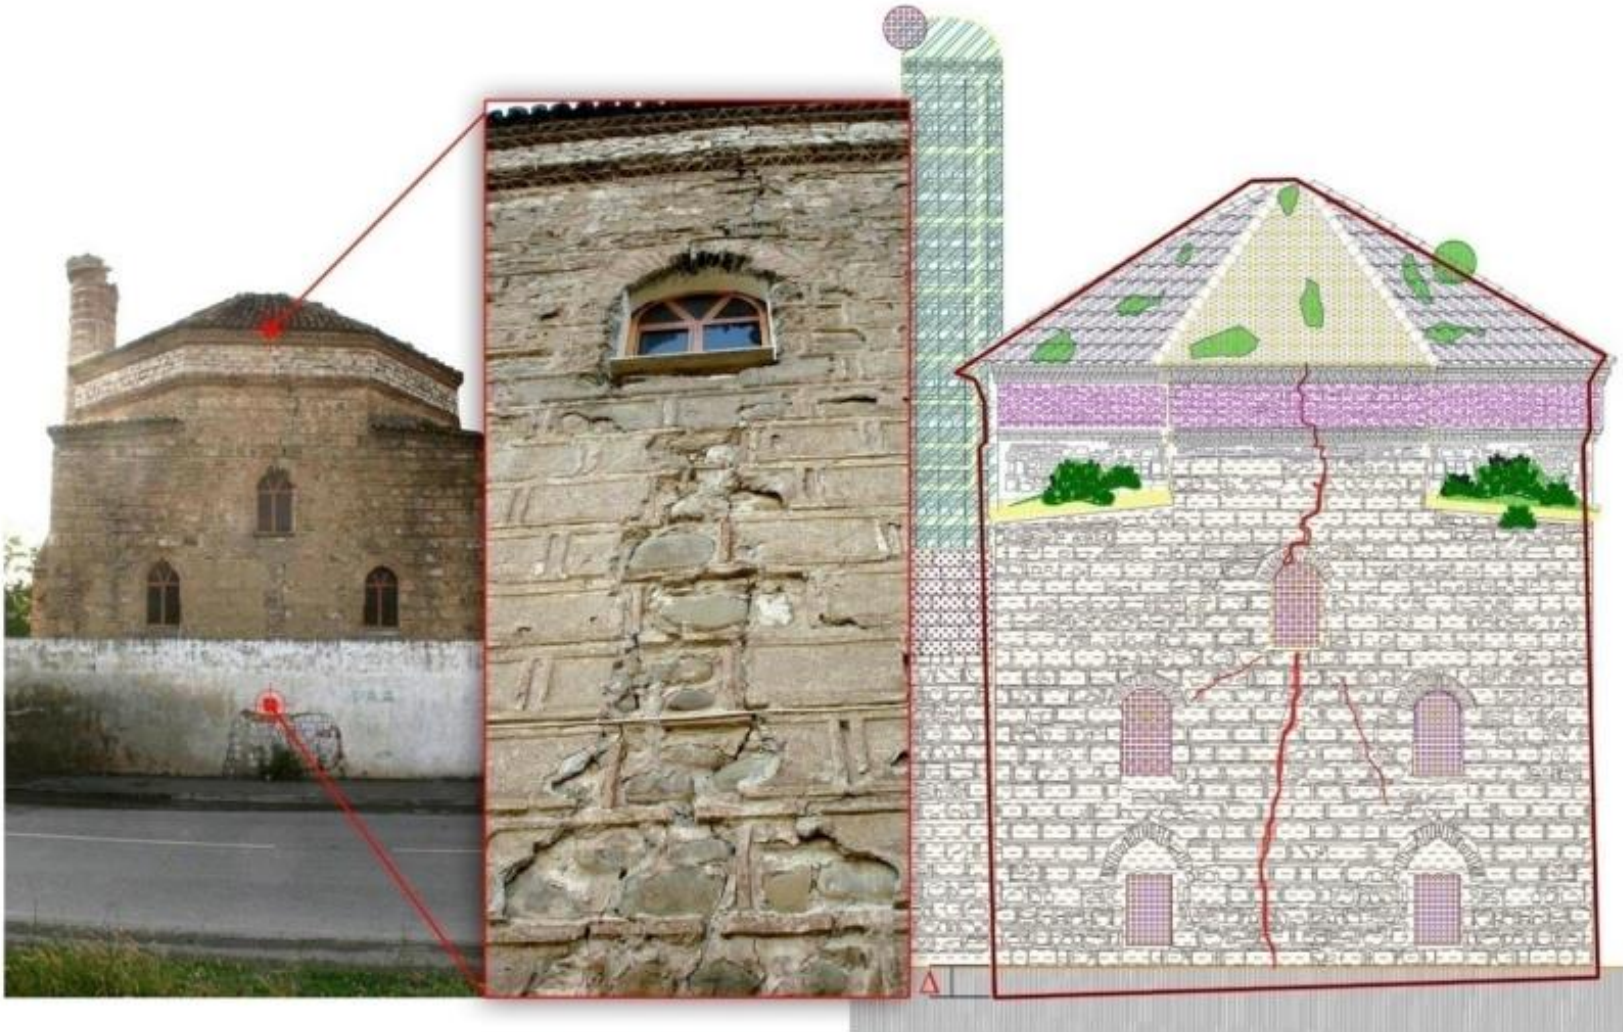
Cracks on the structure due to differential settlement.

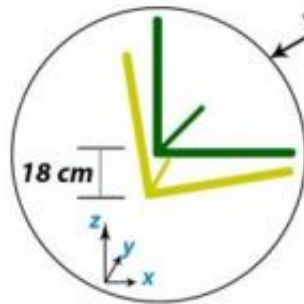
Deformation at the S-E edge of the mosque

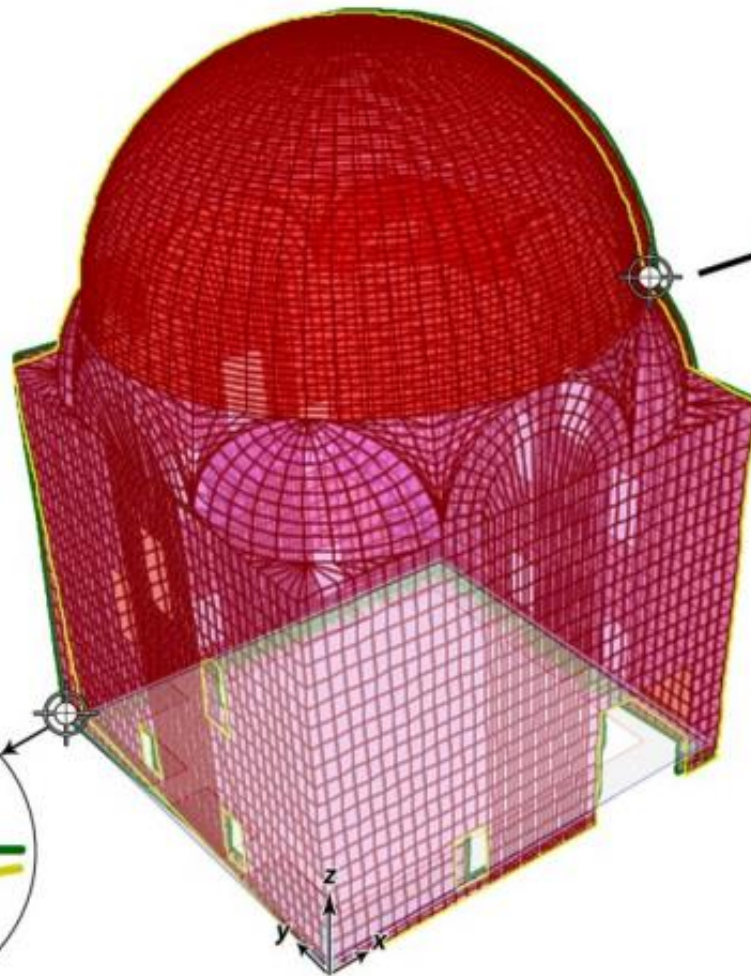
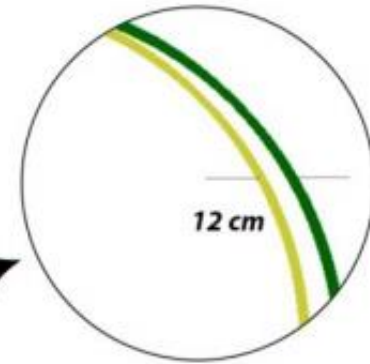
Deformation of the structure at the S-E corner.

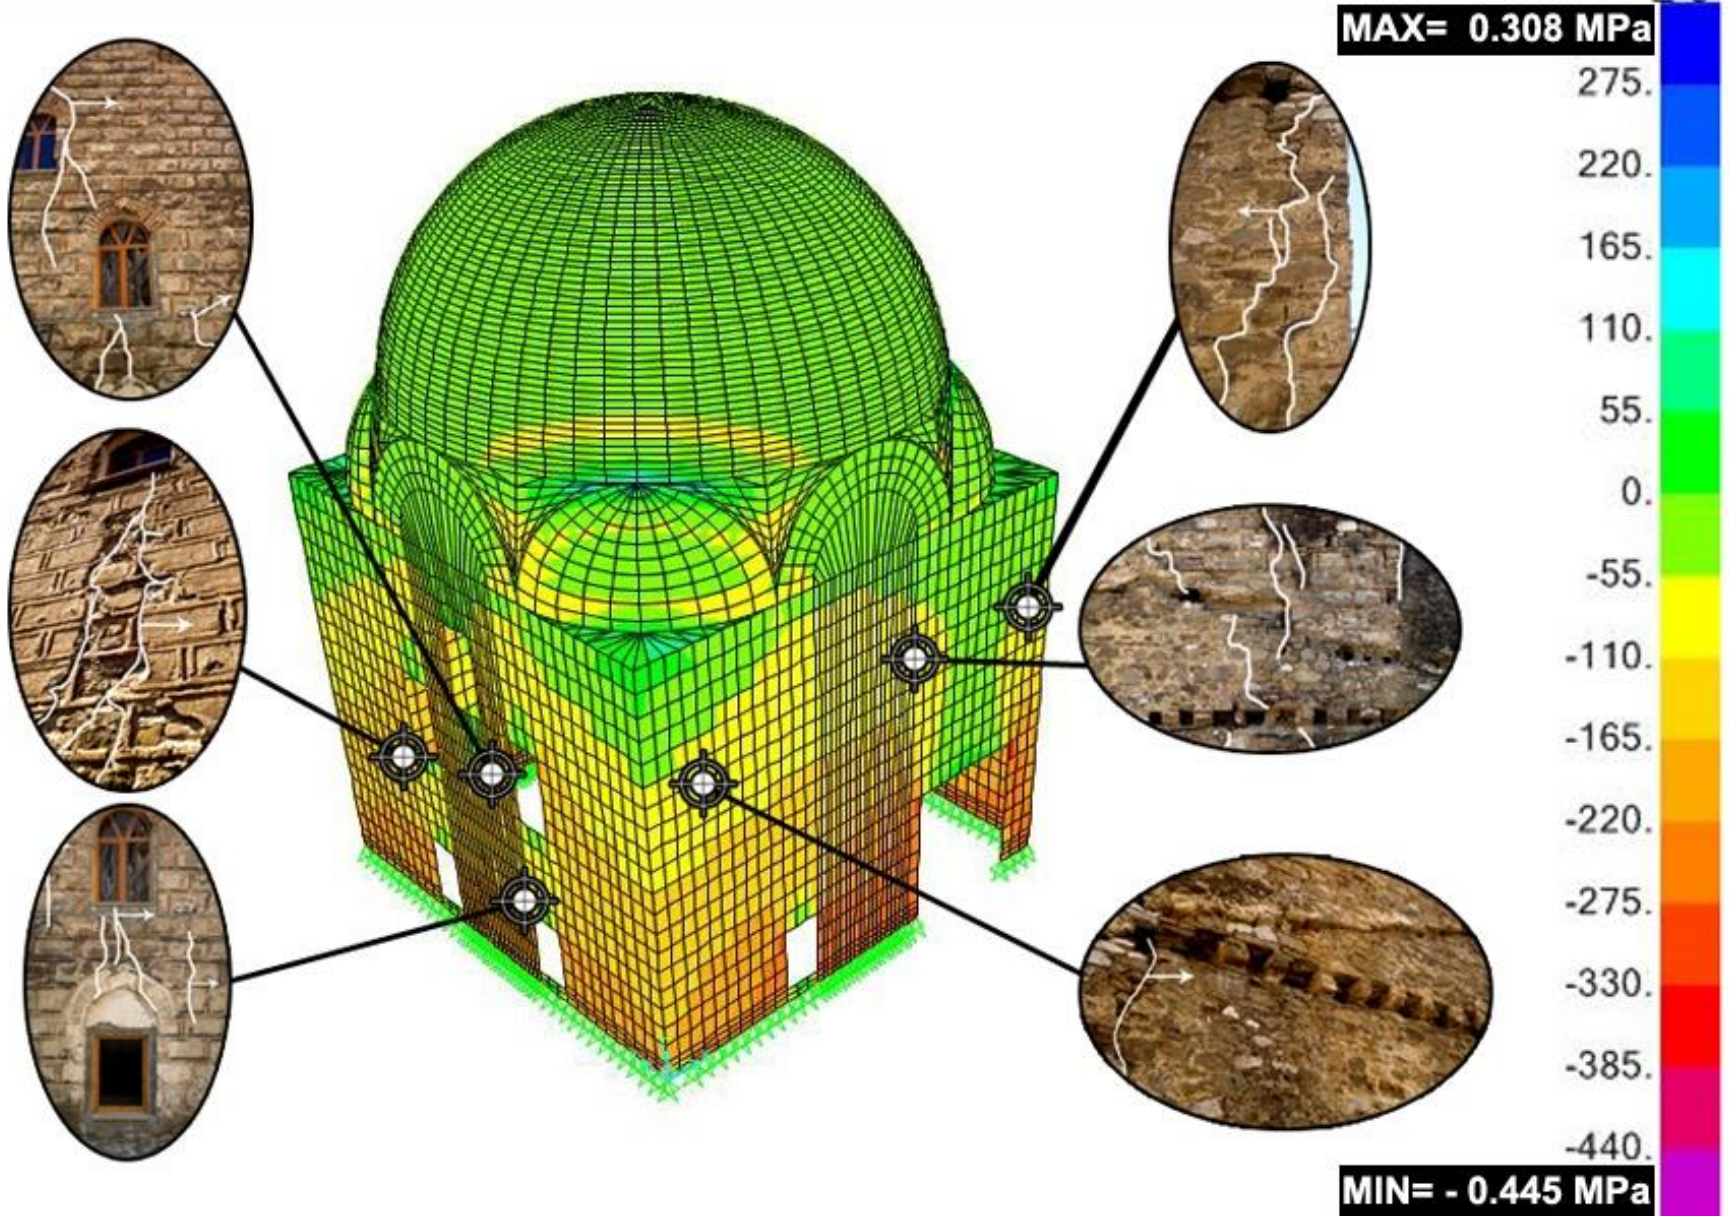
MAX= 0.308 MPa

MIN= - 0.445 MPa

- ❖ Additional tensile and shear resisting elements should be added where necessary and injection should be applied where voids are seen.
- ❖ In areas where non-structural cracks less than 10 mm wide are found, injection technique should be used.
- ❖ Structural shear and tensile cracks near the openings should be repaired with longitudinal FRP bars bonded with epoxy resin or mortar.
- ❖ Local reconstruction “cucci scucci” technique is suggested to be used in the places sanding phenomenon is seen and where massive loss of building units is observed
