**Knowledge FOr Resilient soCiEty
(K-FORCE)**

**EARTHQUAKE GEOTECHNICAL RISKS
WHAT WE KNOW, WHAT WE SHOULD KNOW
LESSONS LEARNED**

Prof. D-r Vlatko Sheshov

**paper presented within
Special Mobility Strand - Teaching Mobility, Erasmus + programme
Open lecture in 2017/2018 at UNS,
8 May 2018, Novi Sad, Serbia**

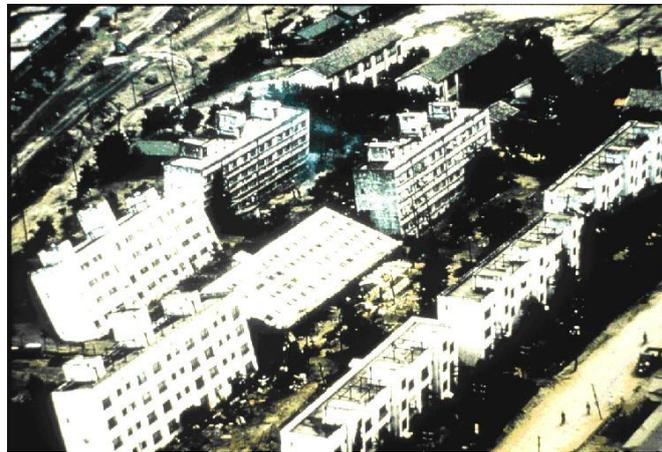
Fig.3.1 Overturning of residential buildings, Niigata, 1964

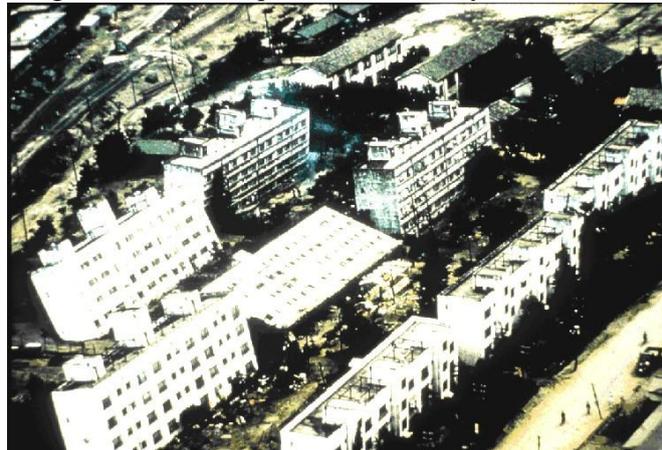
Fig. 3.6 Kawagishi-cho apartment complex, after the Niigata Earthquake 1964

Loss of Bearing Strength. When the soil supporting a building or other structure liquefies and loses strength, large deformations can occur within the soil which may allow the structure to settle and tip (Figure 3.8). Conversely, buried tanks and piles may rise buoyantly through the liquefied soil. For example, many buildings settled and tipped during the 1964 Niigata, Japan Earthquake. The most spectacular bearing failures during that event were in the Kawagishi-cho apartment complex where several four-story buildings tipped as much as 60 degrees (Figure 3.6). Apparently, liquefaction first developed in a sand layer several meters below ground surface and then propagated upward through overlying sand layers. The rising wave of liquefaction weakened the soil supporting the buildings and allowed the structures to slowly settle and tip. Figure 3.7 shows typical example of loss of bearing capacity due to liquefaction during the Izmit Earthquake 1999, Turkey.

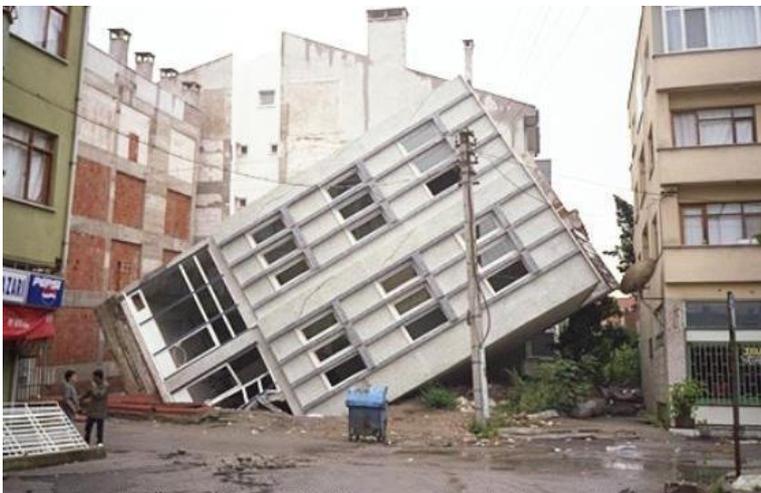
Fig. 3.7 Adapazari, Izmit Earthquake, Turkey 1999: August 17

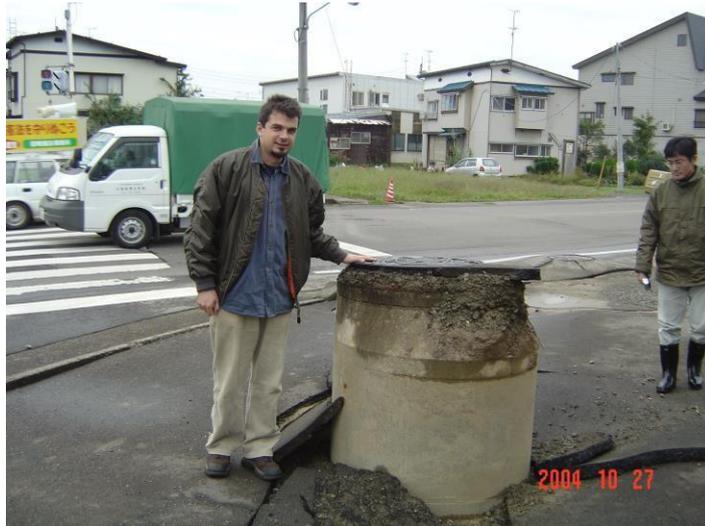
Fig. 3.8 A manhole uplifted during the 2004 Mid Niigata Earthquake

Buoyant rise of buried structures. Soil liquefaction can also induce buoyant rise of underground structure. Normally, the uplift of the buried structure is prevented by resistance from the adjacent soil. However, when soil liquefies, the soil loses its resistance and starts to behave like liquid with unit weight almost twice that of water. When the unit weight of the buried structure is less than that of the liquefied soil, floating of underground structures can occur. Figure 3.8 has been taken four day after Mid Niigata Earthquake 2004.

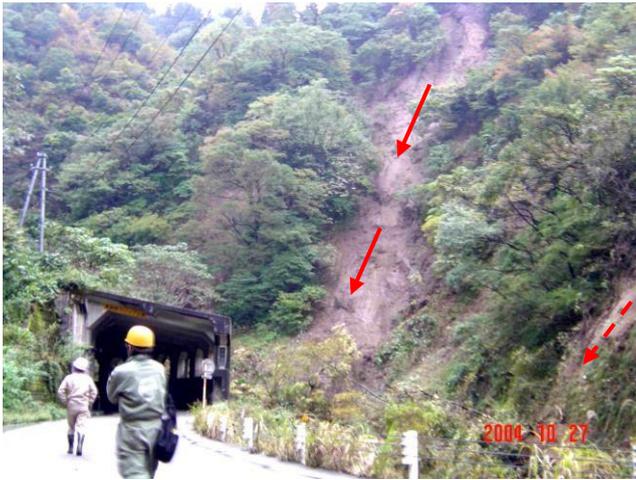
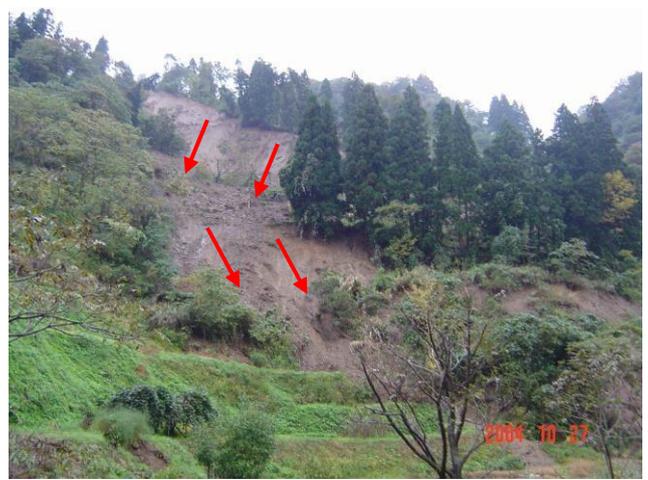
Photo 1- 1. Landslide in mild steep natural slope – due to ground topography sliding of the soil mass had different directions downward the hill. Red arrows indicate directions of sliding of the soil mass

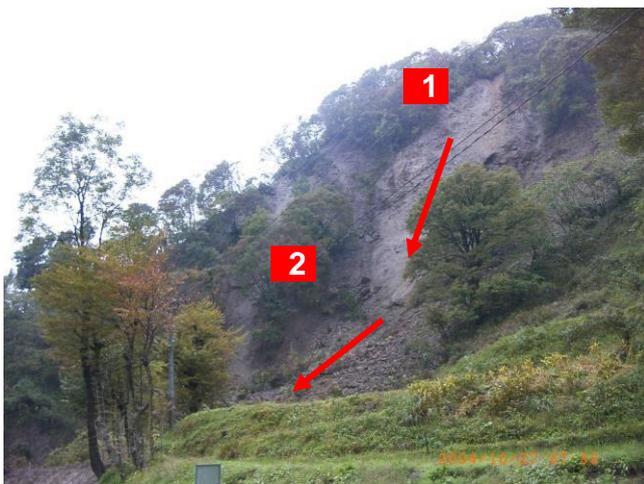
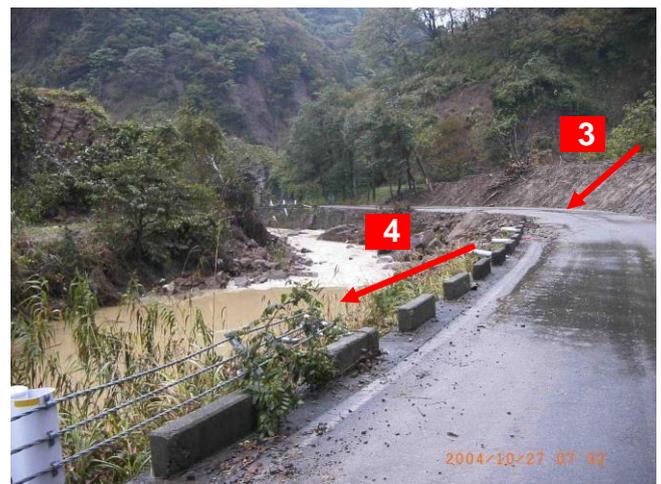
Photos 1-2 & 1-3 Middle sized landslide in natural slope occurred at this place and temporary blocked the local road and small river. Numbers indicate the steps of the soil movements

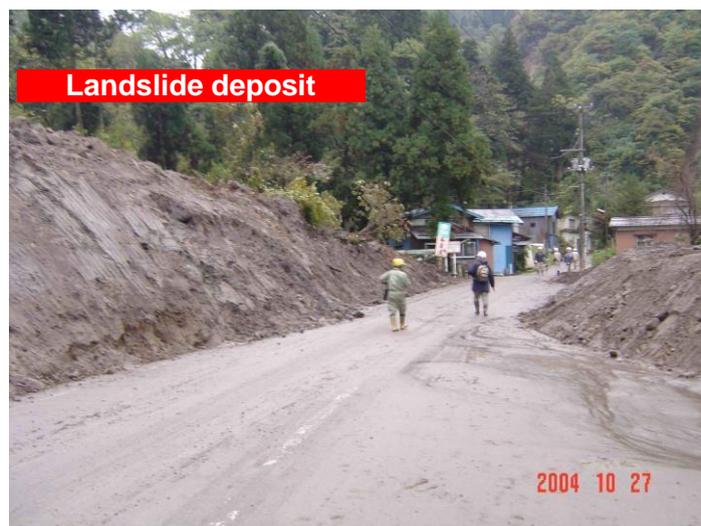
Photo 1- 4. Landslide mass temporary blocked the local road, emergency measures had been taken, landslide mass was removed from the road and traffic was enabled again. Place: Nigorisawa

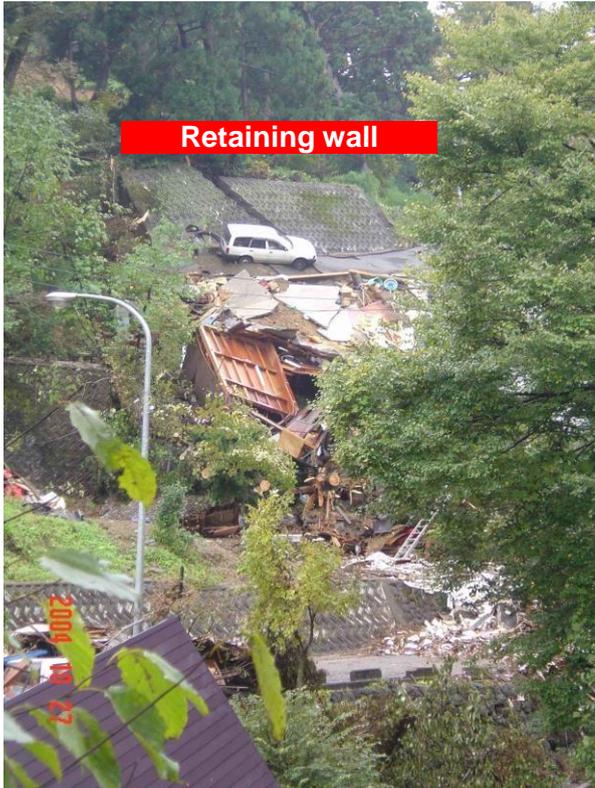
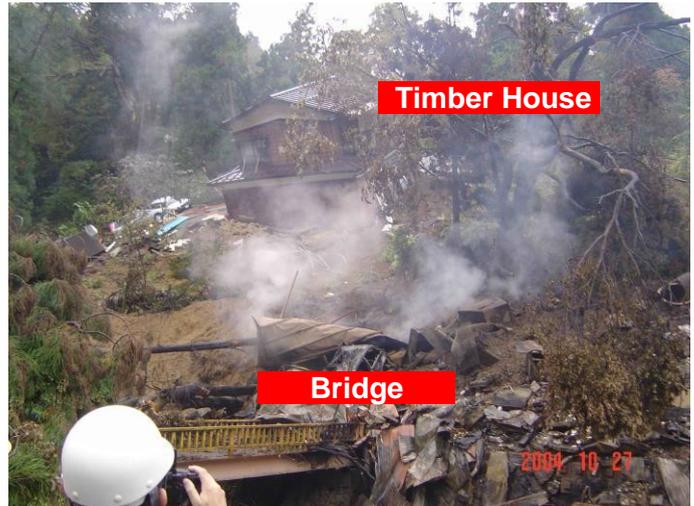
Photos 2-1 & 2-2. Large landslide took place destroying retaining wall and several houses. Soil mass moved more than 50 meters downwards. Place: Nigorisawa

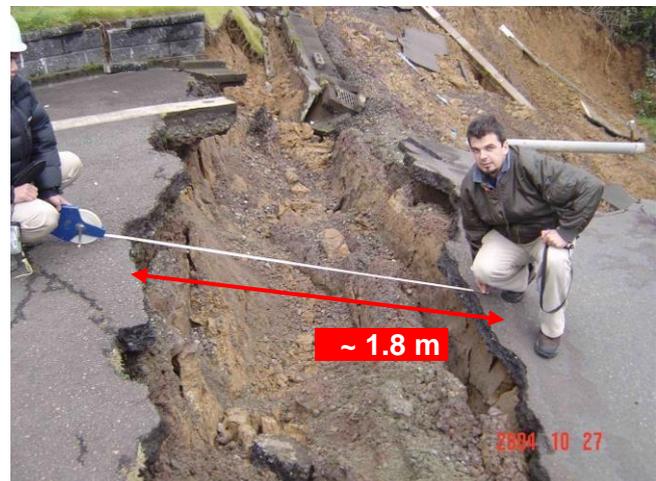
Photo 2-3 & 2-4 Several landslides took place in Takamachi residential area. Large cracks were formed due to soil movement within this area, varied from tens of centimeters to more than one meter. Roads and pipe lines were heavily damaged.

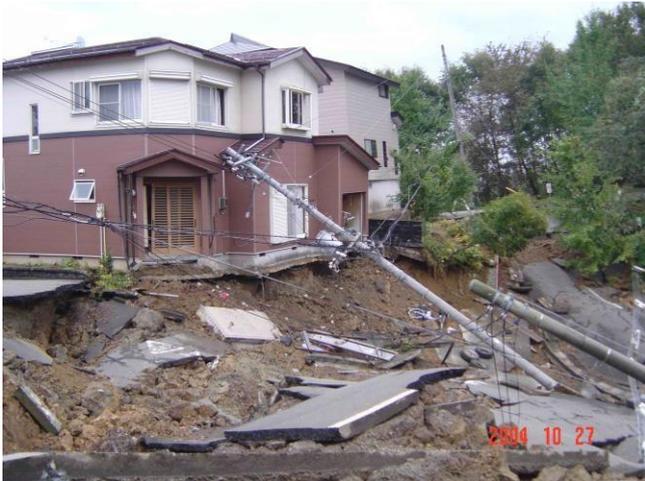
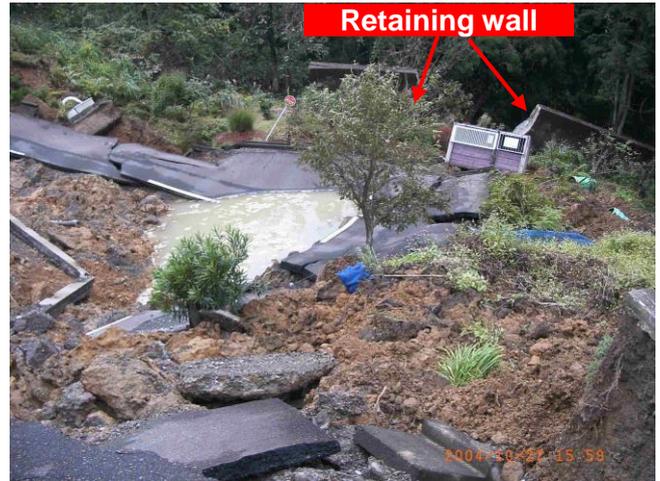
Photo 2-5 & 2-6. This residential area was located on small hill terrace. A ring road at the edge of this terrace was wiped off by the landslides on several places. The landslide mass scarped the surface layer just at the edge of the houses, left photo. The right photo also showed retaining wall which was destroyed by landslide.

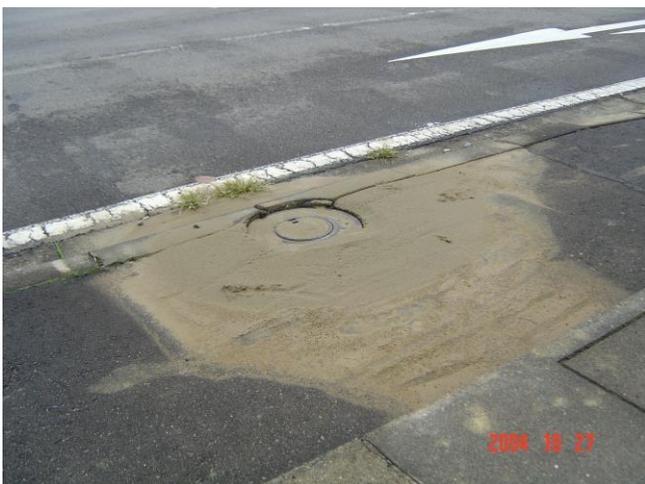
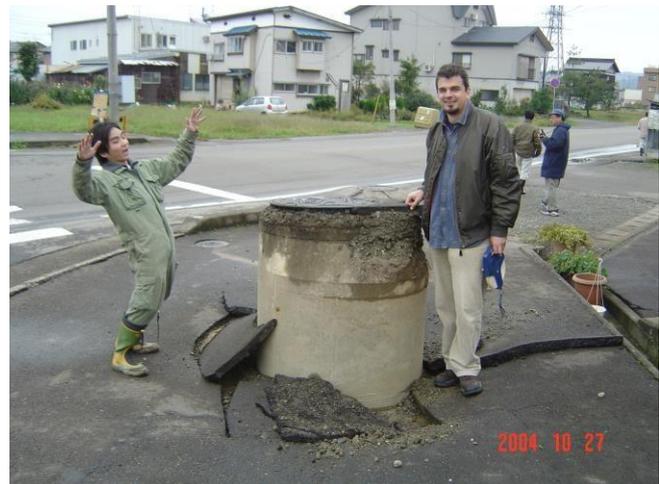
Photo 3-1 & 3-2 Manhole uplifted by buoyancy force due to liquefaction. Sand ejected from the ground was observed in the vicinity of the manhole

- Liquefaction. There were no significant liquefaction induced damages. Up-lifted manholes in Ojiya city and small sand boils in their vicinity were the evidence that liquefaction took place. Also small sand boils could be observed in the rice fields.

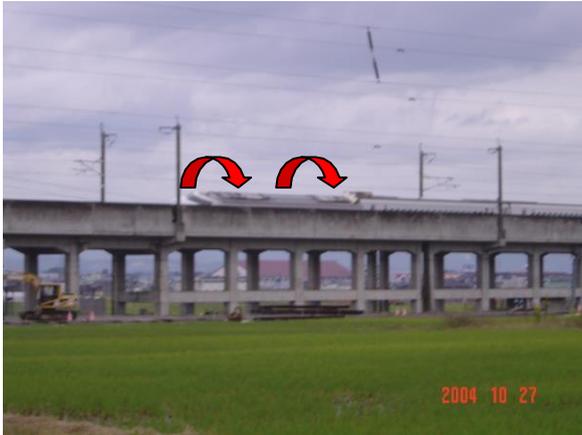
Photo 3-3 Derailment of Shinkansen,

The Super Express Train (Shinkansen) derailed due to the strong shaking. There were some damages on the piers located 10 to 100m away in the north direction from the derailed point. Liquefaction occurred at the foot of the piers which were 10 to 20m away in the north direction from the above-mentioned piers, and the boiled sand reached 70 to 90cm. The gap between the pier and the ground indicates the large displacement the pier experienced. (Honda Riki et al)

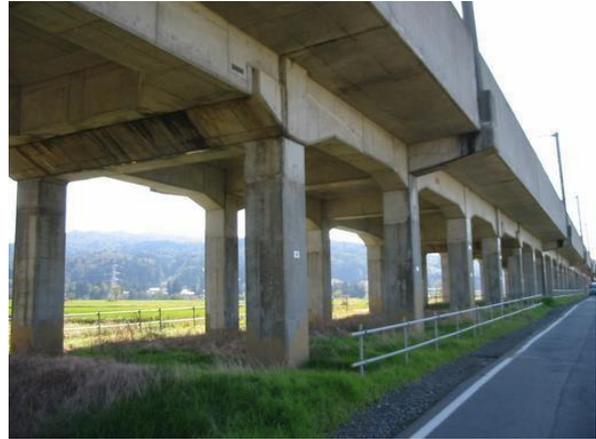
Photo 3-4 Rigid RC elevated railroad

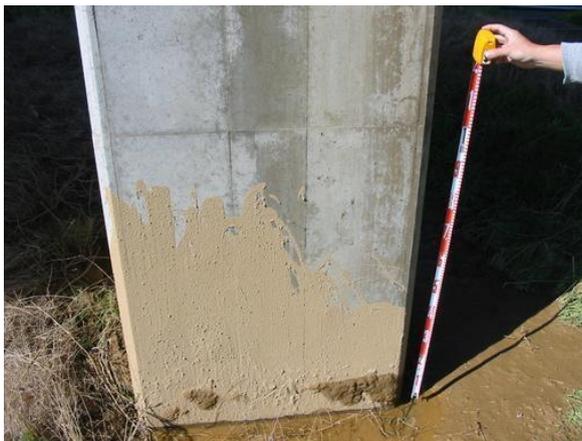
Photo 3-5 Sand boils next to pier

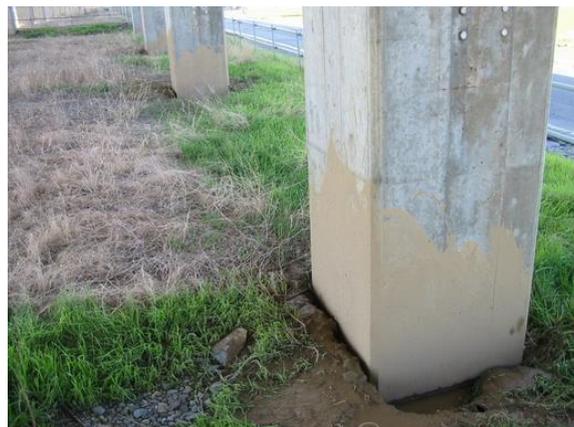
Photo 3-6 Open gap between pier and ground

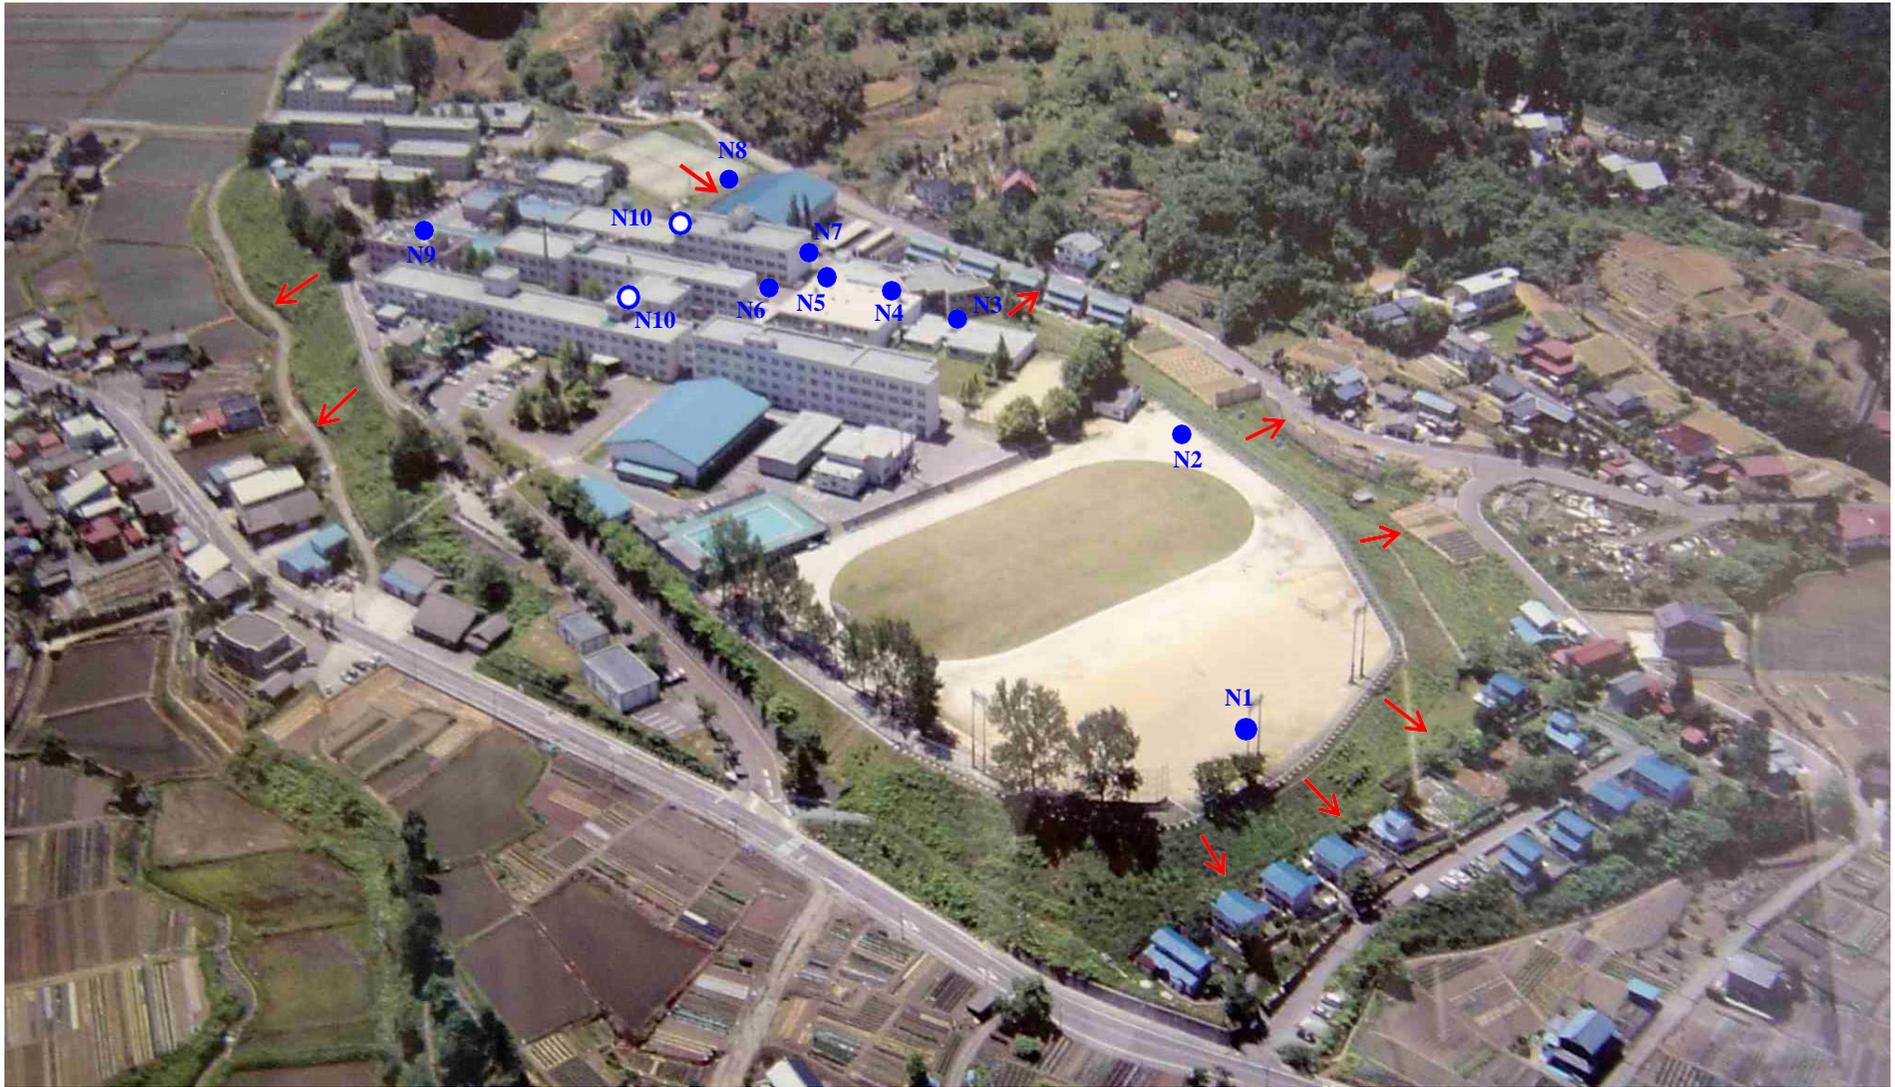
Photo 4-1 Nagaoka National College of Technology – aerial view. Red arrows indicate directions of the observed soil displacements. Blue circles indicate the places where the following photos have been taken.

Large lateral displacements and ground subsidence we observed at Nagaoka National College of Technology which is located on small hill terrace in Nagaoka city. Large cracks in the ground could be seen all over the campus area. Also soil subsidence varied from tens of centimeters to nearly one meter and soil lateral displacement more then one meter occurred within the Campus area. Three and four stories reinforced concrete buildings founded on pile foundations at this College generally performed well during the strong shaking with limited damages on structural elements. Many of the embedded pipe lines were severe damaged due to large ground deformations.

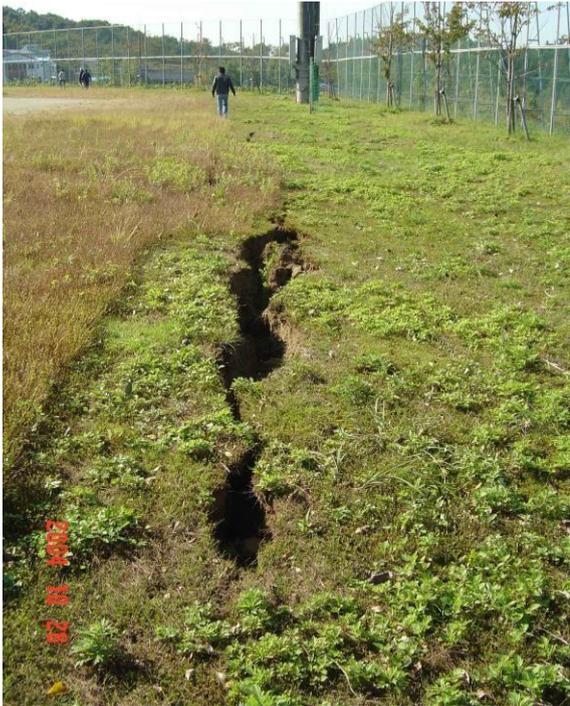
Photo 4-2. Soil moved toward the slope of the hill terrace and large cracks appeared at the ground surface. Place: N1, see Photo 4-1.

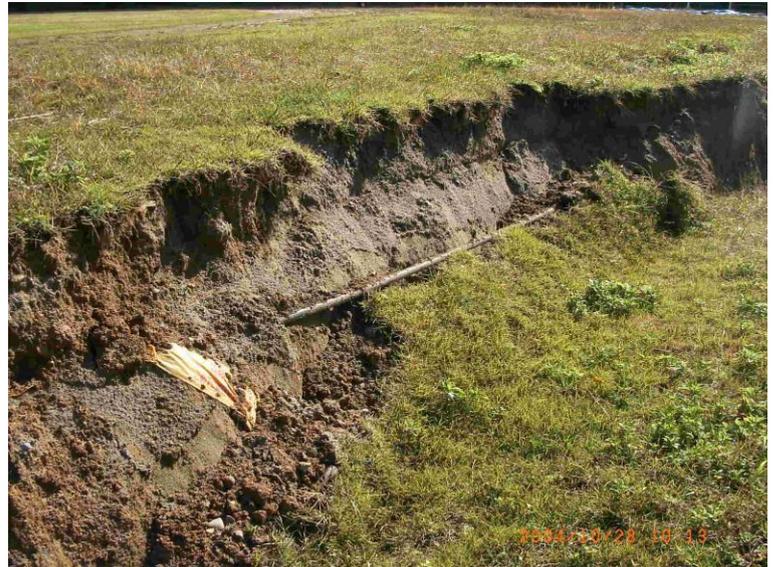
Photo 4-3. Ground subsidence of nearly 1 m at the college playground. Place: N2, see Photo 4-1.

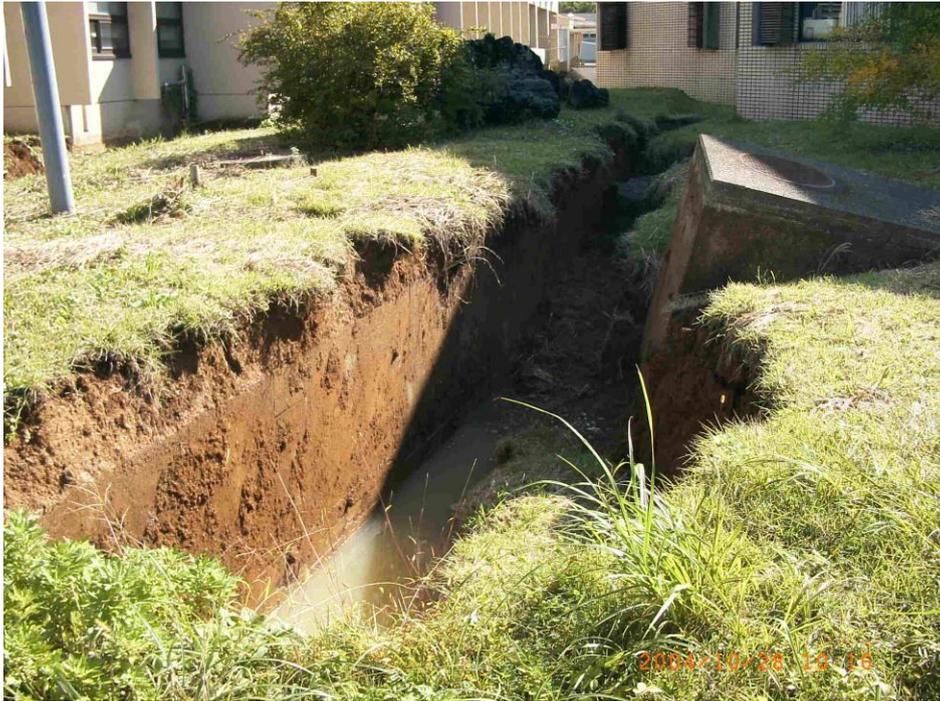
Photo 4-4. Fill material separated from underground concrete structure due to large permanent soil displacement. Place : N3, see Photo 4-1

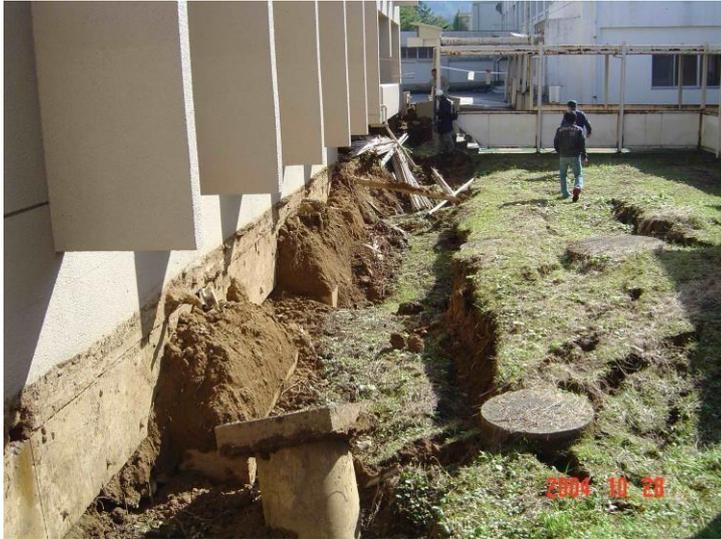
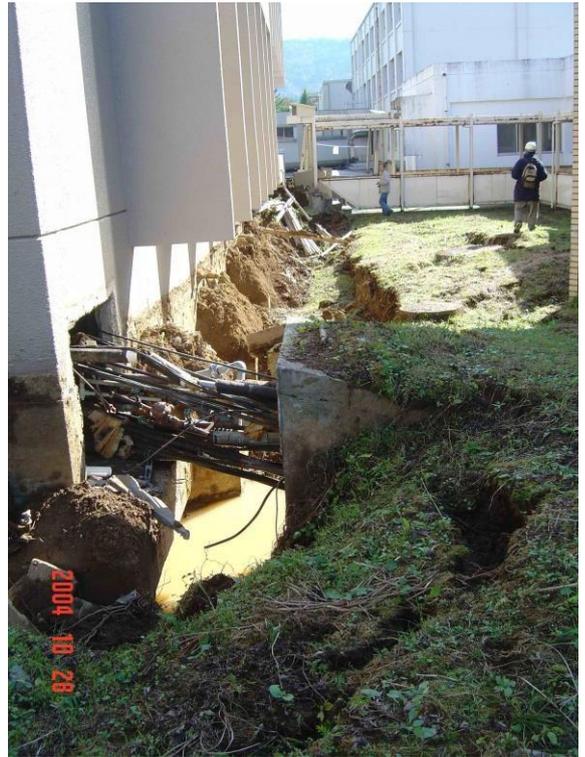
Photo 4-5 & 4-6. Large ground deformation was observed between two buildings. RC building which is shown at the left side of the Photos, lay on pile foundation and we didn't observed any significant visual damages. Surrounding soil was completely deformed with large soil displacement and settlements heavily damaging the embedded pipe lines. Place: N4

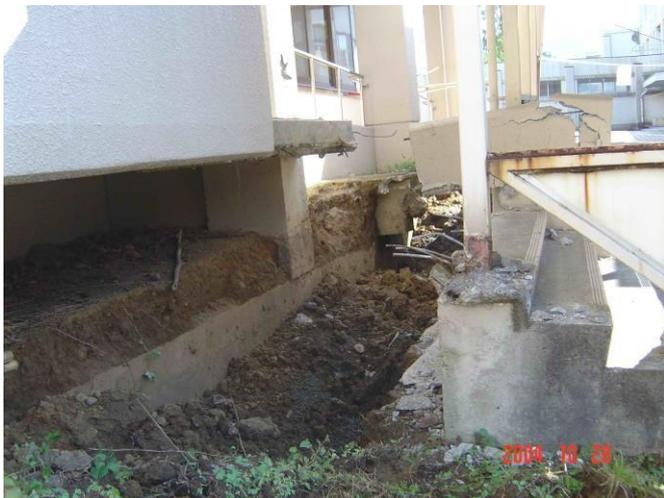
Photo 4-7 Stairs which lead to entrance of the building (Photo 2-17) were break apart and separated from the building. Place: N5

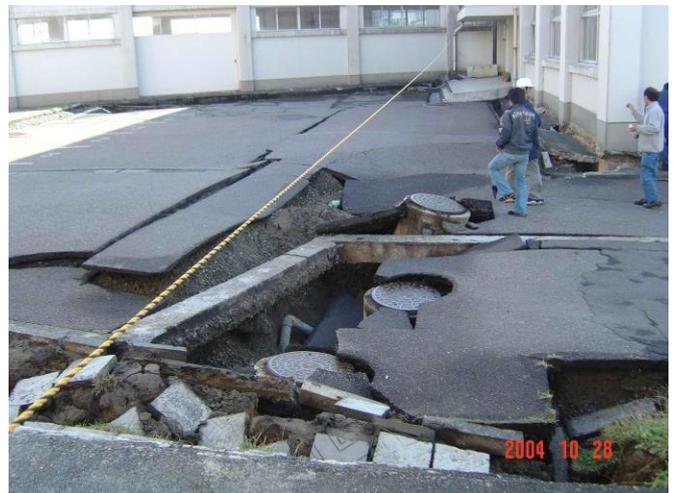
Photo 4-8 Asphalt pavements and embedded pipe lines were heavily damaged due to ground deformation. Place: N6

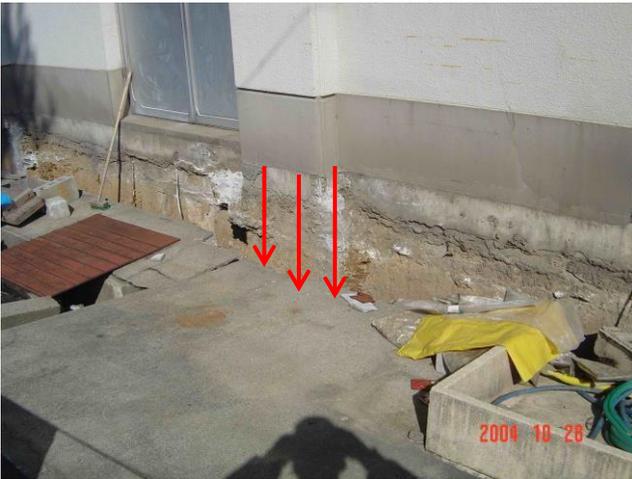
Photo 4-9. Soil settlements up to one meter were observed near to this three stories building which is founded on pile foundation. Place: N7
