# **SPECIAL MOBILITY STRAND**

**THE IMPORTANCE OF CONCRETE DURABILITY IN RC STRUCTURES**  
**ERION LUGA, PhD**  
**NOVI SAD 05.03.2019**

*Epoka University*  
*Department of Civil Engineering*

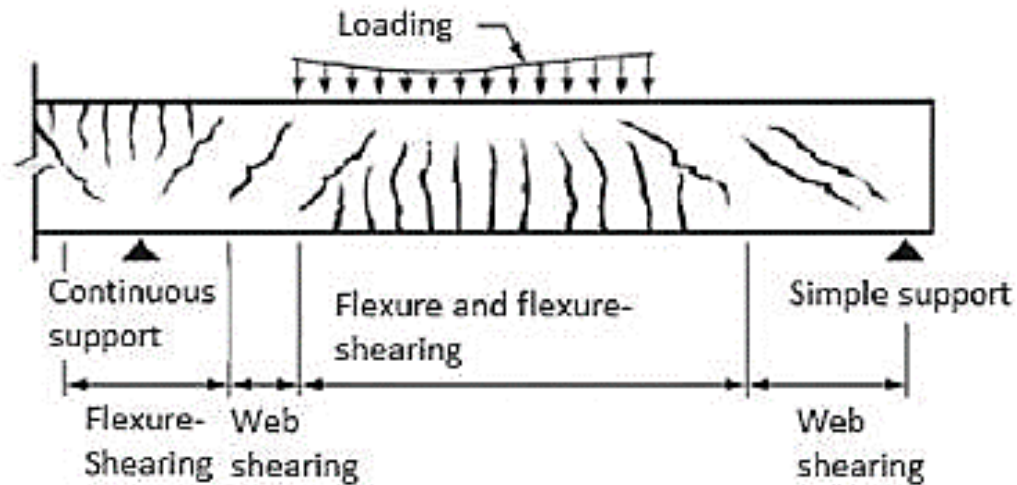
*Concrete cracks when the tensile stresses > maximum tensile strength.*

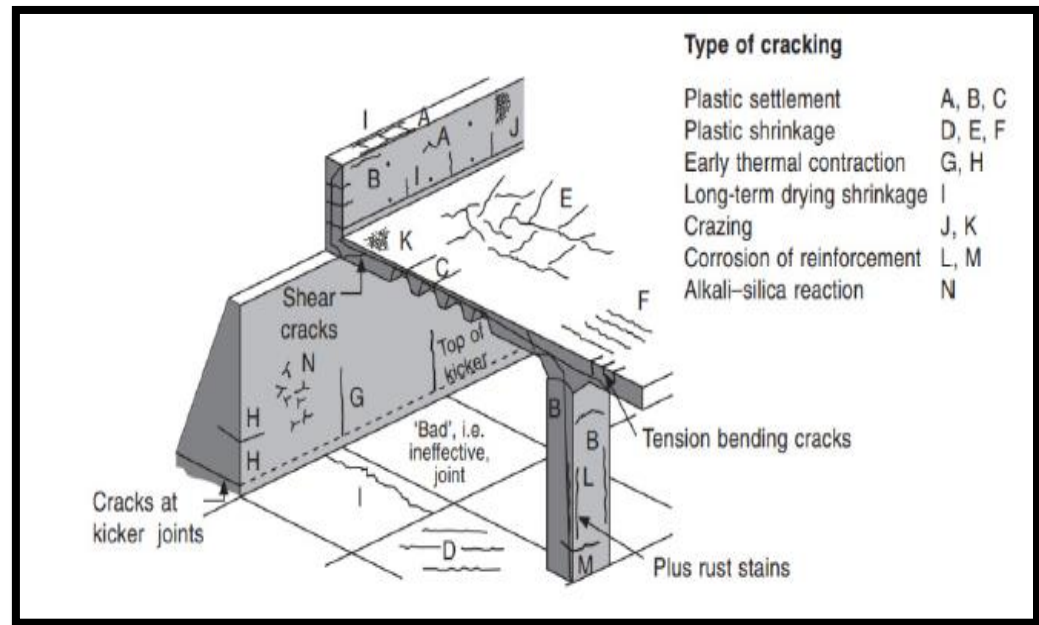
Types of cracks (Day, R. and J. Clarke, 2003)

Cracks can occur in hardened or unhardened concrete and may be caused by some of the following conditions:

- *Plastic Shrinkage cracking*
- *Plastic Settlement cracking*
- *Structural cracking*
- *Rust cracking*
- *Thermally-induced cracking*
- *etc*

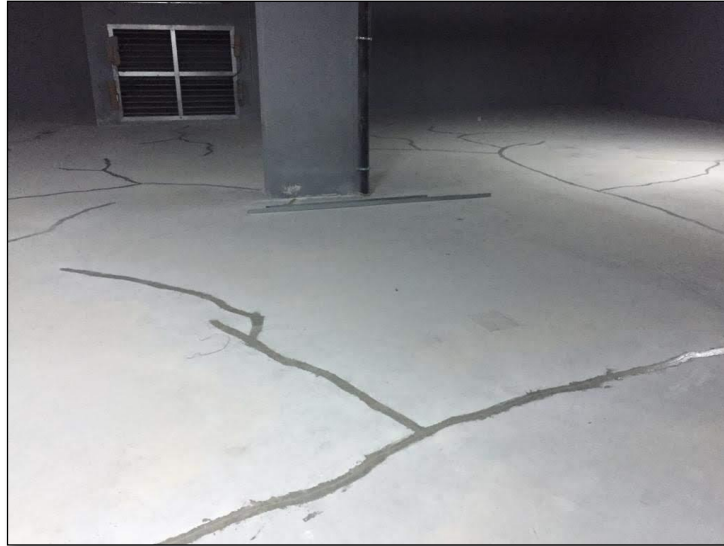
➤ *Plastic Shrinkage cracking*

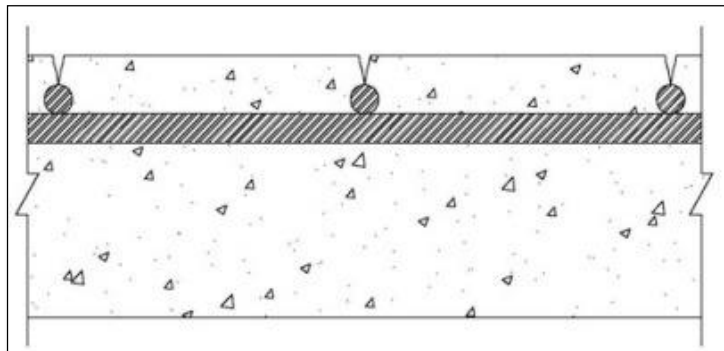
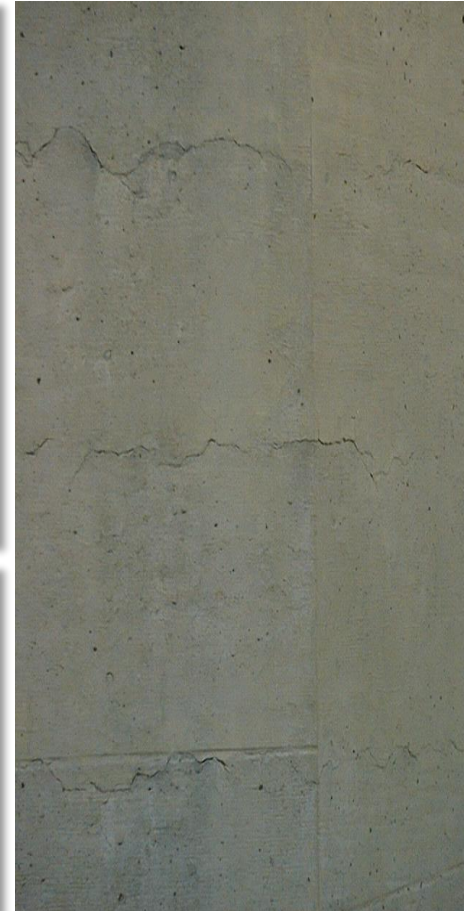
➤ *Plastic Settlement cracking*

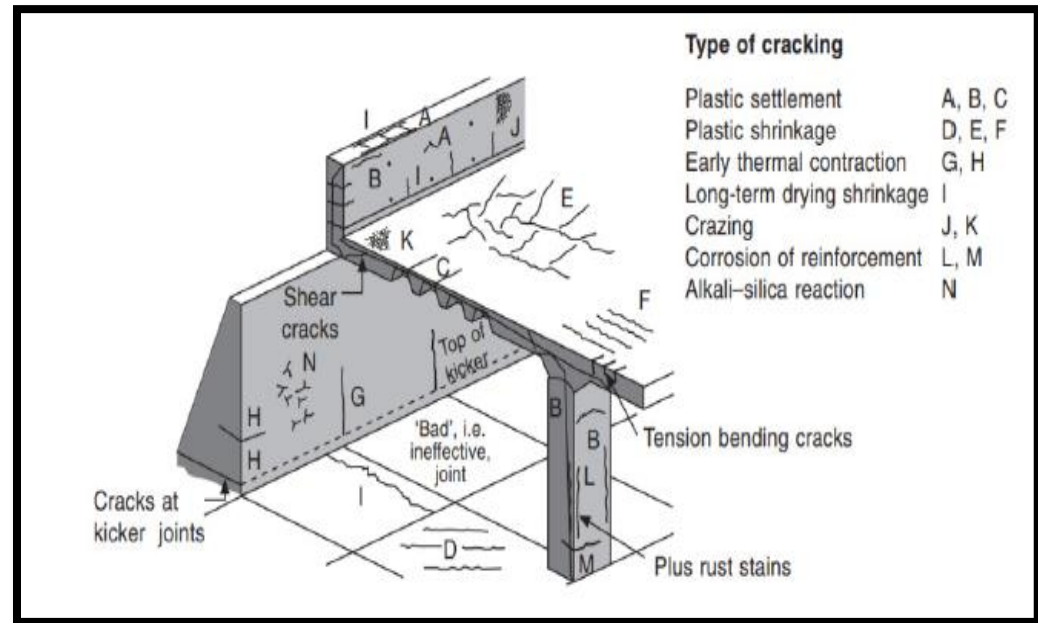
Types of cracks (Day, R. and J. Clarke, 2003)

- *Structural cracking*
- *Rust cracking*
- *Thermally-induced cracking*
- *Etc.*

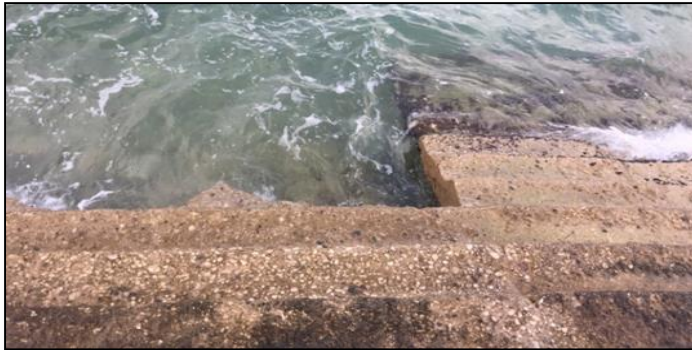
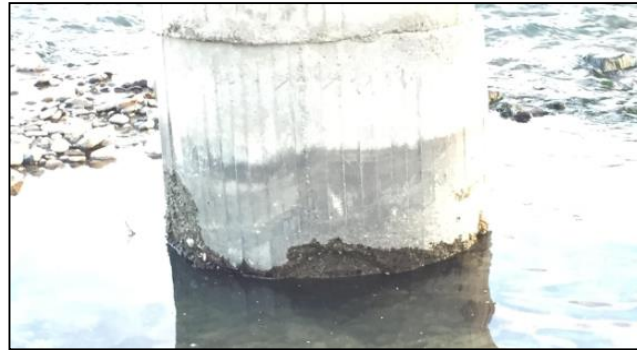
*The most damaging forms of abrasion occur*

- *on vehicular traffic surfaces,*
- *bridge piles,*
- *surfaces in contact with waves etc.*

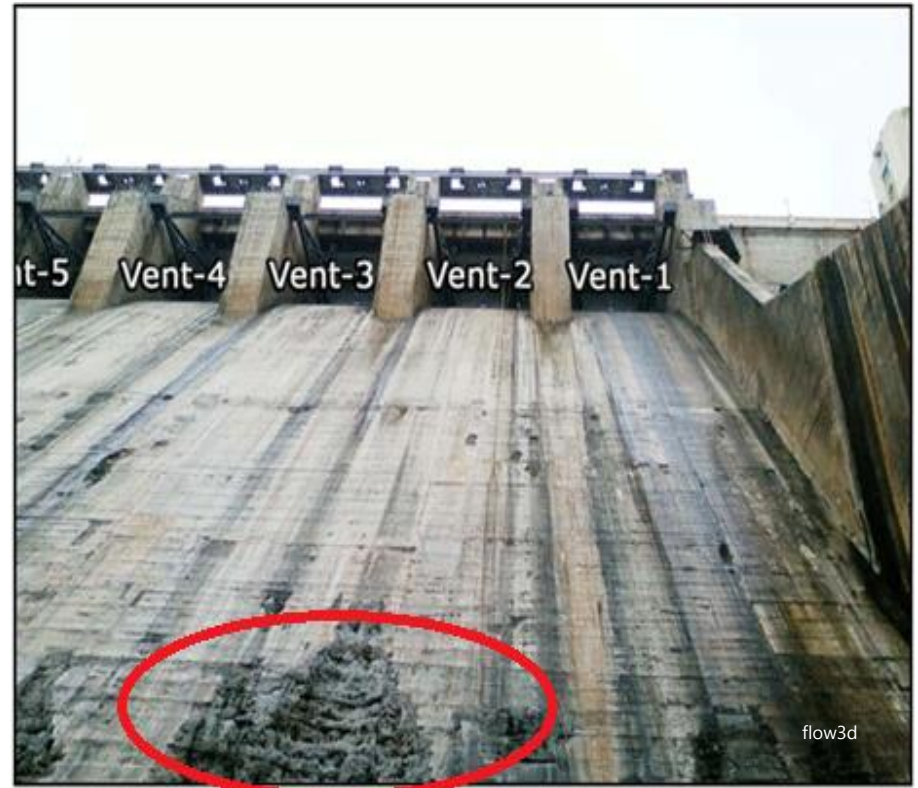
- *Formation of bubbles or cavities in a liquid.*
- *The cavities form where the local pressure drops to a value that will cause the water to vaporize at the prevailing fluid temperature.*
- *Cavitation damage is produced when the vapor cavities collapse, causing very high instantaneous pressures that impact on the concrete surfaces, causing pitting, noise, and vibration.*

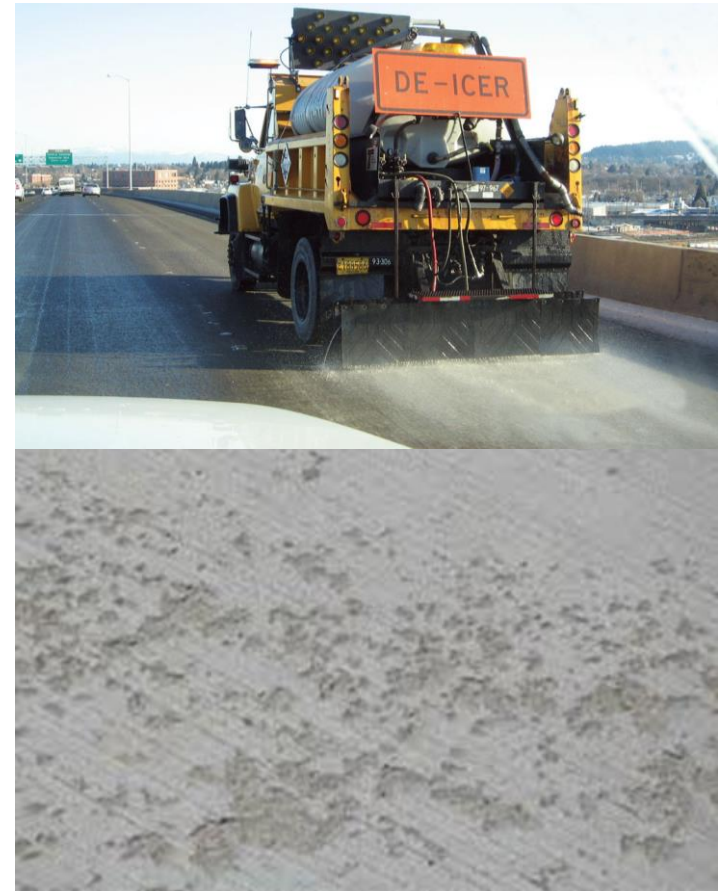
- *Deicing chemicals, such as sodium chloride, can aggravate freeze-thaw deterioration.*
- *Osmotic and hydraulic pressures in excess of the normal hydraulic pressures produced when water in concrete freezes.*
- *Salt absorbs moisture, it keeps the concrete more saturated, increasing the potential for freeze-thaw deterioration.*

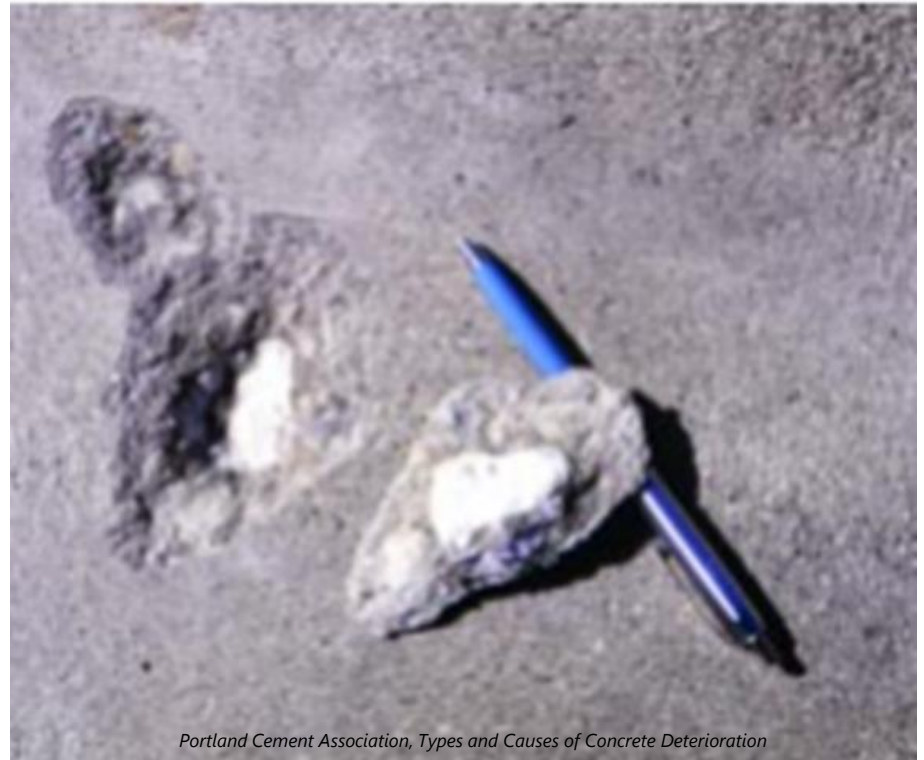
- Some aggregates absorb too much water, expand and increase hydraulic pressure during the freezing of water.
- Also aggregates such as CaO expand about 2.5-3 times in the presence of moisture.
- Concrete disintegrates if these are in high quantity.
- If it is near the surface of the concrete, it can cause a pop out.

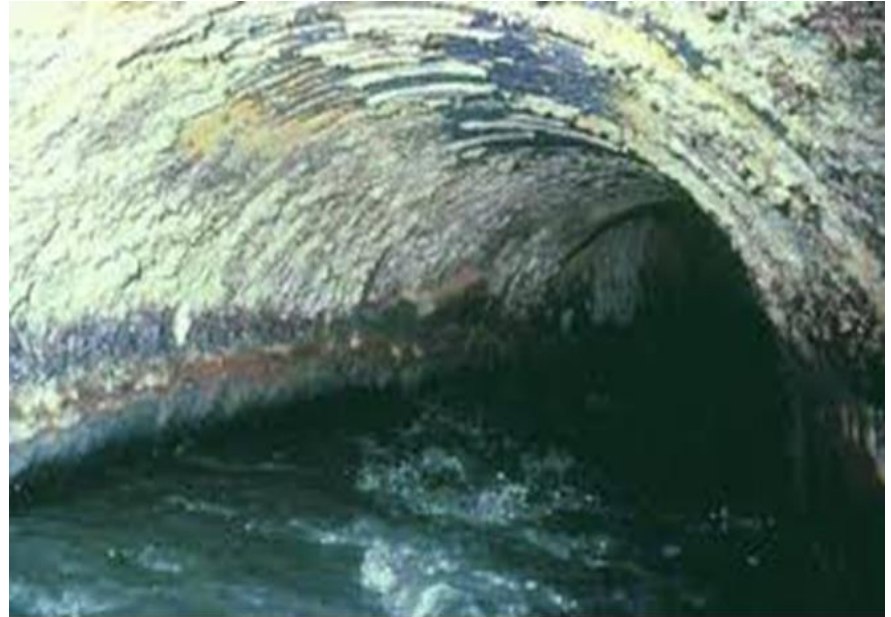
- *Portland cement concrete is not resistant to acids or solutions with a pH of 3 or lower.*
- *It may resist to some weak acids if the exposure is occasional.*
- *Acids react with the calcium hydroxide of the hydrated Portland cement.*
- *It forms water-soluble calcium compounds, which are then leached away by aqueous solutions.*

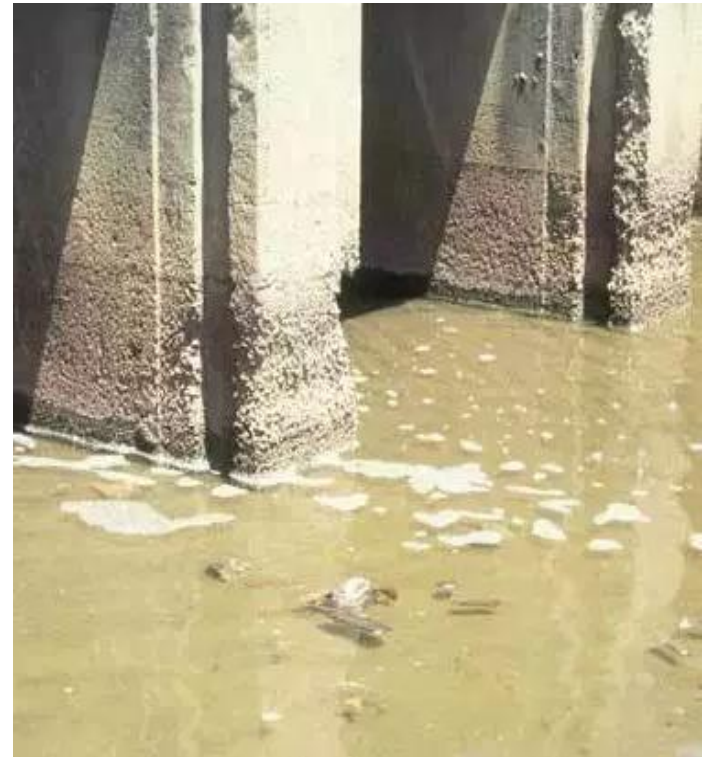
- *Sulfates of sodium, potassium, calcium, or magnesium are sometimes found in soil or dissolved in groundwater.*
- *React with aluminate compounds, calcium and hydroxyl of hardened Portland cement forming ettringite and gypsum.*
- *In the presence of sufficient water, these reactions of delayed ettringite formation cause expansion of concrete leading to irregular cracking.*
- *The cracking of concrete provides further access to penetrating substances and to progressive deterioration.*

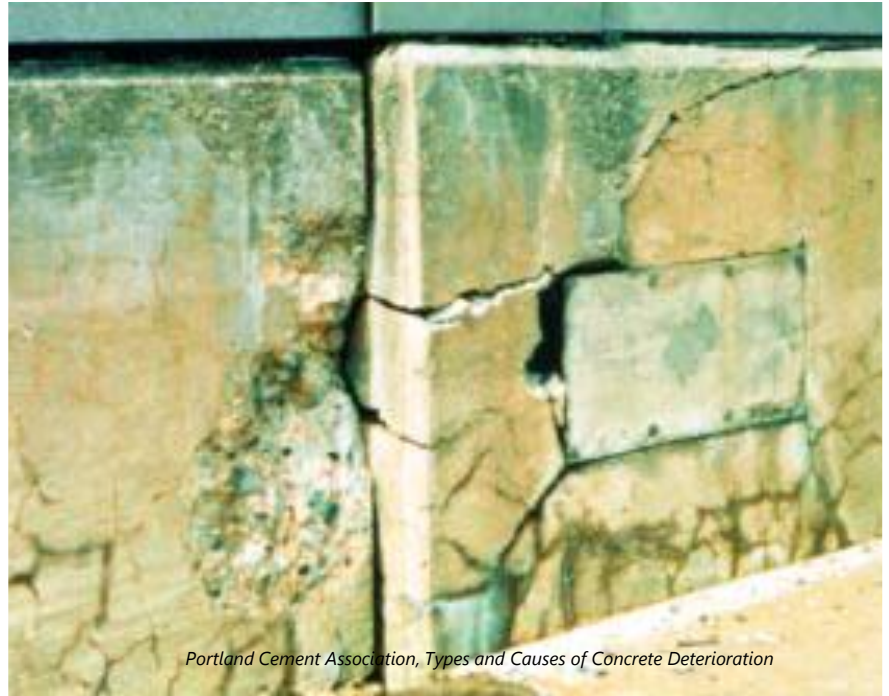
*Alkalies react with silica containing aggregates and not with cement.*

*Free alkalies present in cement dissolve in the mixing water and forming a caustic solution, which attack the reactive silica in the aggregate.*

*The alkali silica gel so formed swells in the presence of moisture, and exerts osmotic pressure on the concrete internally.*

- *Alkalies + Reactive Silica → Gel Reaction Product*
- *Gel Reaction Product + Moisture → Expansion*

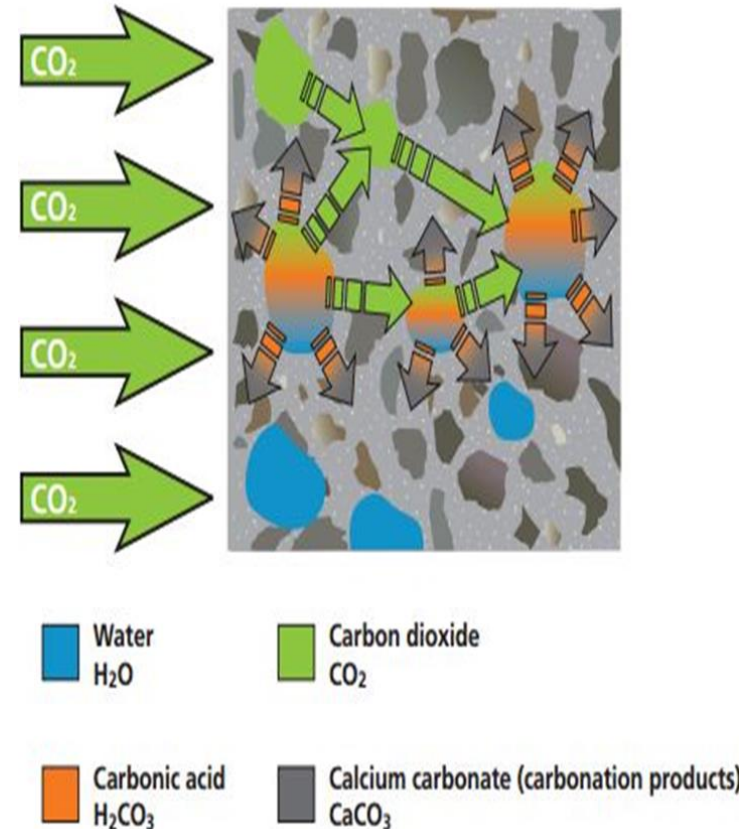
➤ The concrete will carbonate if CO<sub>2</sub> from air or from water enters the concrete according to:

When Ca(OH)<sub>2</sub> is removed from the paste hydrated CSH will liberate CaO which will also carbonate. The rate of carbonation depends on porosity & moisture content of the concrete.

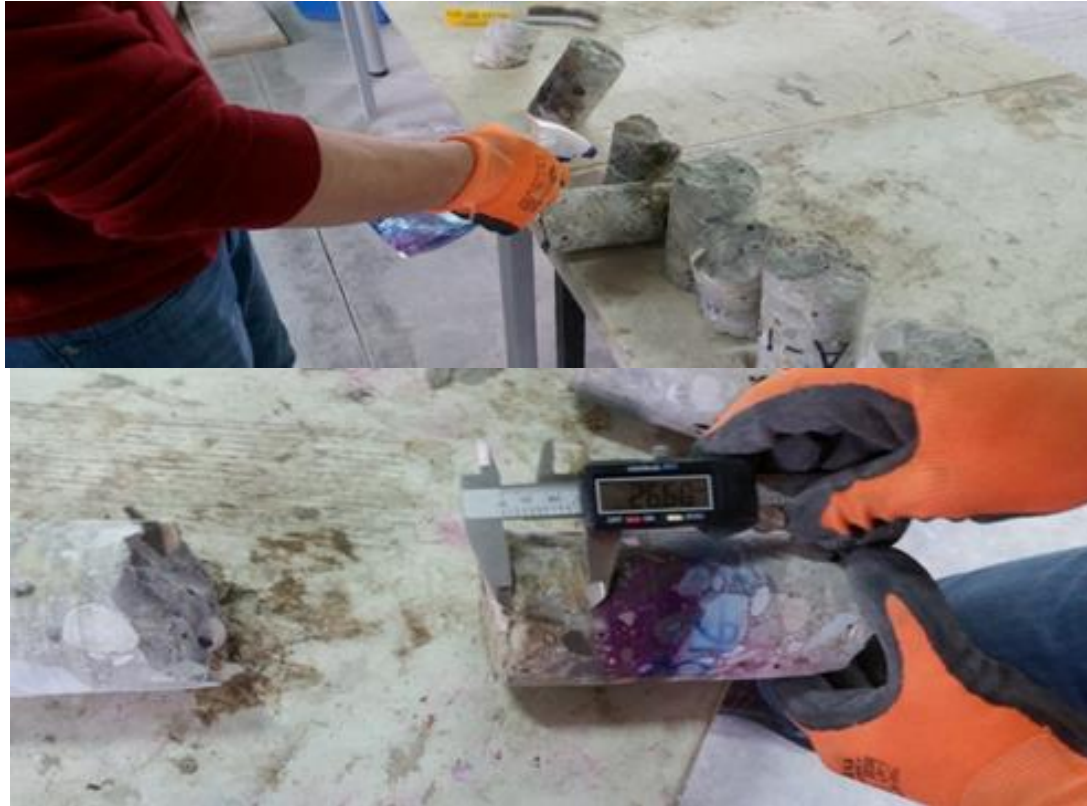
*Measuring of carbonation depth with Phenolphthalein solution*

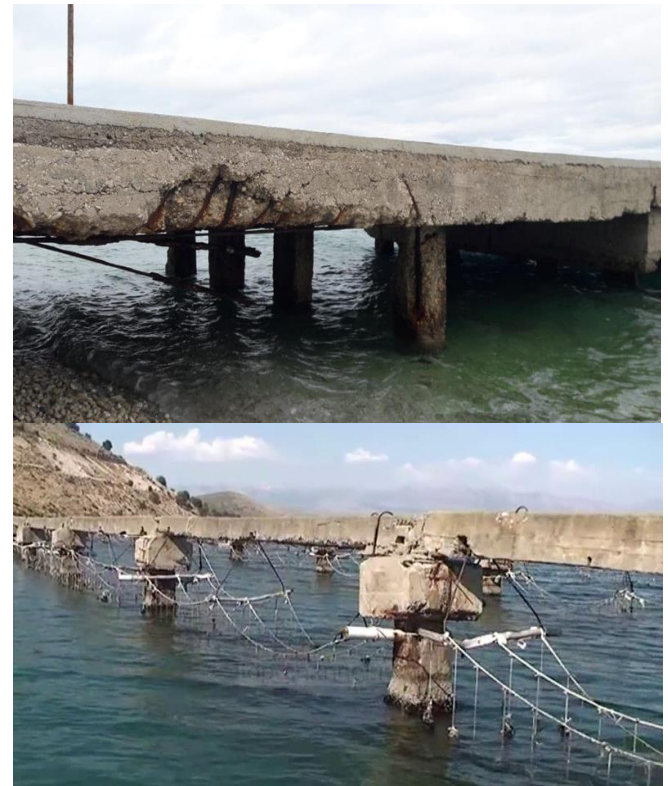
- *Submerged Zone, continuously covered by seawater,*
- *Splash Zone, subject to continuous wetting and drying*
- *Atmospheric Zone, subject to occasional seawater spray concrete.*

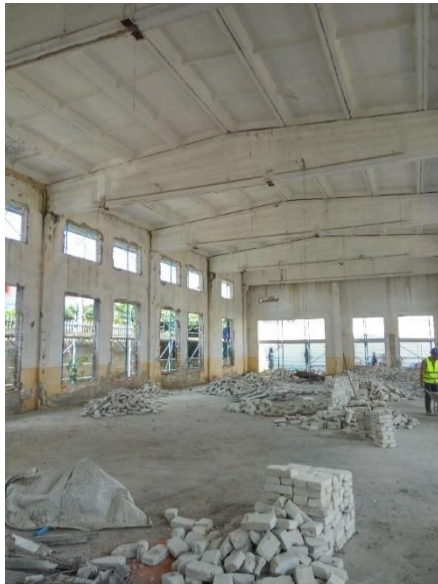
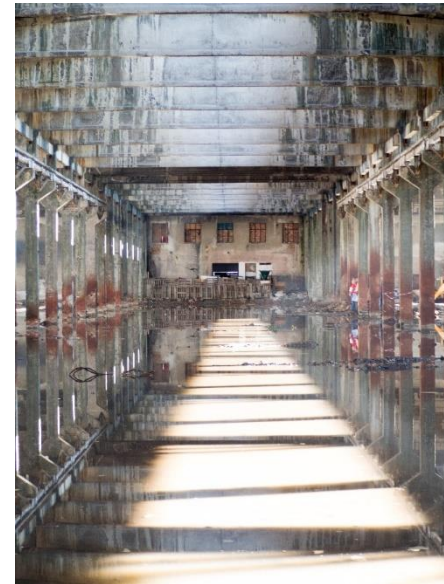
- a. A state protected building, "Ish NISH GOMA" in Durres, Albania;
- b. The construction is made in 1974;
- c. 43 years old;
- d. Composed of two main warehouses.

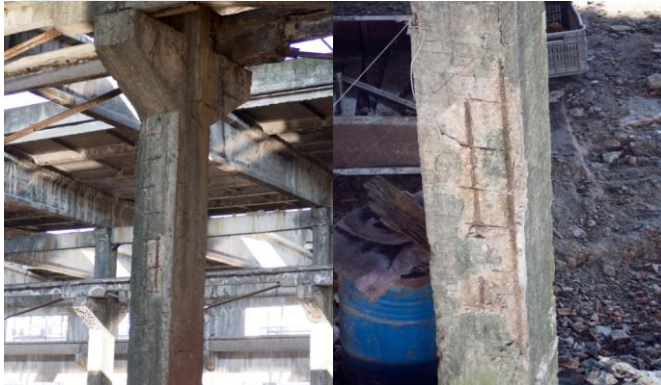
Columns of Existing Structure

- a) The structural elements - precast reinforced concrete produced in the construction site or in the precast production sites.
- b) The roof elements - beams with two different directions, covered by precast reinforced concrete plates.
- c) The problems noticed are:
  - Technological problems of the concrete cover;
  - Carbonation phenomena;
  - Moisture and water presence;
  - Lack of technical conditions and knowledge during construction;
  - Exposure class;
  - Lack of maintenance conditions of the inspected object.

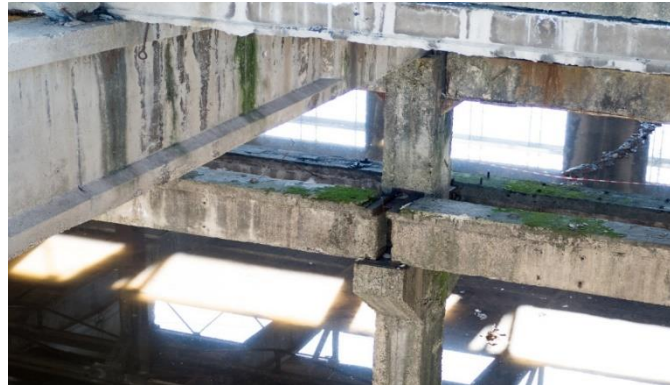
Joints of columns with beams

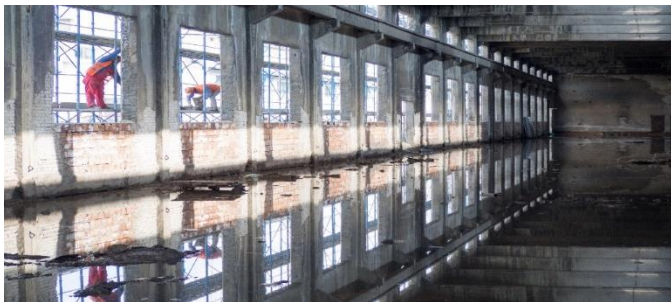
Existing Structural Beams

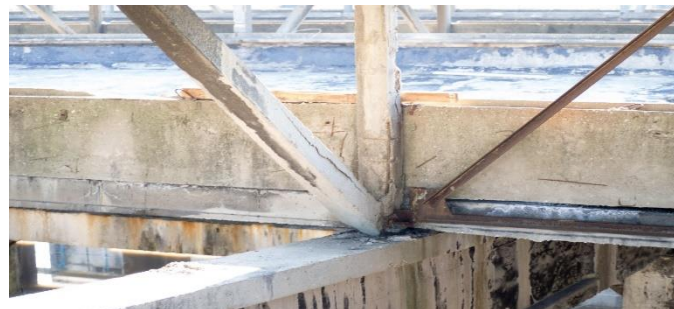
Existing Structure Cover

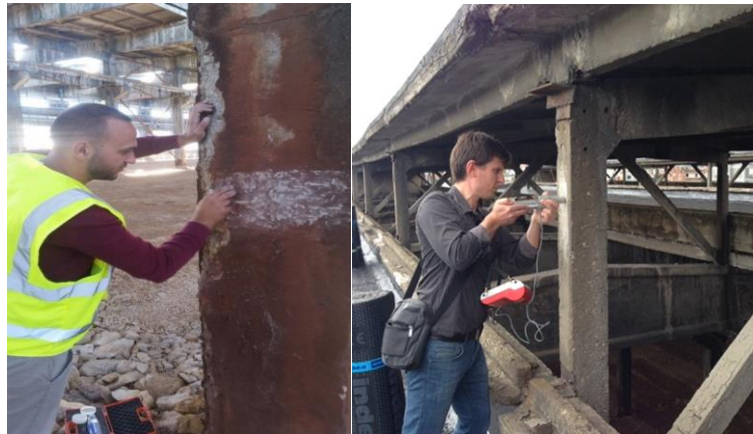
Used in the **vertically overhead** or **vertically downward** positions and in addition at any middle of the edge, given that the hammer is opposite to the surface under test. Before leading any estimations, we did the **cleaning process**. The distance from each **test point is 2 cm**. Were taken **10 values** and then were proceeded with the same steps for all the columns.

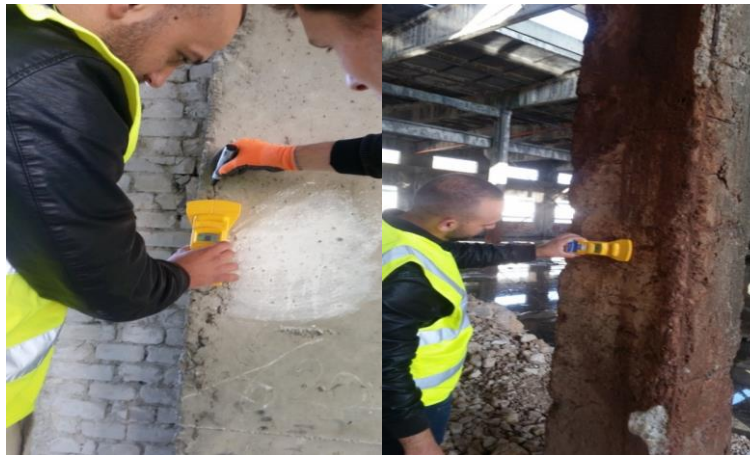
Finds in which section is the **steel located** inside the columns. After the detection of the steel, the zone where **the sample** would be taken was marked.

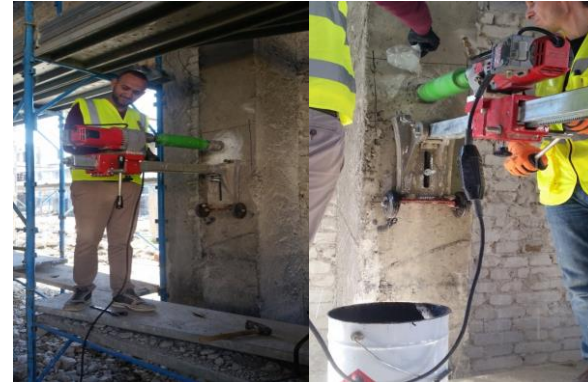
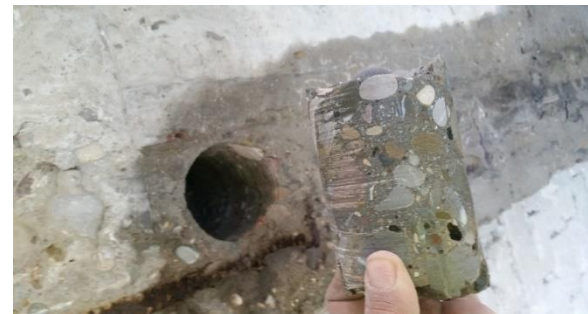
- a) Based on standard **S SHEN 13791**.
- b) After **concrete inspection**.
- c) First the **machine is fixed** in the column with screw.
- d) After, is proceed with the **taking of the sample** through drilling.
- e) In this study **11 cylindrical samples** were taken from the columns. The diameter of the core drill was 75 mm and all this test was performed with reference to EN 12504-1:2008.

Process of Core drilling test

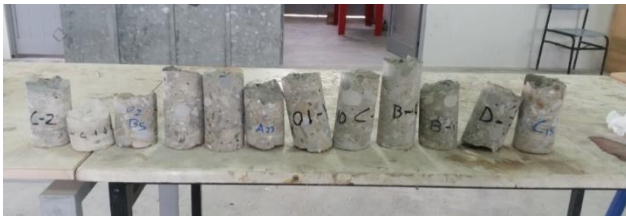
The samples provided from the case study building

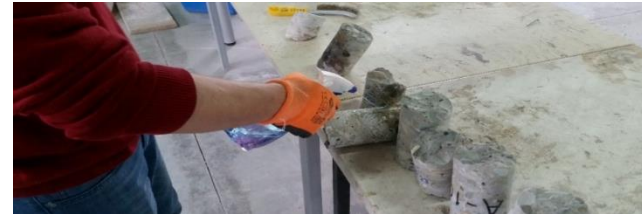
Performing carbonation test through phenolphthalein solution

- a) The depth of the carbonation was found using **1% phenolphthalein** that was prepared by dissolving 1gm phenolphthalein 90cc in ethanol.
- b) Then the solution obtained was **added to the extent 100cc with distilled water** and after that the solution was **sprayed on the surface** of the samples.
- c) The solution became on a **pink color** indicating the depth of carbonation.
- d) Later, the **carbonation depth** was measured using calibrated tool and some record for each of the sample was done.
- e) The average depth of carbonation is 22.43 mm.

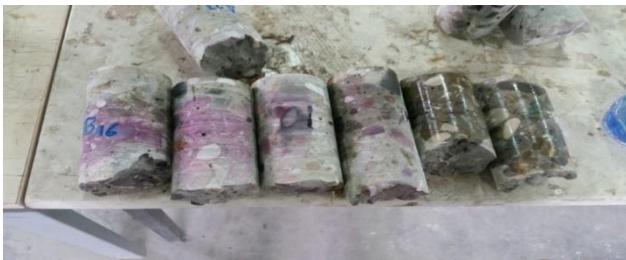
Visual results after applying phenolphthalein

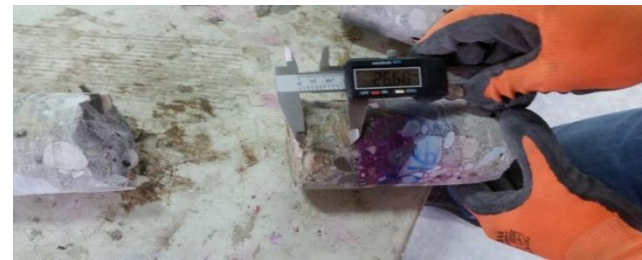
Measuring the depth of carbonation

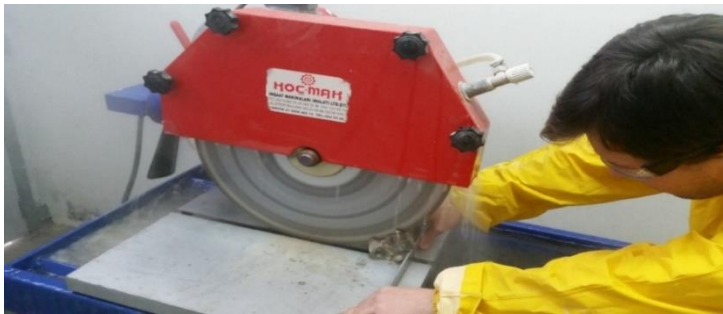
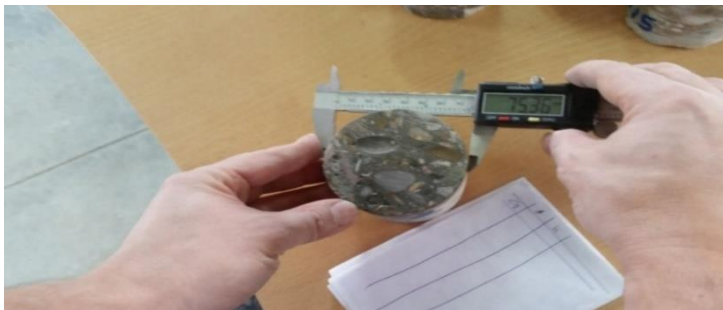
- a. The samples were **cut in the same length**. They should have a regular shape in the top and in the bottom part.
- b. The **diameter** for each of the samples were recorded, to use them for **compressive strength calculation**.

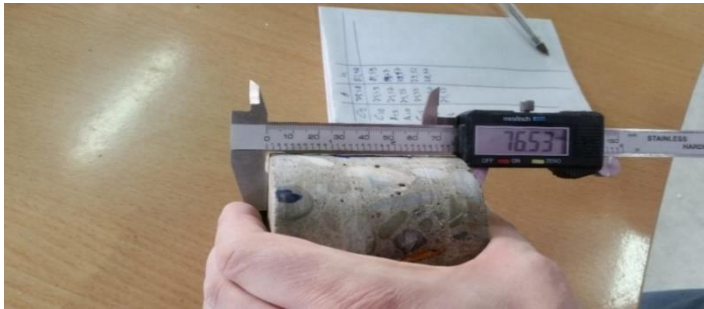
- c. The **diameter** for each of the samples were recorded, to use them for **compressive strength calculation**

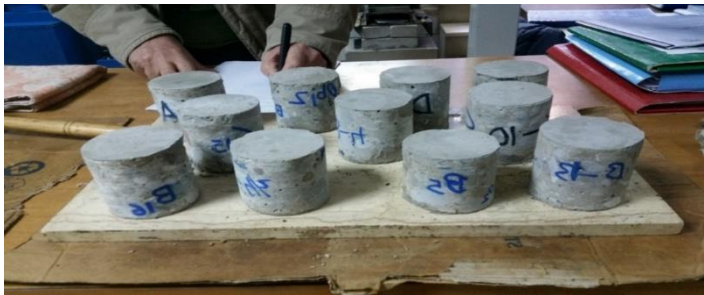
- d. Samples **ready for compressive strength test**

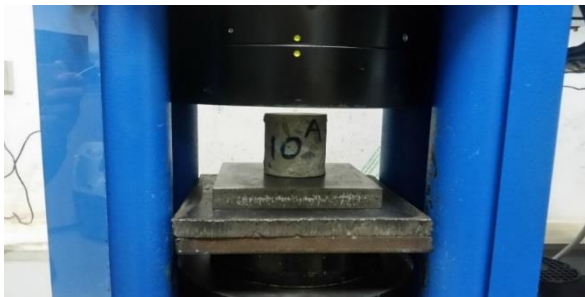
- a) Reference to the standard **SSH EN 12390-1-2000**.
- b) The specimens were **centrally placed** in the testing machine in such a way that the **load** would be applied to the **opposite sides-position** of the specimen mold.
- c) A load was applied until the specimen went **failure**.
- d) The **maximum load** corresponding to specimen failure and **strength** was recorded by the **computer software** and written down for each of the samples.

Testing procedure

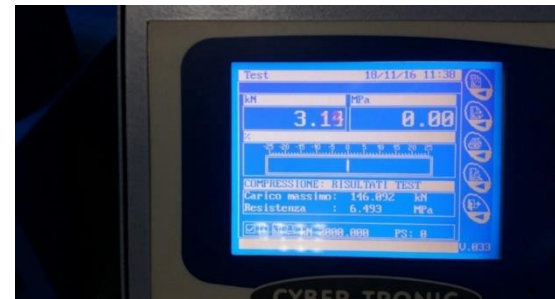
Results in testing procedure

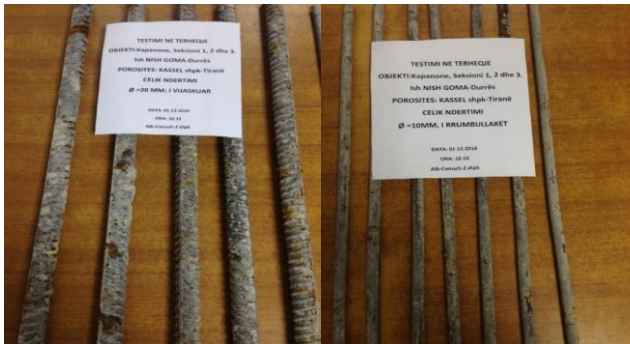
- Reference to the standard **SSH EN 9892-1:2009**.
- The **steel samples** were taken from **non-structural elements**.
- Three samples each of **diameters 10 and 20mm** respectively.

Samples of steel for tensile strength test.

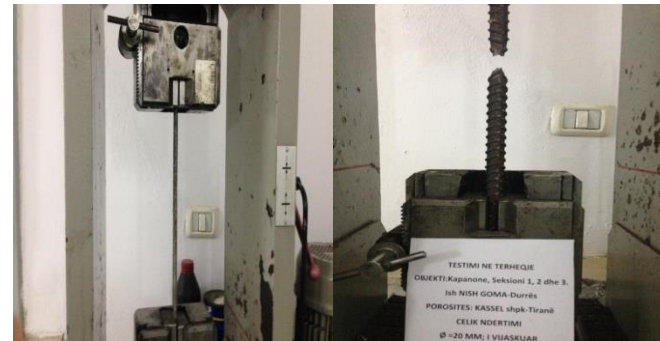
Testing the steel rebar

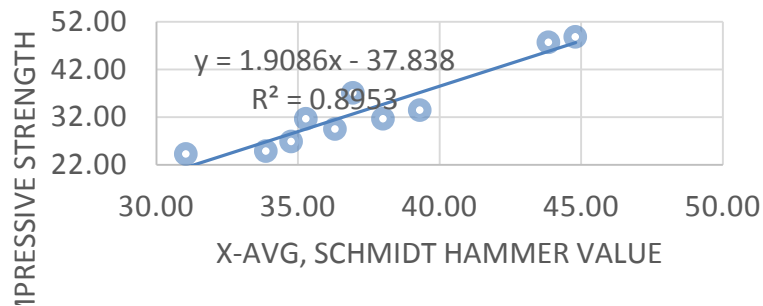
The correlation between Schmidt Hammer Values and the Compressive Strength

- Coefficient is obtained  $R^2=0.8953$  from which the correlation coefficient  **$R=0.9462$** .
- if  $R<0.2$  - correlation is very weak (interdependence will not exist)
- if  $0.2<R<0.4$  - correlation is weak (interdependence will be weak too)
- if  $0.4<R<0.7$  - correlation is average (average interdependence)
- if  $0.7<R<0.9$  - correlation is strong (strong interdependence)
- **if  $R>0.9$  - very strong interdependence**

$$Y=1.9086 * X - 37.838$$

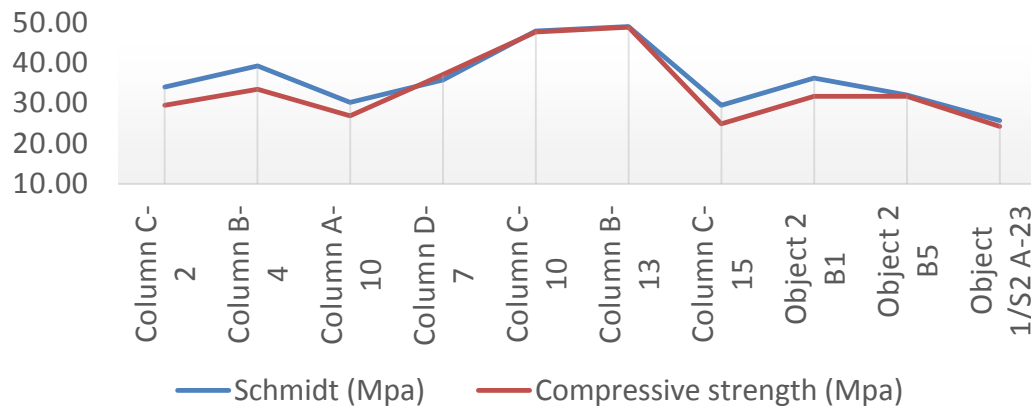
Comparisson between compressive strength values

- The chart shows the comparison between Schmidt hammer compressive strength and the compressive strength of the cored drilled concrete samples.
- There is a slight difference between the values given from the Schmidt Hammer and the core drilled compressive strength
- 5.8 MPa higher in favor of the Schmidt hammer values.

The comparison of the Schmidt Hammer compressive strength and the Compressive Strength for each structure elements.
