EARTHQUAKE PROTECTION OF HISTORIC BUILDINGS AND MONUMENTS IN REPUBLIC OF NORTH MACEDONIA

Prof. Dr. Veronika SHENDOVA

K-FORCE TRAINING VISIT AT UKIM - May 9th, 2019

Institute of Earthquake Engineering and Engineering Seismology,
UKIM-IZIIS, Skopje

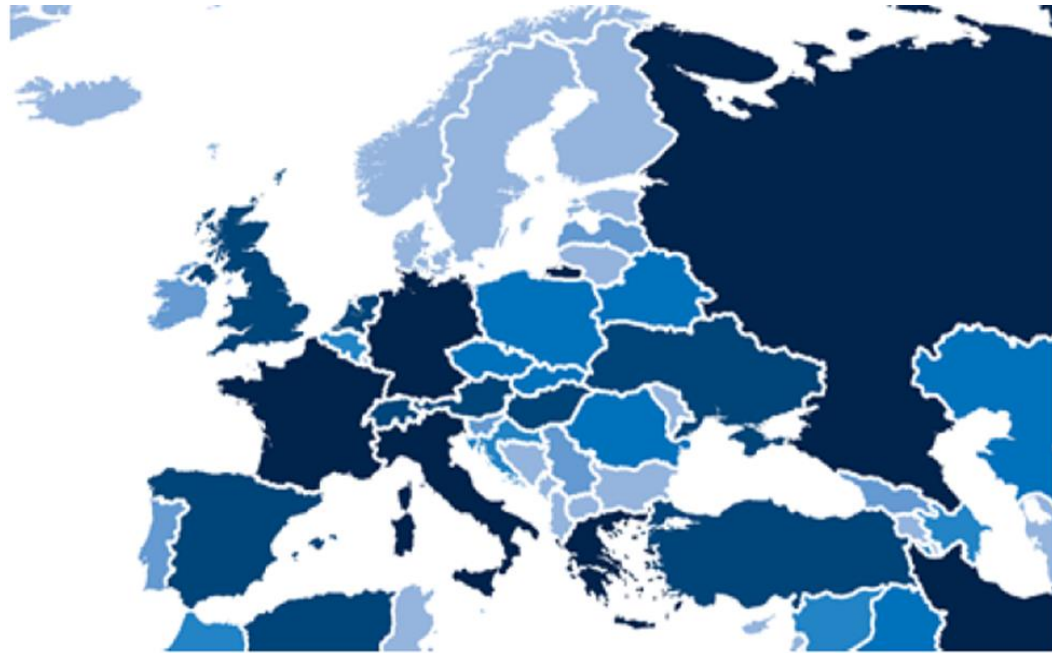
Multi-hazard (earthquakes, floods, cyclones)
average annual loss in million US\$

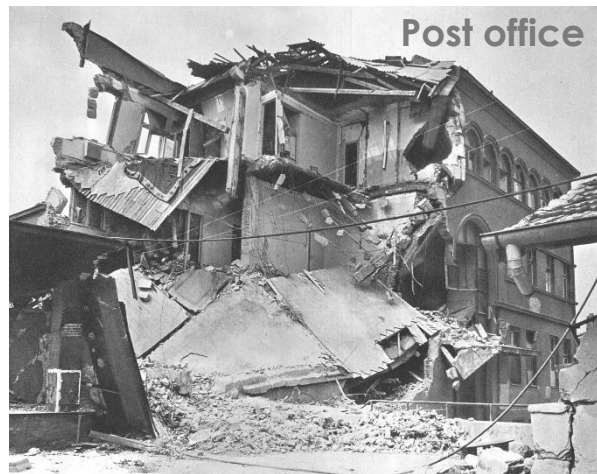
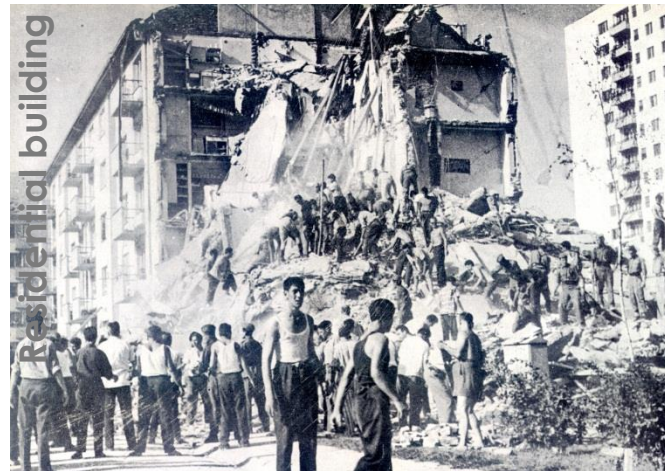
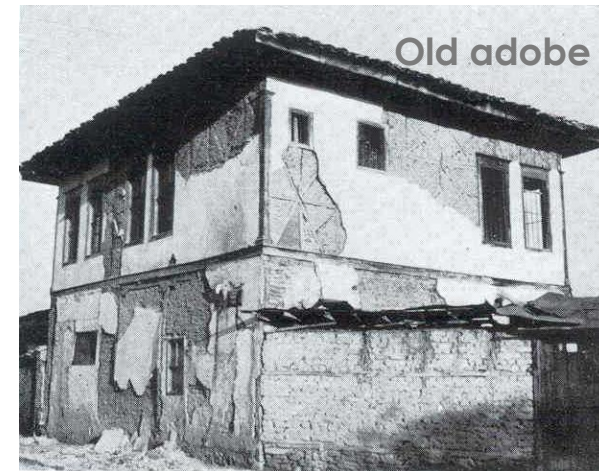
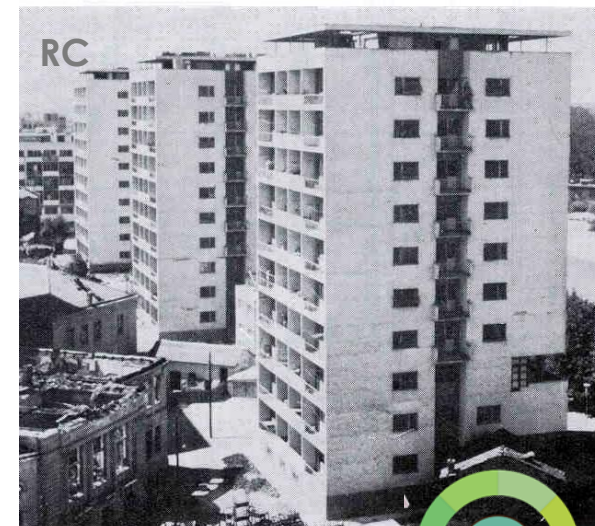
Skopje 26.7.1963 5:17 - M6.1 1071 deaths 3300 injured

Damage degree	Residential buildings	Other buildings	Housing area	Percent of population
Destroyed	11.3	9.2	7.0	8.5
Heavily damaged	44.1	33.0	29.9	36.4
Damaged (%)	22.0	32.9	39.9	30.6
Slightly damaged	16.5	20.1	19.8	20.3
Undamaged	6.1	4.8	3.4	4.2

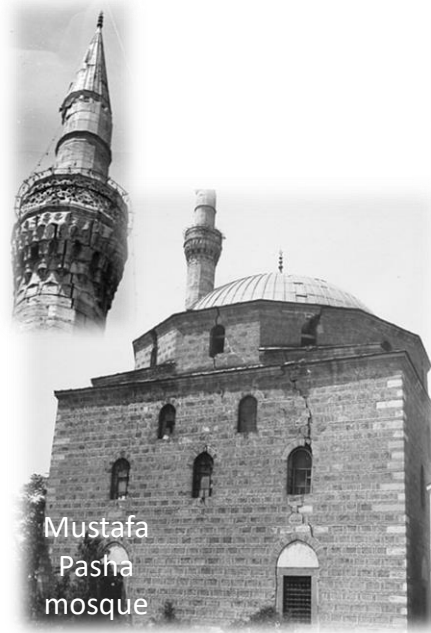
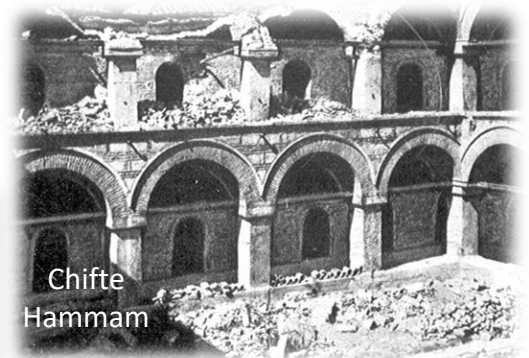
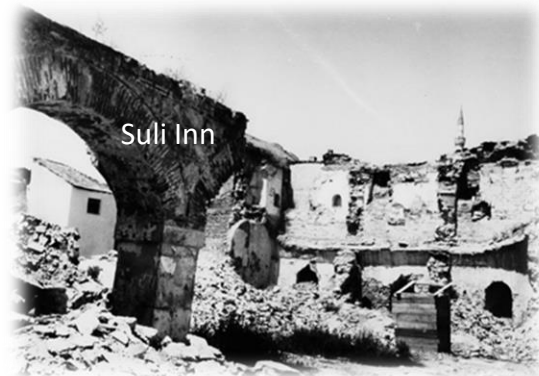
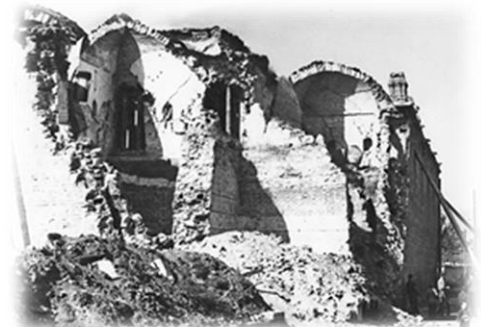
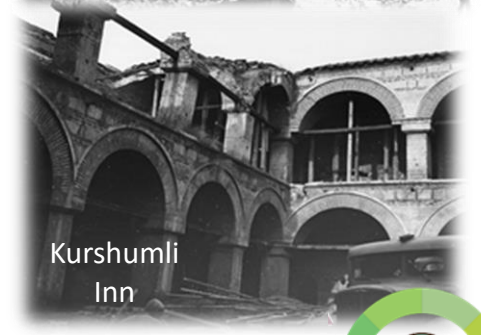
1963 Earthquake effect on Architectural Heritage

- entire monument fund was more or less damaged
- failure of individual parts of the structures
- large cracks
- inclination and deformations of structural elements
- part of it was completely destroyed

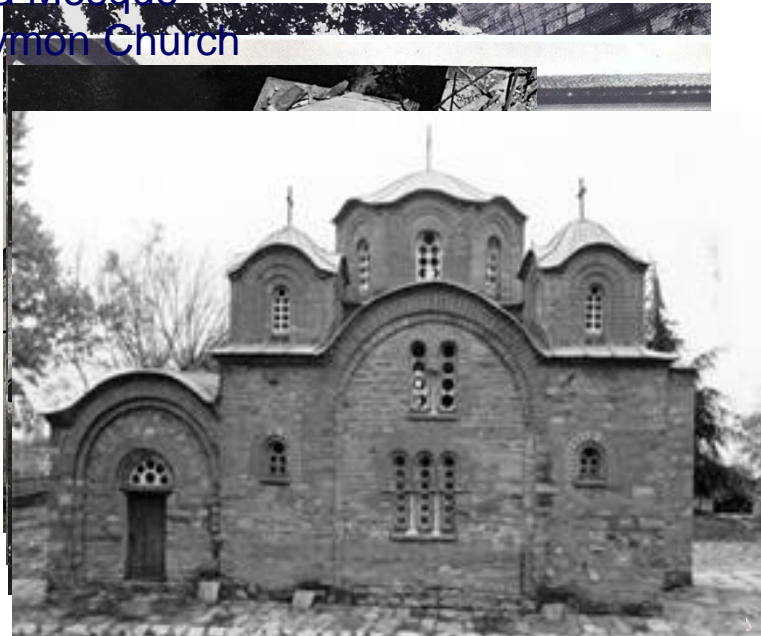
Mustafa Pasha Mosque
St. Panteleymon Church

Post-earthquake **Repair and Seismic Strengthening**

- immediate structural consolidation
- repair & strengthening during renovation process,
- involving RC bearing elements, columns and belt courses incorporated into the existing masonry

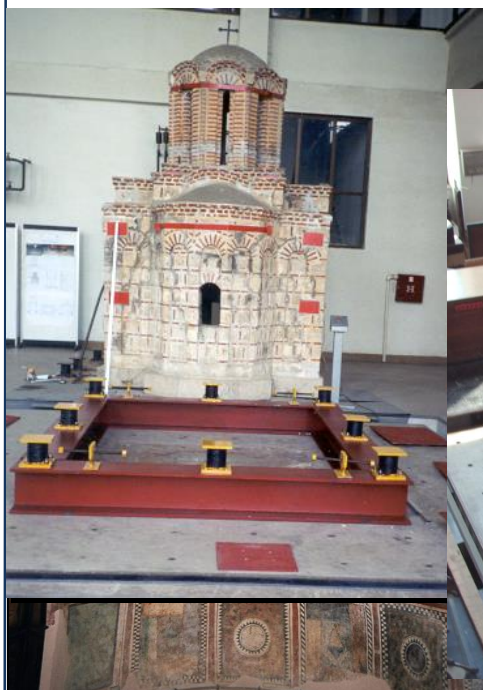
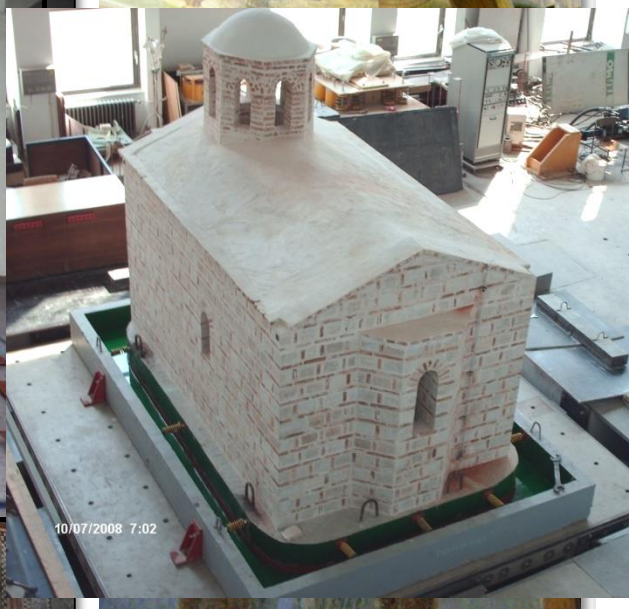
- adverse affect of cement – *Skopje recommendation 1988* – unite efforts of architects, engineers, conservators, restaurateurs, material scientists – prohibition of cement...
- extensive research 1990 – 2000 (IZIIS & National conservations center)
- experimental verification of different retrofitting techniques (ties and injection, seismic base isolation, composite (CFRP) materials)

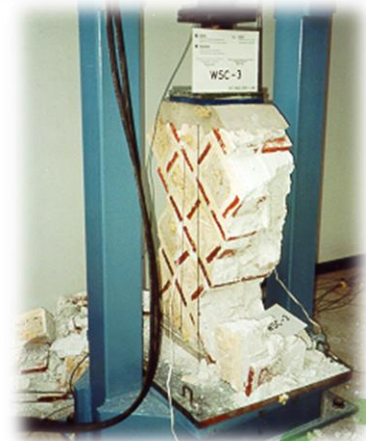
- Experimental testing of wall elements

- Design and testing of the church model in typical Byzantine style

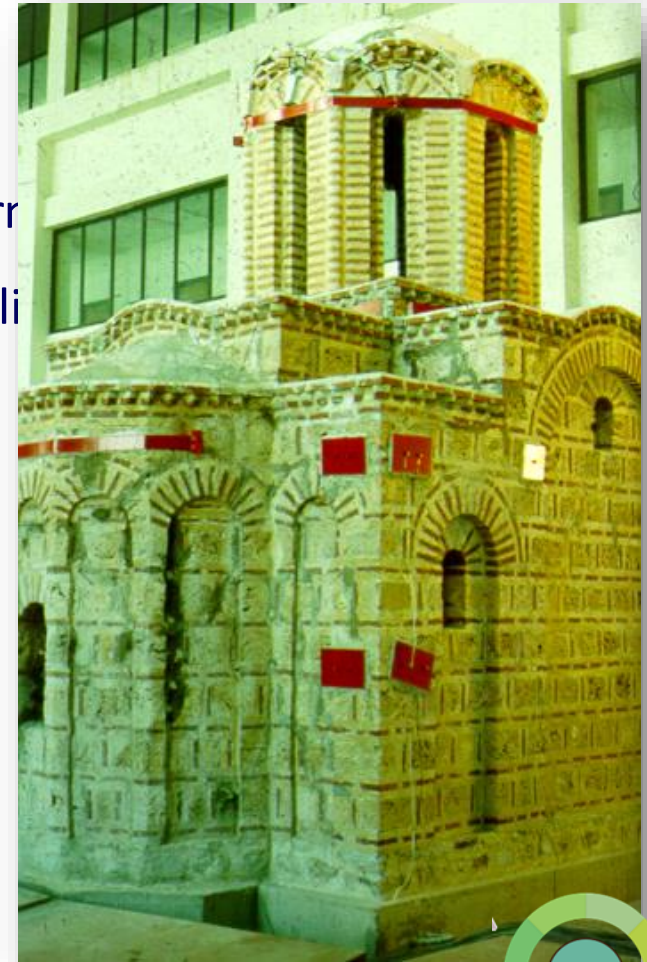
Concept for Repair and Strengthening - traditional

Design Criteria:

- **Level I:** without damage, $t_p = 100$ years
- **Level II:** linear behaviour, limited nonlinear deformation
- **Level III:** deep nonlinearity- not disturbed stability

Selected method for strengthening:

- *incorporation of horizontal steel ties*
- *systematic injection of elements*
- *incorporation of vertical steel ties*

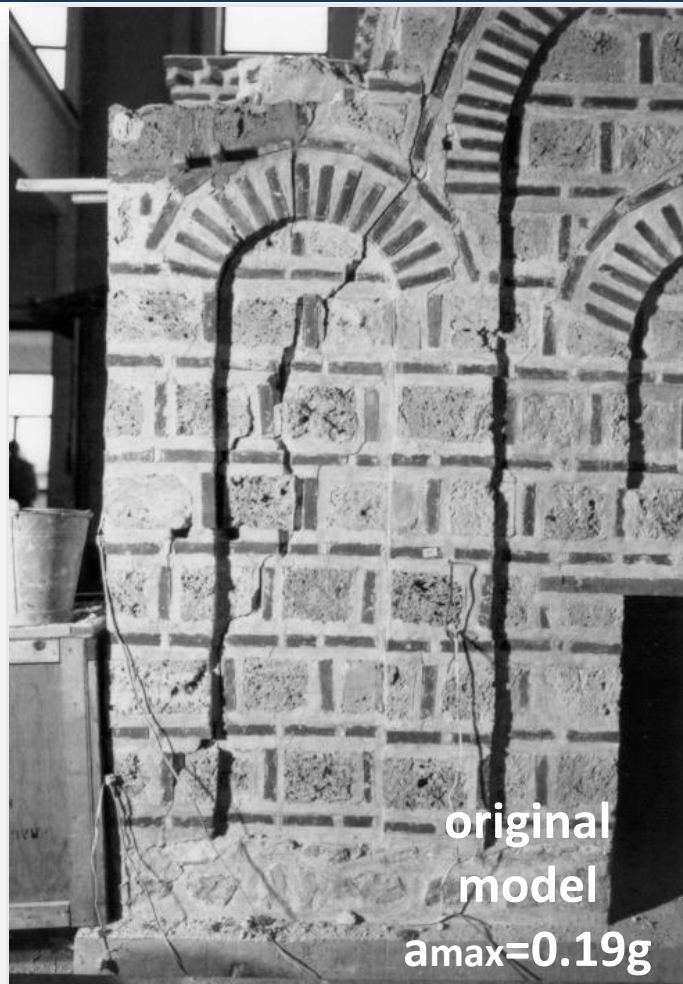
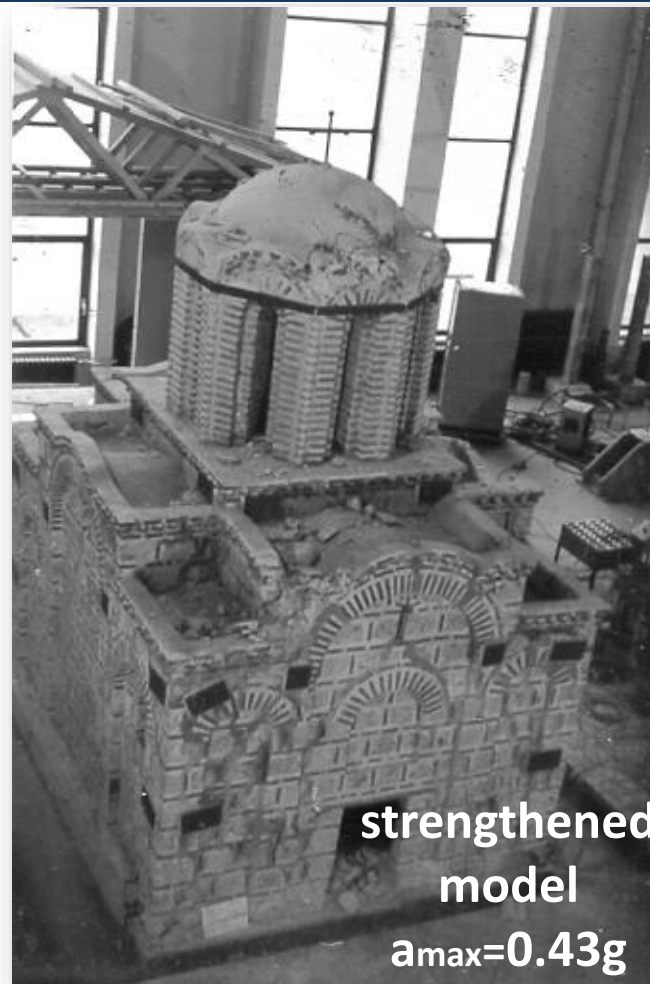
Experimental verification of methodology

lower damage level even under higher level of input excitation

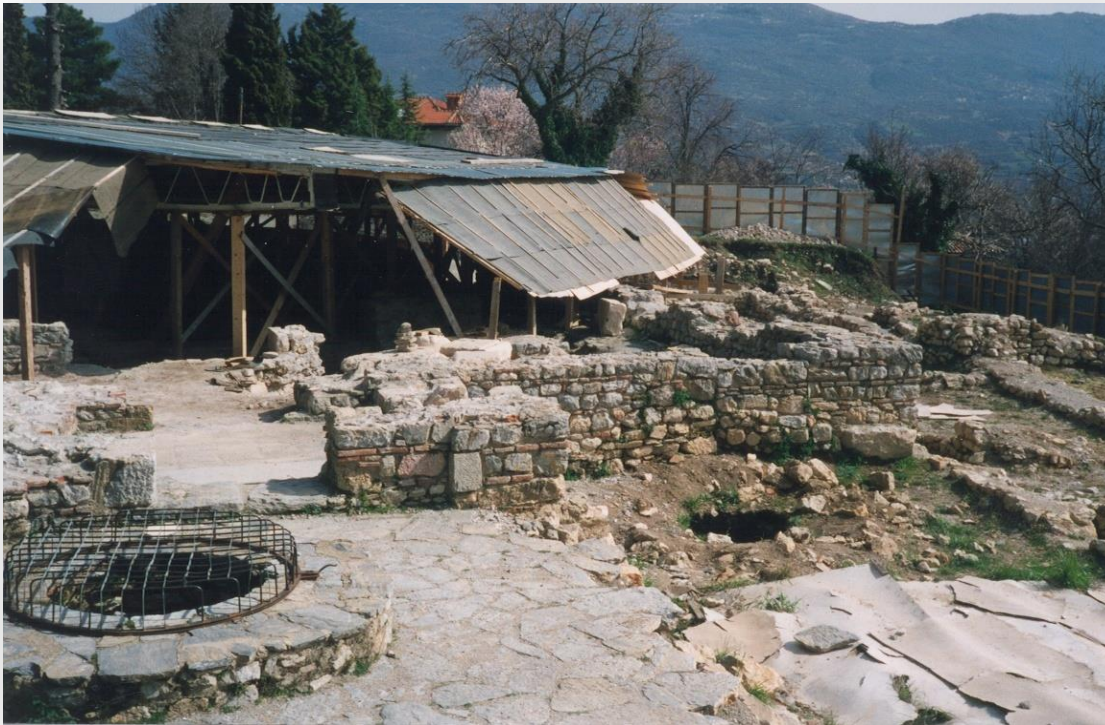
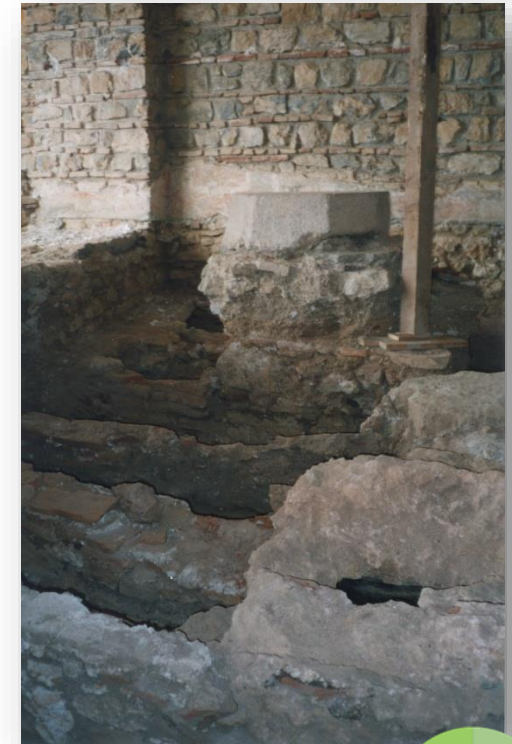
Consolidation and Reconstruction of the Structure of the St.Pantelymon Church in Plaoshnik, Ohrid

Concept for Consolidation and Rebuilding

- ✓ Injection of the walls:
 - Walls below the floor level with cement emulsion
 - Walls over the floor by use of lime-based emulsions
- ✓ Contact between the existing and the rebuilt walls
- ✓ Strengthening and the consolidation of the existing foundation walls up to level 0.00
- ✓ Reinforced concrete floor slab with a thickness of 20 cm
- ✓ Construction of the church as massive stone and brick masonry in lime mortar with incorporated **horizontal and vertical steel ties**

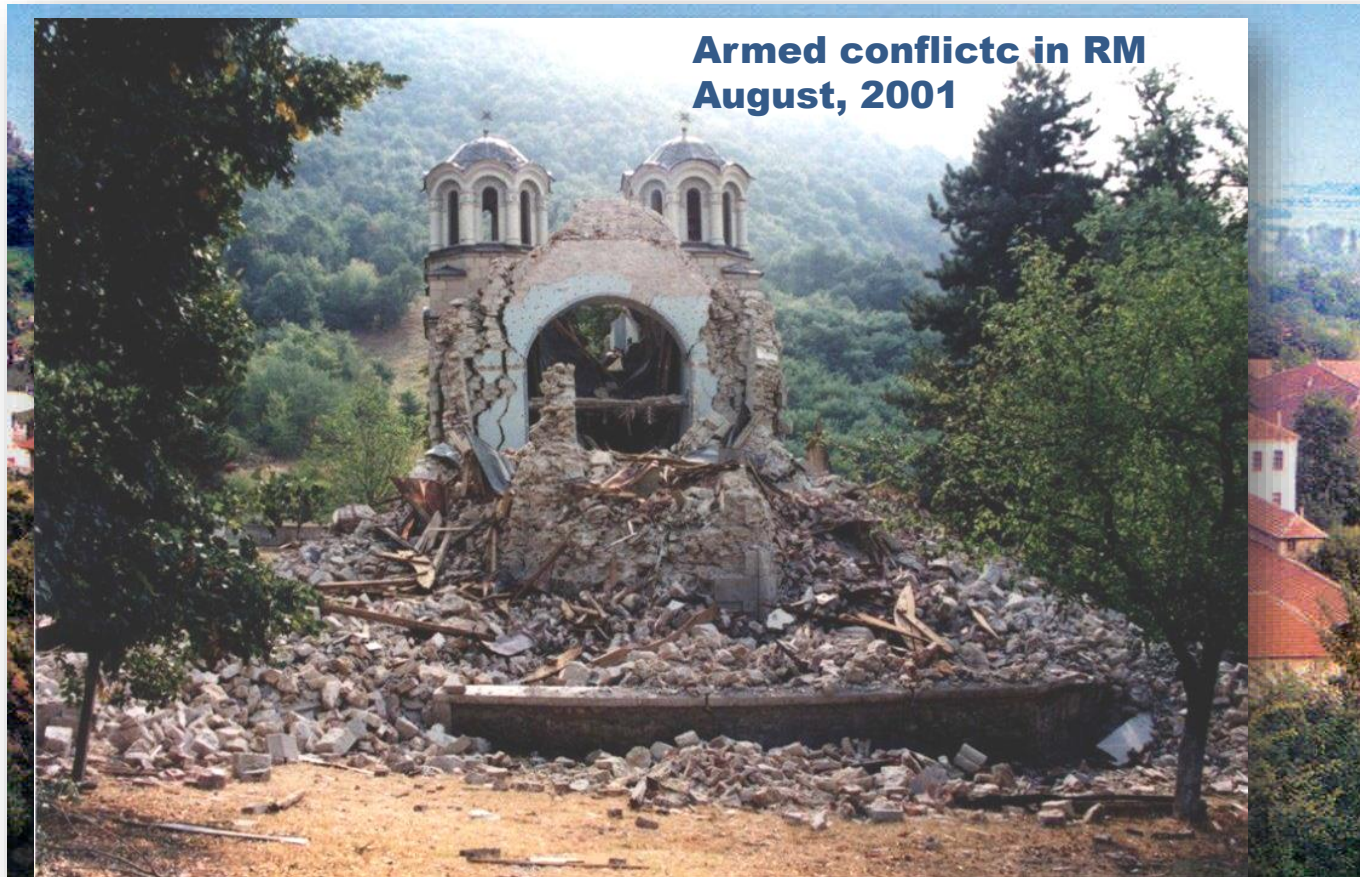
Reconstruction, Seismic Strengthening and Repair of the St. Athanasius Church in Leshok

Concept for Repair, Strengthening and Reconstruction

1. Repair and structural strengthening up to the design level of seismic safety for the *damaged existing part*
2. Complete reconstruction by maximum possible use of selected material in lime mortar plus structural strengthening elements for the design level of seismic safety for the *demolished part*
3. Dilatation (not less than 3 cm) between the structural units

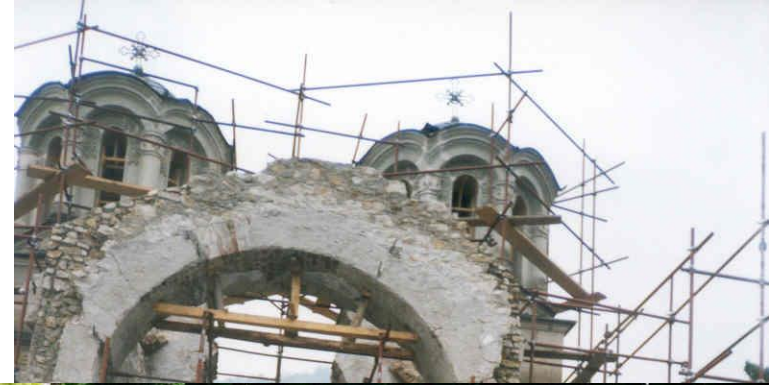
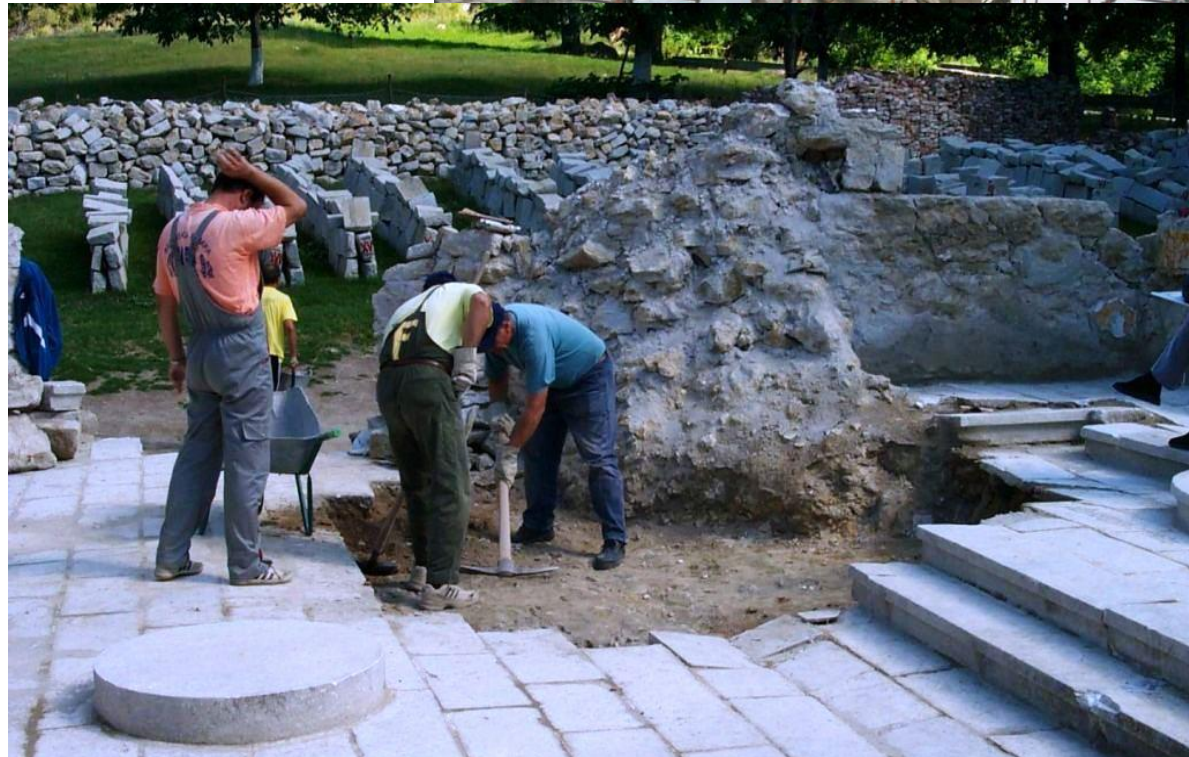
Experimental verification of Input Design Strength of Lime Mortar

- Job mix formula for lime mortar
M = 1 (slaked lime) : 1 (broken half-backed brick) : 1 (sand)
- Building of wall elements
- Testing of elements under axial pressure
- Testing of elements under diagonal pressure

Wall element	Age of element (months)	Cross-section A (m ²)	Maximal force P _{max} (kN)	Compressive strength $\sigma_c = P_{max}/A$ (kPa)
W1-1	4	0.243	372	1530
W1-2	4	0.243	355	1460
W1-3	4	0.243	292	1200

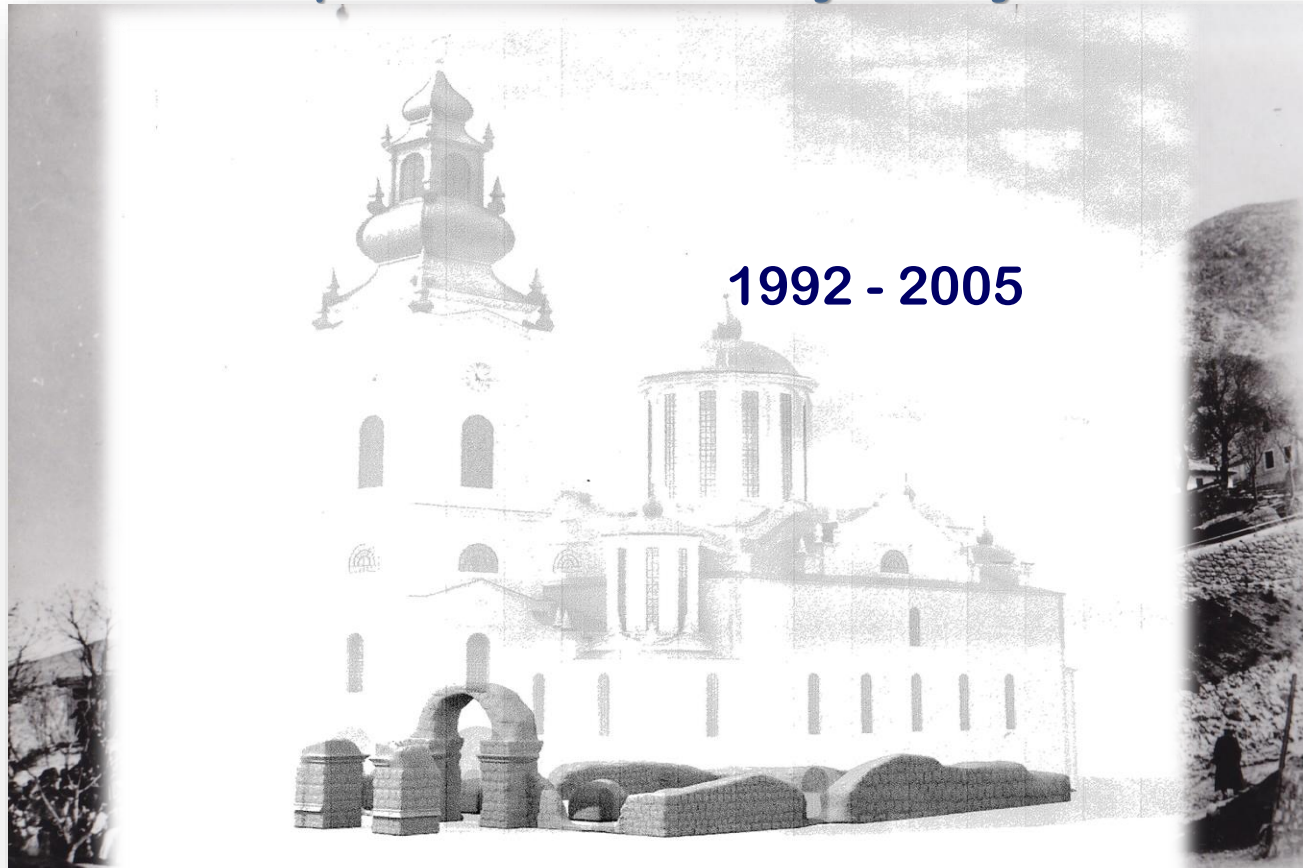
Reconstruction and Seismic Strengthening of the Blown Up Church of the Holy Trinity in Mostar

Concept for Strengthening and Reconstruction

1. Full reconstruction with maximum possible use of the existing preserved material and minimum additional intervention
2. Three general states have been analyzed:
 - (1) structural system of plain stone masonry (PS);
 - (2) strengthened structure by horizontal steel element (HS)
 - (3) strengthened structure by horizontal & vertical steel strengthening elements -confined masonry (HVS)

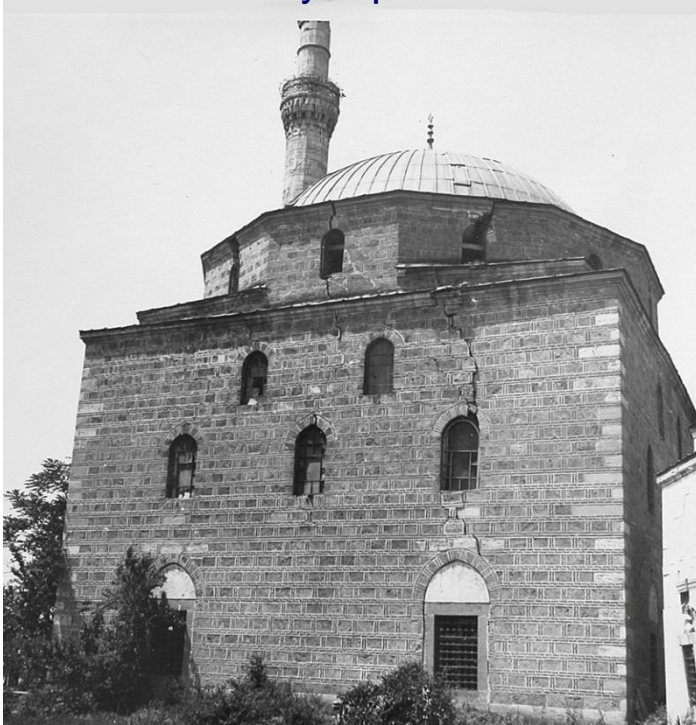
Seismic Upgrading of Mustafa Pasha Mosque, Skopje

- One of the biggest and best preserved Ottoman monuments in Skopje and Balkan
- Damaged by Skopje earthquake in 1963 (domes, east facade, minaret)
- Today represents cultural historic monument of extraordinary importance

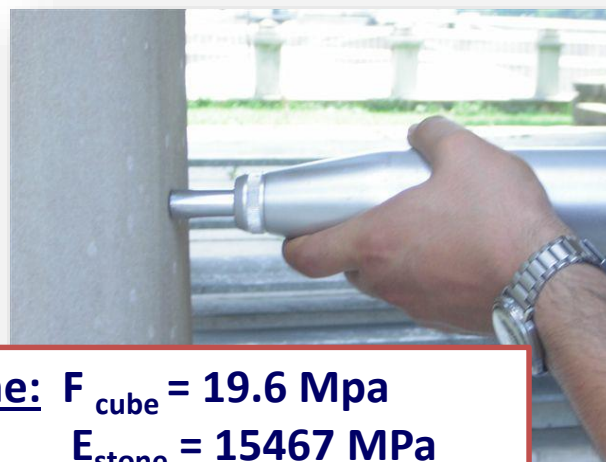
stone: $F_{\text{cube}} = 19.6 \text{ Mpa}$
 $E_{\text{stone}} = 15467 \text{ MPa}$

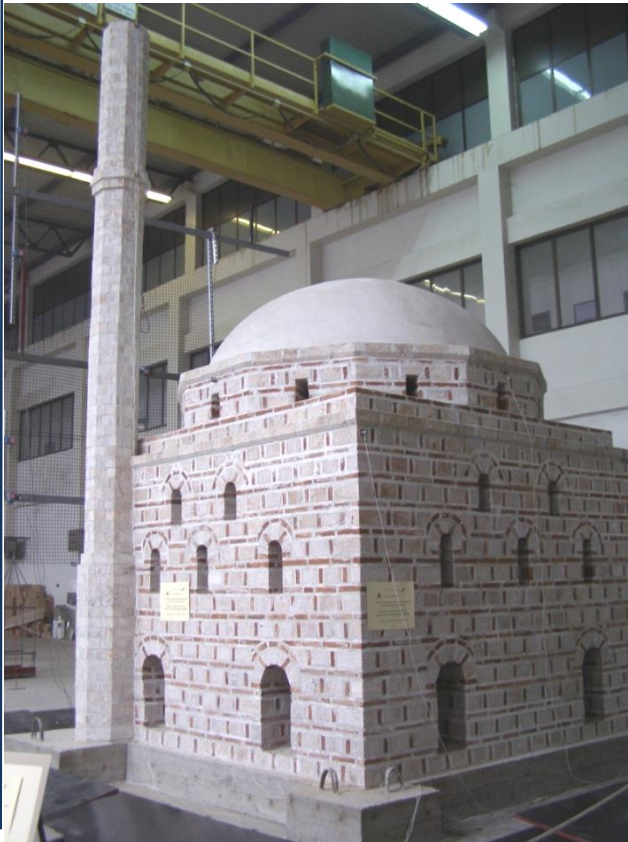
original state

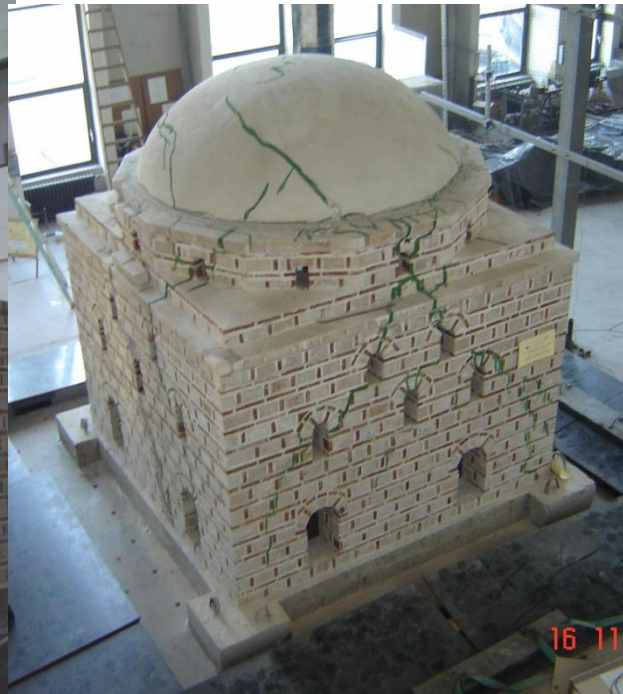
strengthened by
CFRP bars & wrap

DOME Structure (A)
CFRP wrap in a layer of epoxy glue within a width of 2.9m

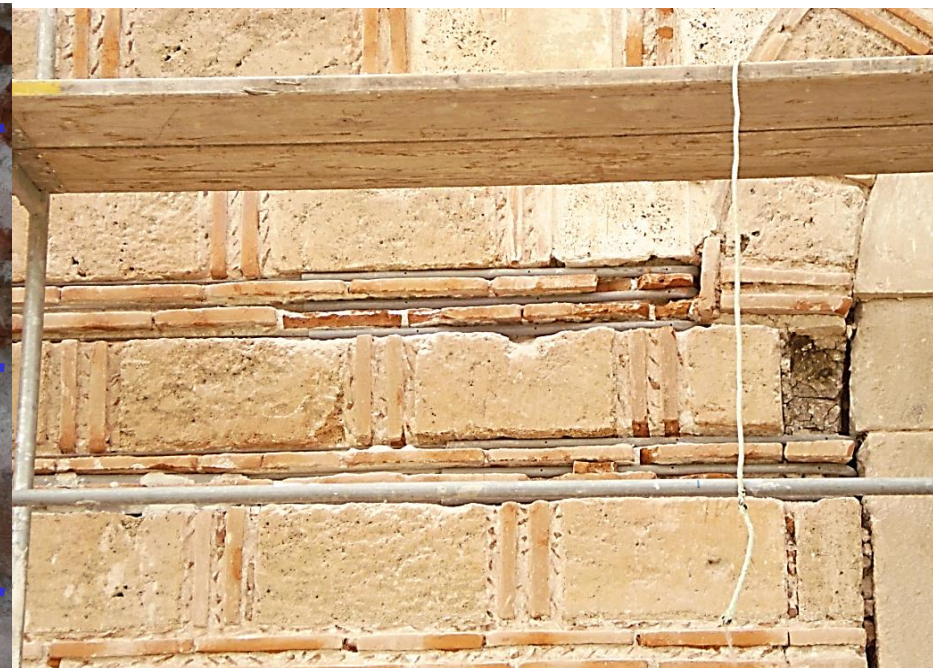
Strengthening of bearing walls

- ✓ Cleaning of all joints on the outside with a depth of max 7-8 cm
- ✓ Placement of CFRP bars (d=1cm) in an epoxy mortar layer
- ✓ Filling of the joints with pointing lime mortar

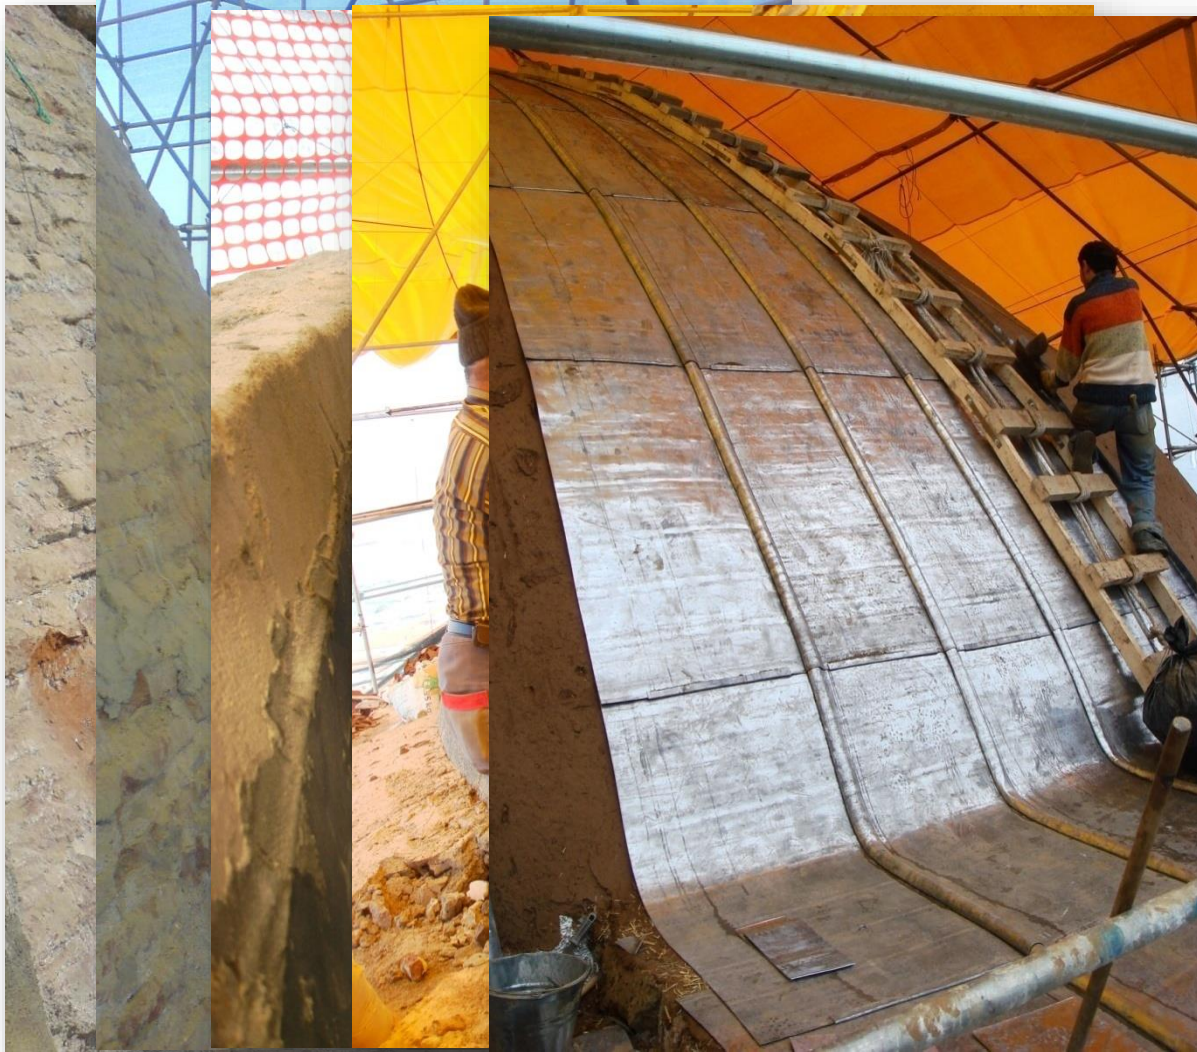
Strengthening of central dome

- ✓ Removal of the cement mortar layer
- ✓ Coating of existing RC ring with injection mixture based on lime mortar
- ✓ Placement of CFRP wrap in a layer of epoxy glue along the perimeter with the width of 3m
- ✓ Coating of entire dome with a protective layer of lime mortar

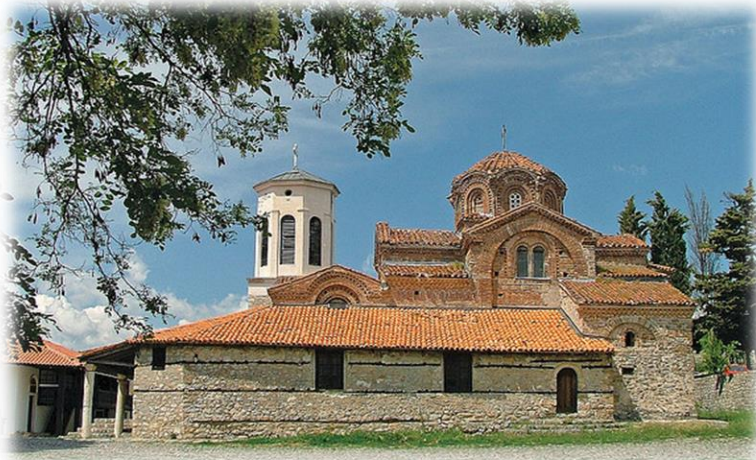
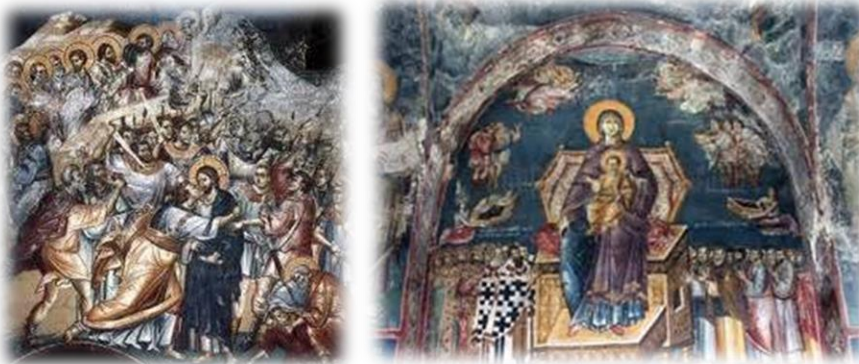
Seismic Safety and Stability of Existing Structure of St. Mary Peribleptos Church in Ohrid

- single dome, inscribed developed cross
- among most important medieval monuments
- A1, church, 1295
- small chapels, XIV c.
- A2, A3 porch, XIX c.
- conservation 1950
- strengthening 1986

- repairing of cracks
- inserting of steel ties in central area
- placing of RC slab over the vaults
- placing of RC rings in the tambour base
- covering of the dome with cement layer

INCORRECT !

- structure – in stable condition
- appropriately incorporated ties
- no new cracks
- visible damage to fresco paintings
- direct causes – technical solution, damage to facade joints, nonexistence of drainage system
- although free standing, RC plates cannot be removed without vibration

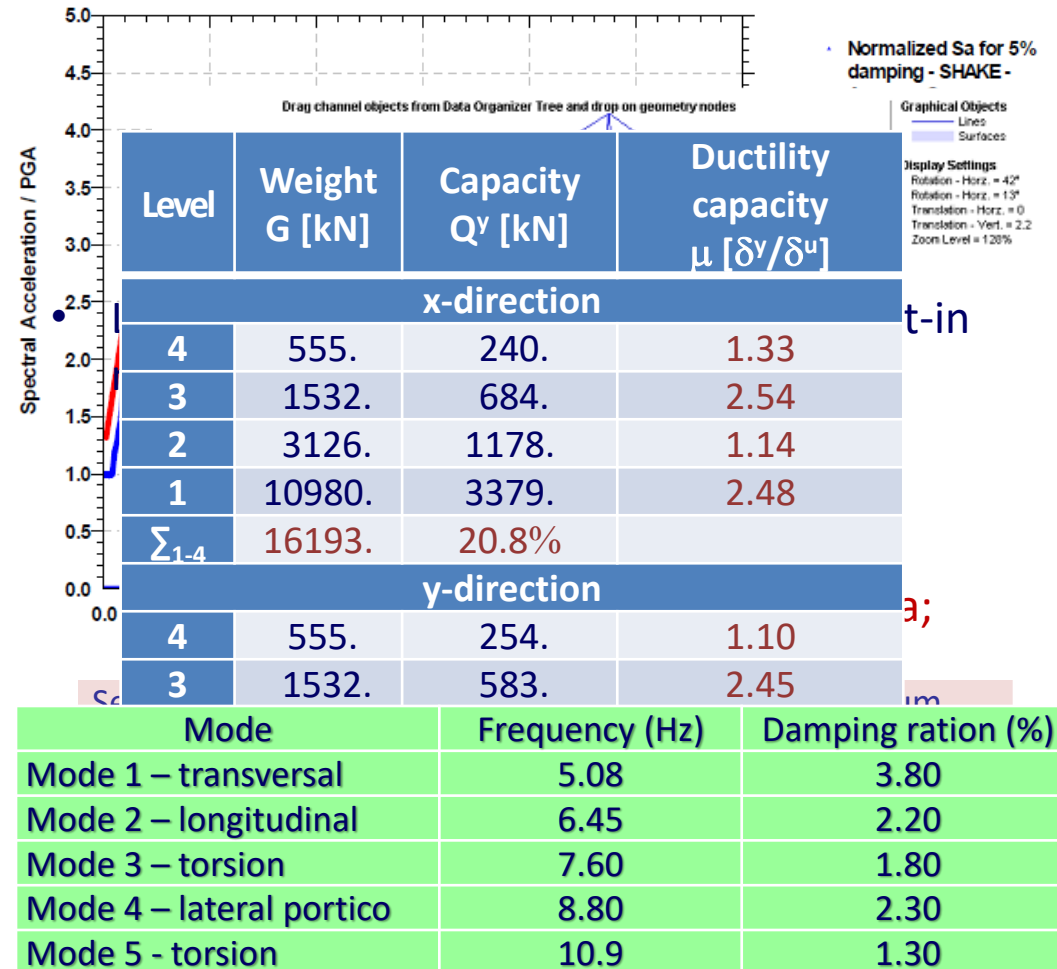
Investigation on the site an structure:

- seismic potential of site
- dynamic characteristics by AVT
- built-in material testing
- relevant structural analysis shows sufficient bearing capacity, but non-sufficient deformation capacity
