Earthquake Geotechnical Risks

What we know, What we should know

Lessons learned

Prof. D-r Vlatko Sheshov

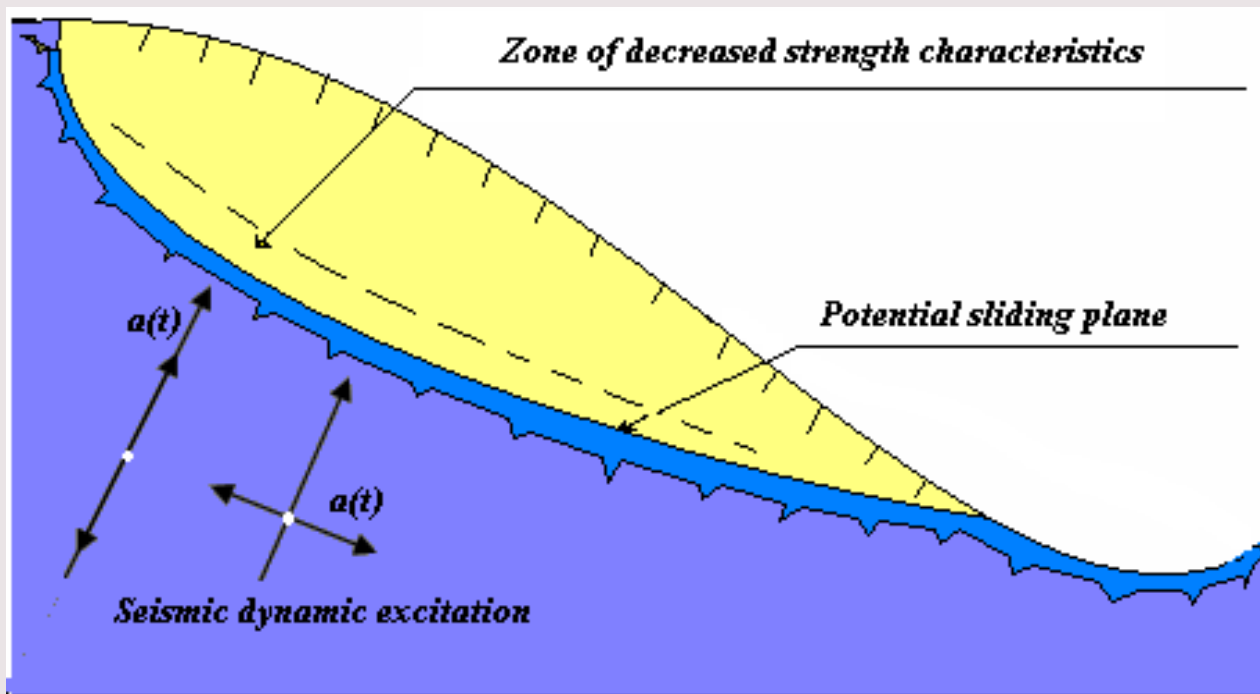
Potential conditions for the instability of the natural slope under seismic dynamic excitation effect

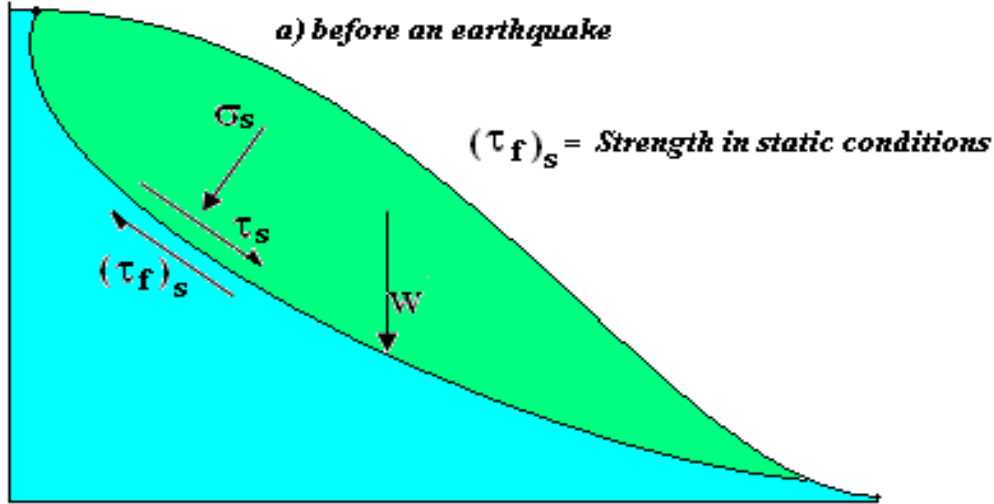
As general case, in static conditions, the soil mass of the slope, above the potential zone or a sliding plane is under the effects of the **gravity load (w)** in vertical direction.

(σ_s) - normal stress

(τ_s) - shear stress

$$(\tau_f)_s = f(\sigma, c, \phi)$$

$$\tau_s < (\tau_f)_s \quad \text{equilibrium}$$

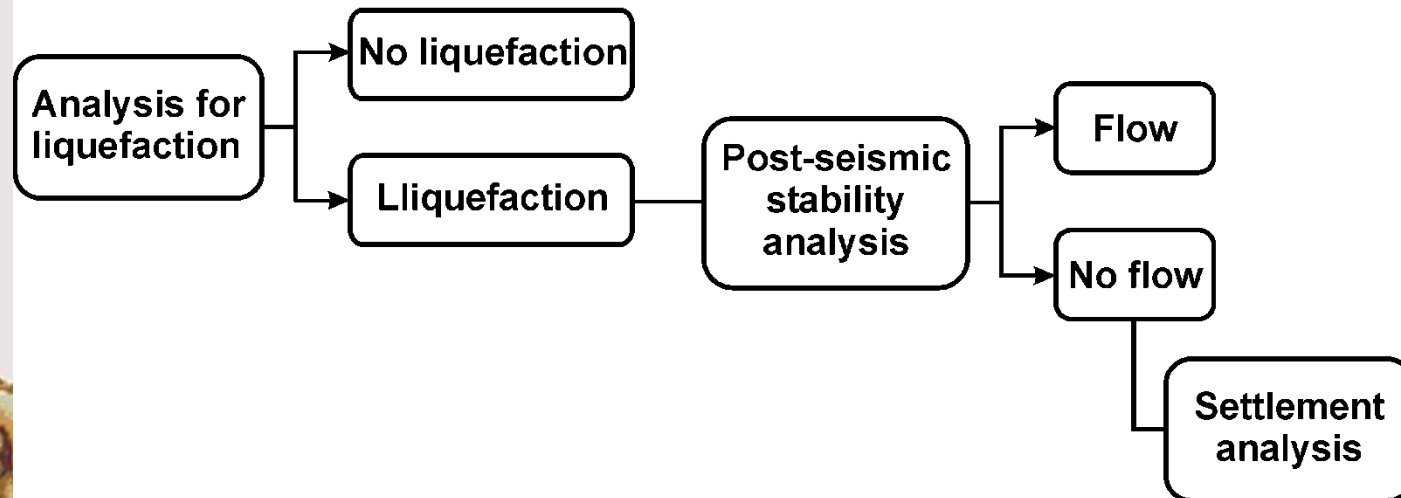
SLOPING GROUND

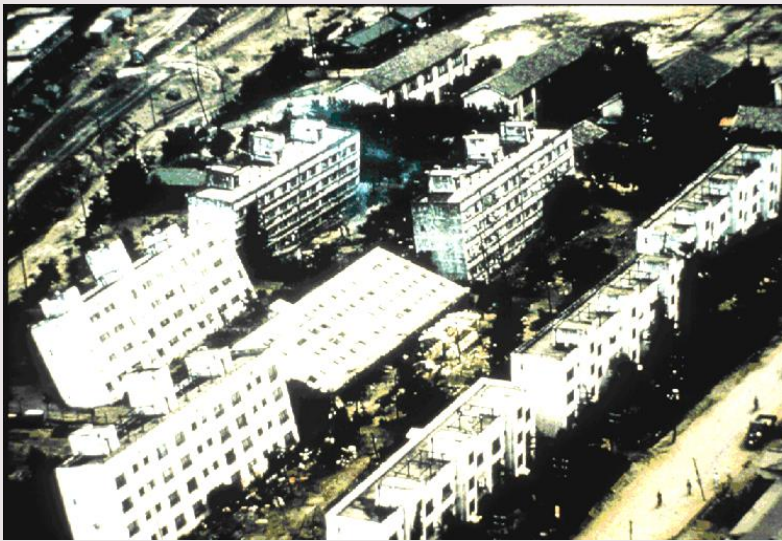
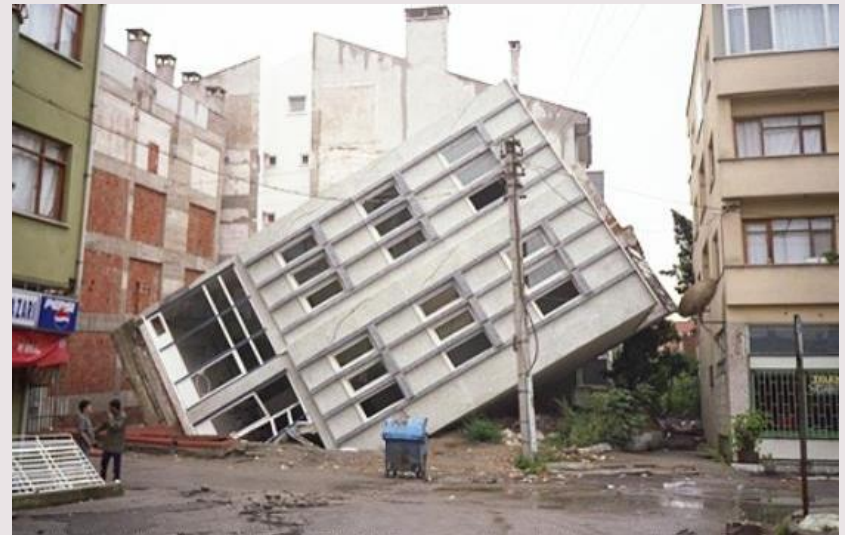
Niigata Earthquake 1964

Loss of Bearing Strength. When the soil supporting a building or other structure liquefies and loses strength, large deformations can occur within the soil which may allow the structure to settle and tip

**Adapazari, Izmit Earthquake, Turkey
1999: August 17**

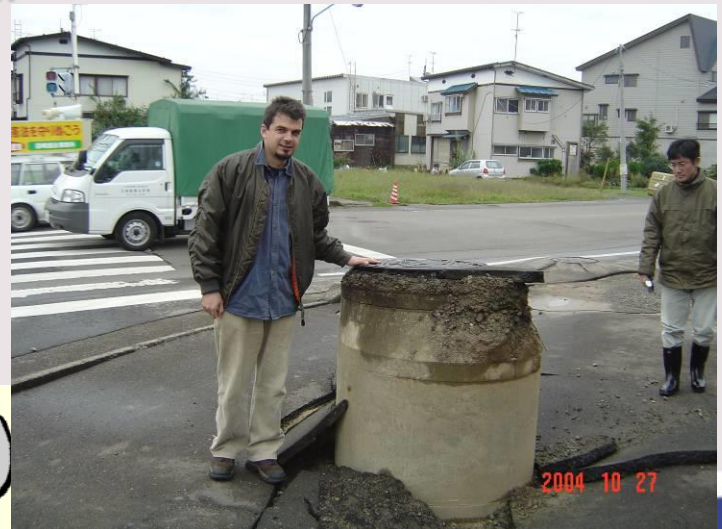
Buoyant rise of buried structures. Soil liquefaction can also induce buoyant rise of underground structure. Normally, the uplift of the buried structure is prevented by resistance from the adjacent soil. However, when soil liquefies, the soil loses its resistance and starts to behave like liquid with unit weight almost twice that of water. When the unit weight of the buried structure is less than that of the liquefied soil, floating of underground structures can occur.

A manhole uplifted during the 2004 Mid Niigata Earthquake

- *Up-lifted manholes* in Ojiya city and *small sand boils* in their vicinity were the evidence that liquefaction took place. Also small sand boils could be observed in the rice fields.

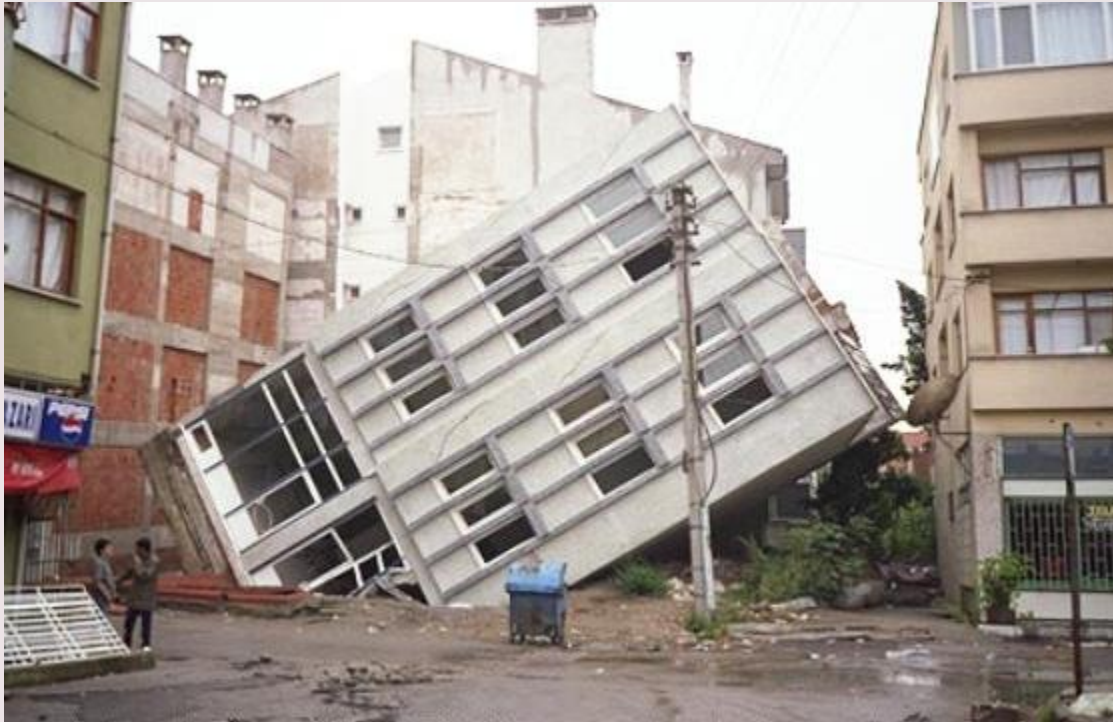
Adapazari, Turkey

Loss of bearing capacity in foundation

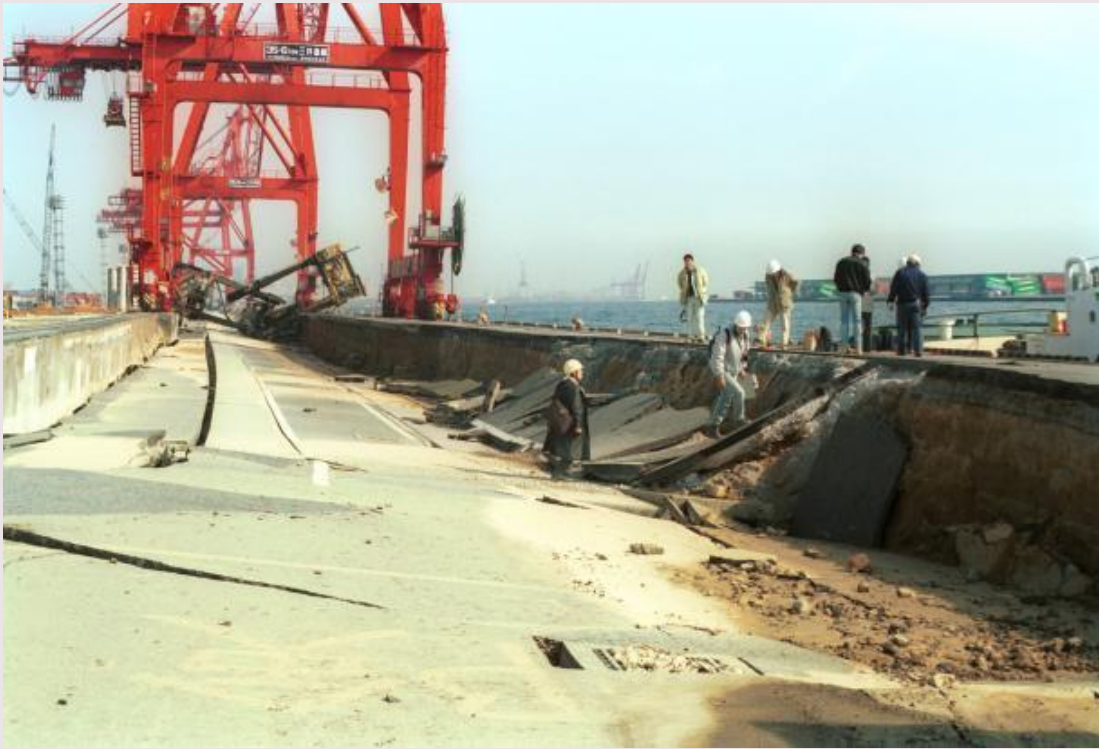
Quay walls - Kobe, Japan

Dislocation of retaining walls

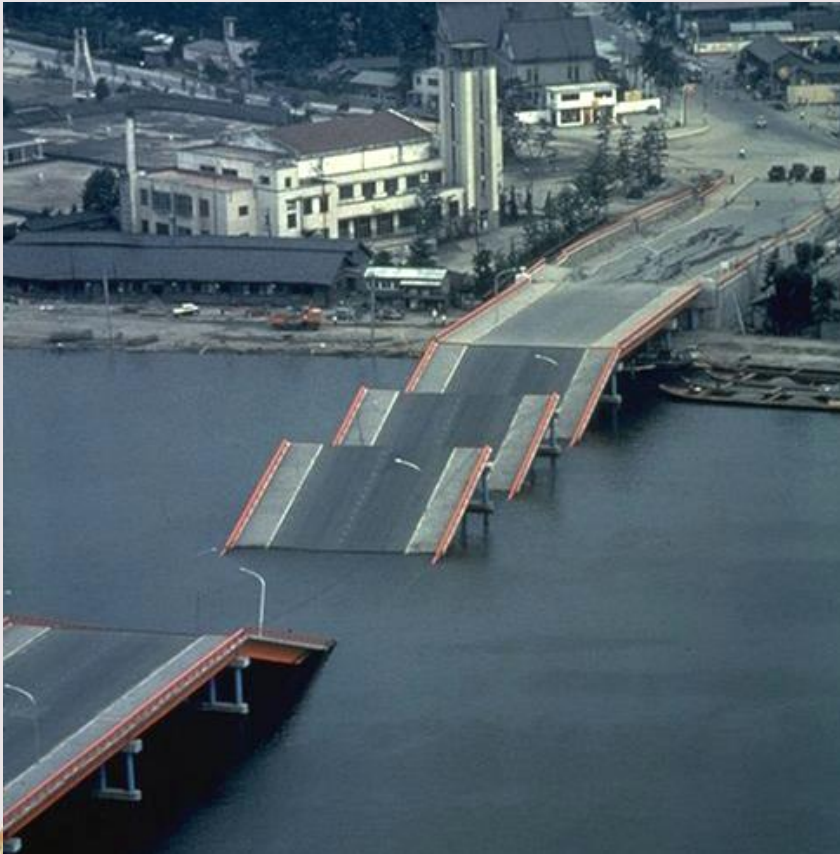
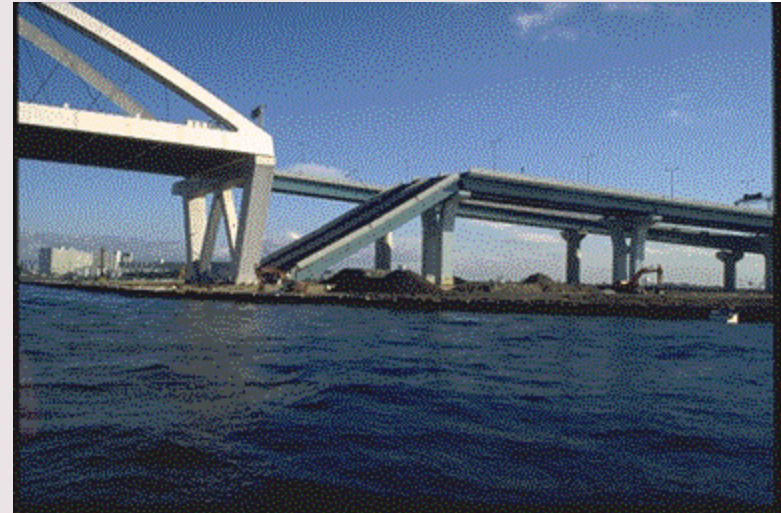
Nishihomiya Bridge - Kobe, Japan

Lateral movement of soil

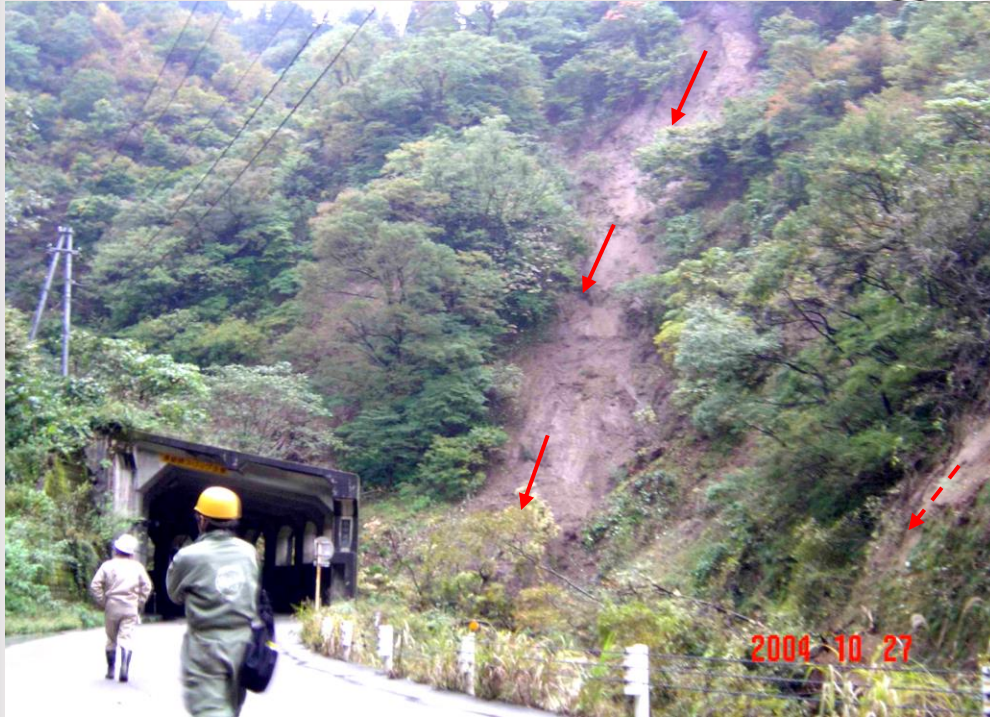
Landslide in steep natural slope

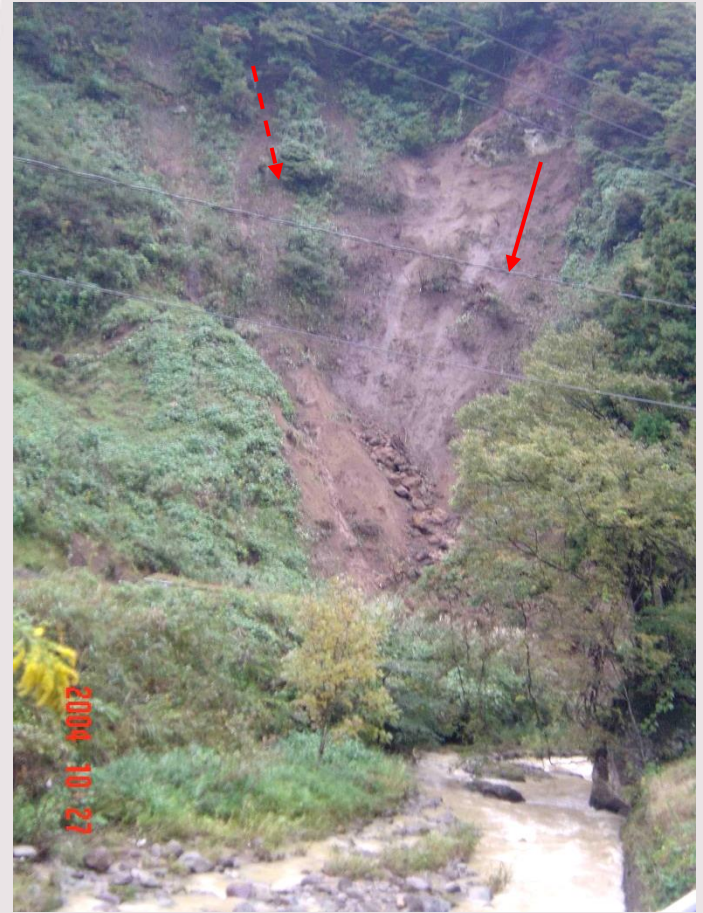
Surface soil layers from top part of the slopes slide downwards. Place: Nigorisawa

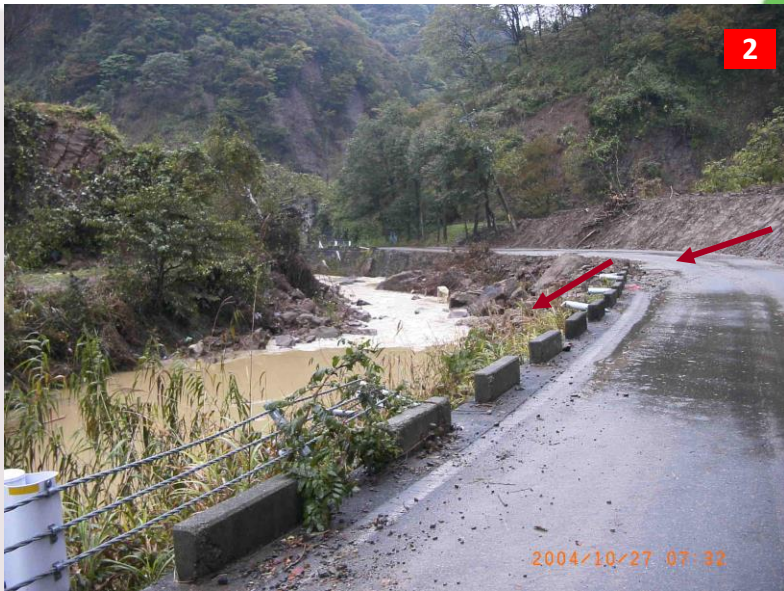
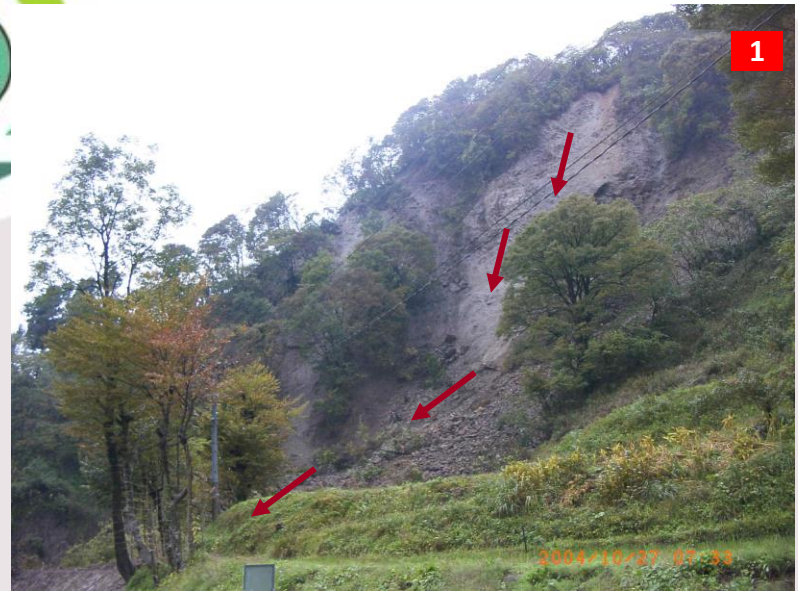
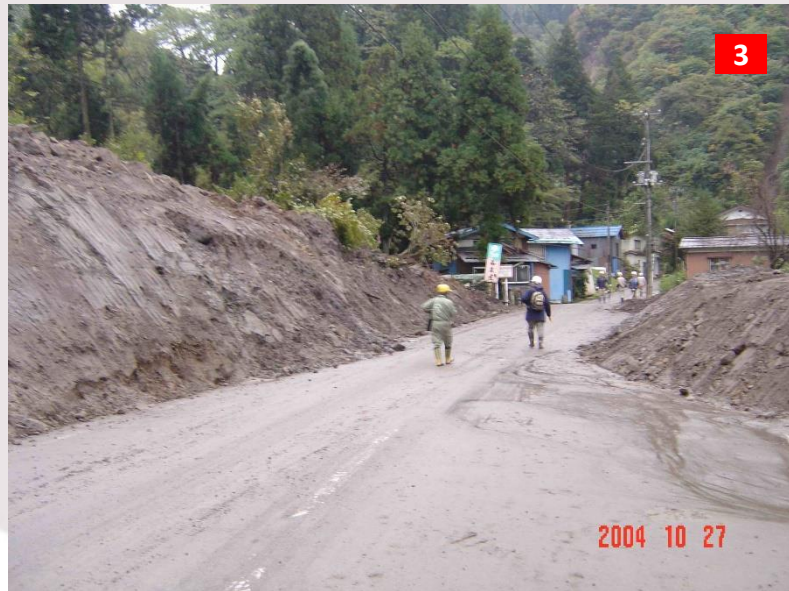
Place: Nigorisawa

Middle sized landslide in natural slope occurred and temporary blocked the local road and small river.

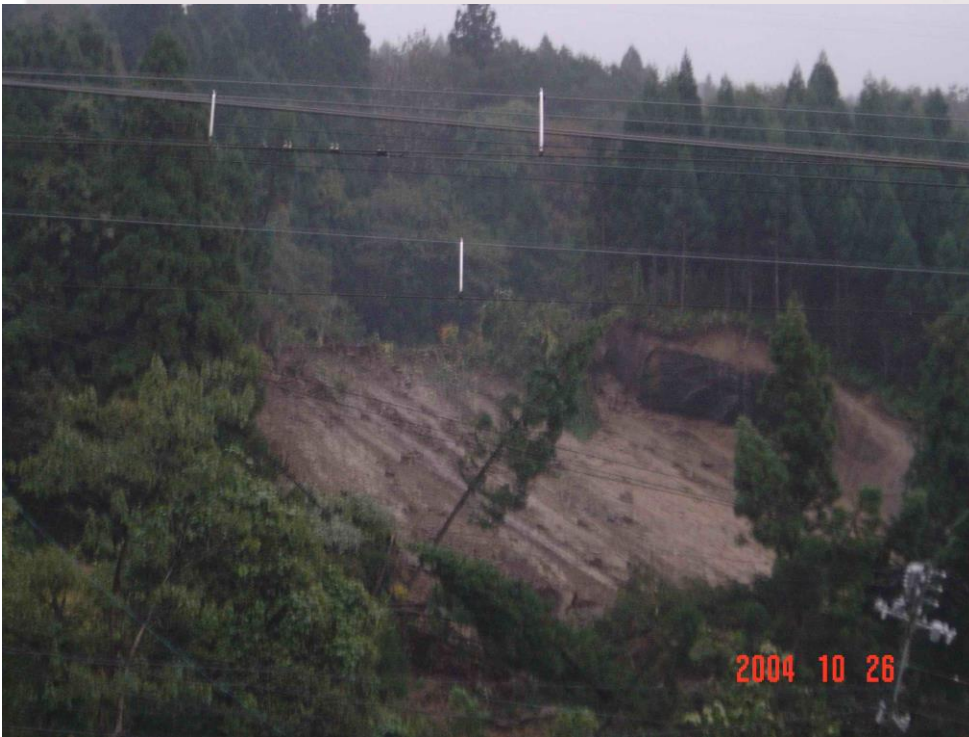
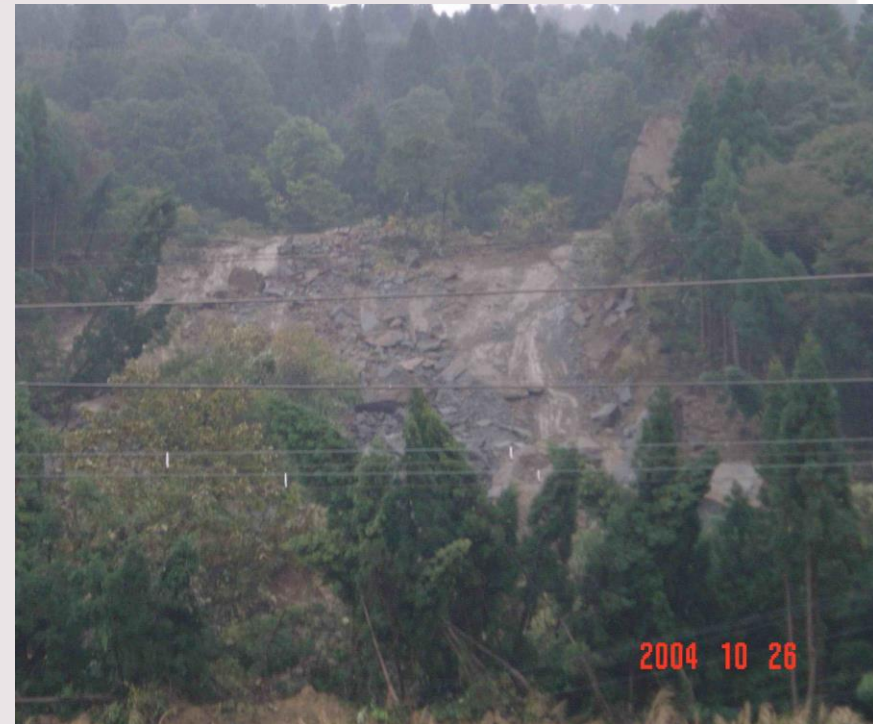
Place: Ojiya-city, Myoken, near Uragara Bridge.

The landslide mass scraped the surface layer more than one meter and moved downward. Sliding surface is almost flat.

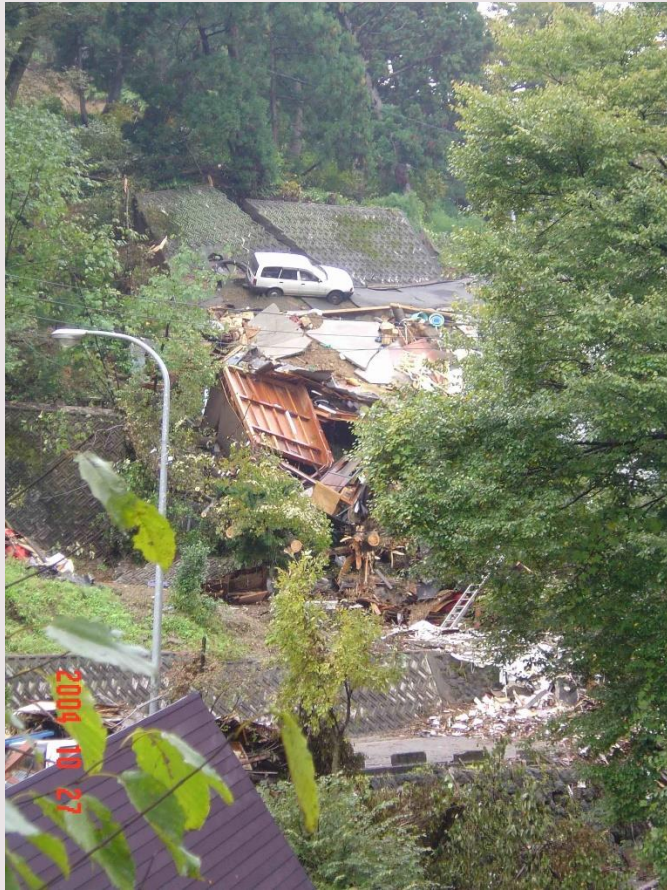
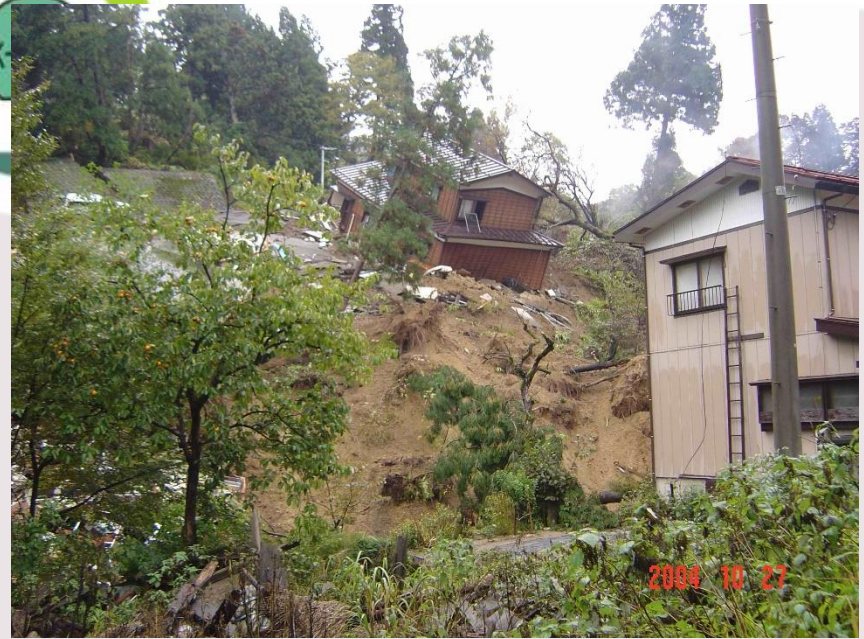
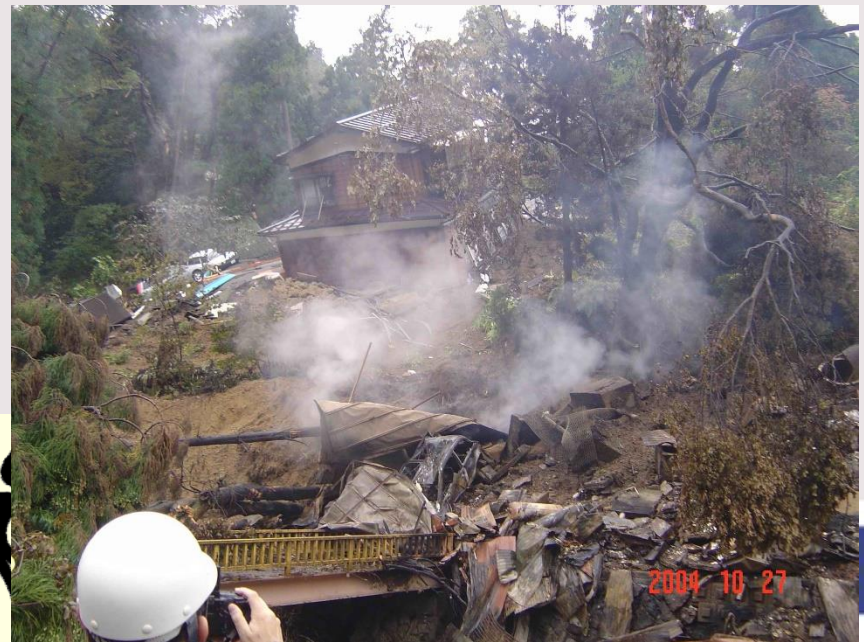
Place: Nigorisawa village

Large landslide took place destroying retaining wall and several houses built on the slope. Soil mass moved more than 50 meters downwards.

Many of the local roads and railways connecting the villages in the mountain area east of Ojiya-city were built by cutting the natural slopes. Some of these manmade slopes were affected by earthquake triggered landslides and slide debris blocked the traffic. *Mid sized landslide in Nigorisawa village* that destroyed several houses and blocked the local road. The biggest landslide we observed took place *near to Uragara bridge, Myoken*, Ojiya-city. Huge rocks and mud stones completely blocked and destroyed the road in length of more than hundreds meters. Several landslides also took place in residential area in *Takamachi*. Ring road which was passing at the edge of this this residential area was destroyed by several landslides which took place during the earthquake.

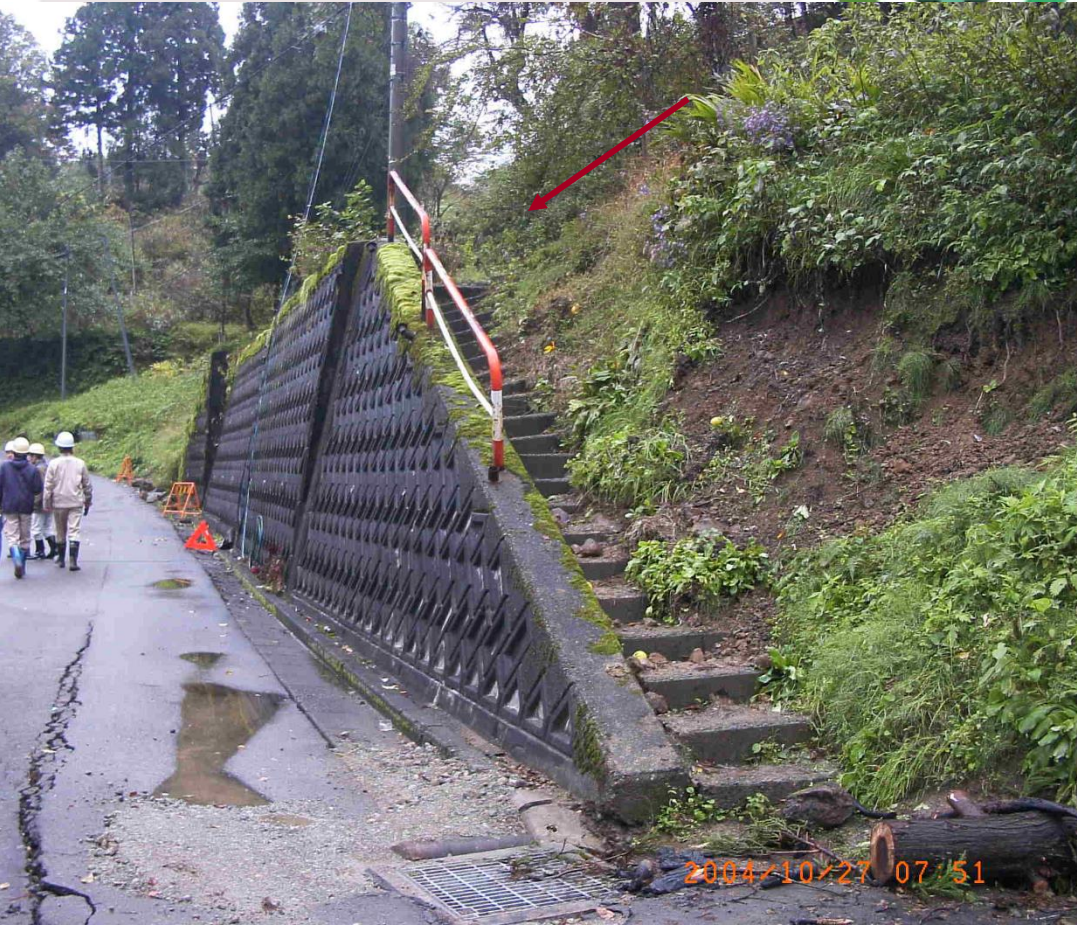
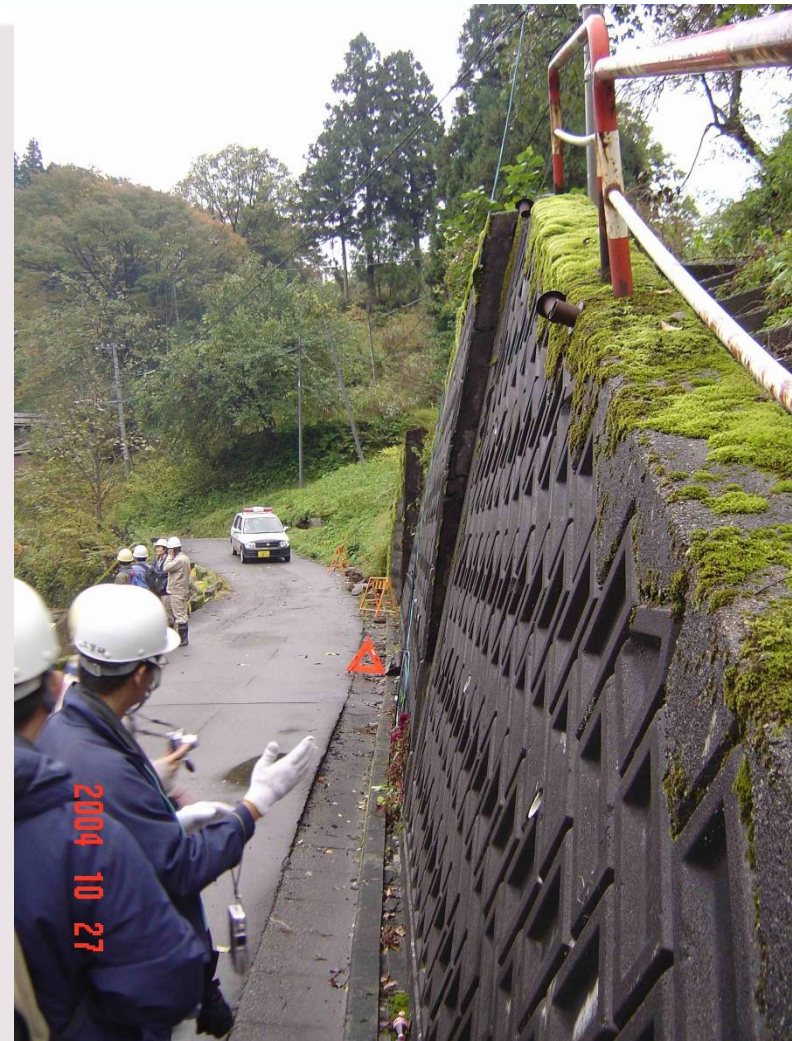
Damaged retaining wall. Place: Nigorisawa village

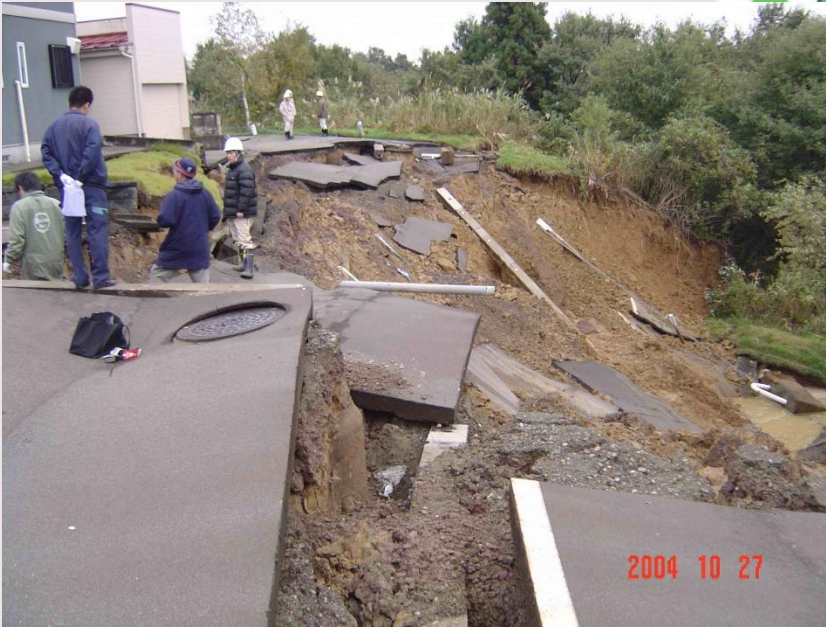
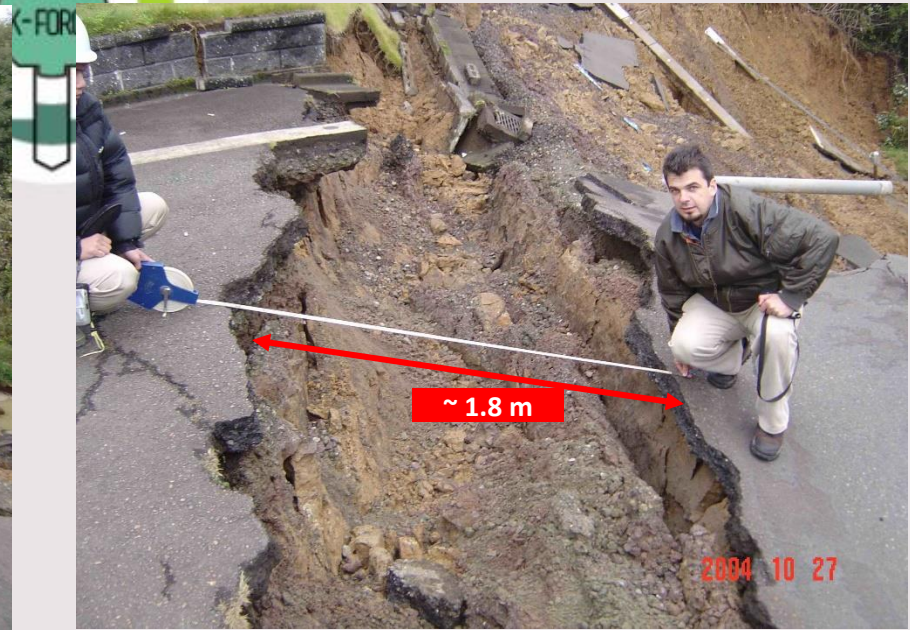
LANDSLIDES AT TAKAMACHI RESIDENTIAL AREA

This residential area was located on *small hill terrace*. A *ring road* at the edge of this terrace was wiped off by the landslides on several places.

Several landslides which occurred at this residential area didn't caused collapse of the houses but heavily damaged the roads and pipe lines. The landslide mass scarped the surface layer just at the edge of the houses.

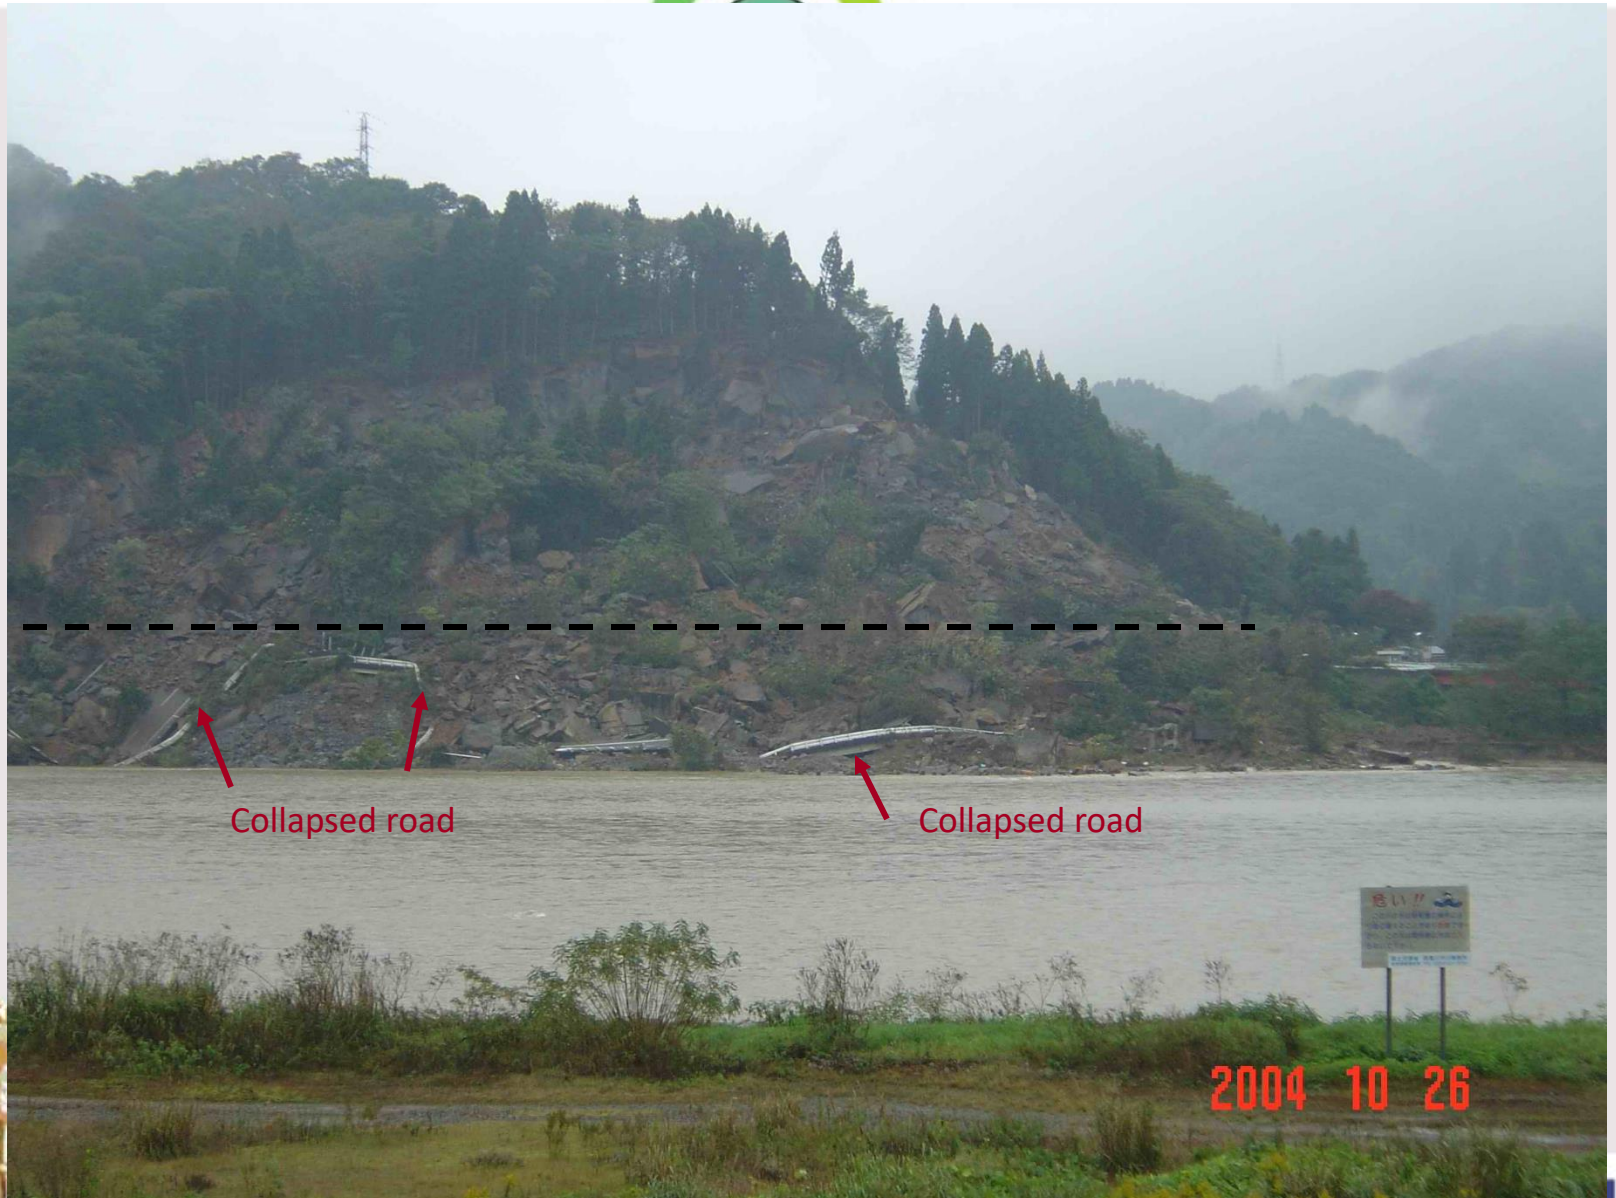
LARGE LANDSLIDE AT MYOKEN, OJIYA city

Collapsed road

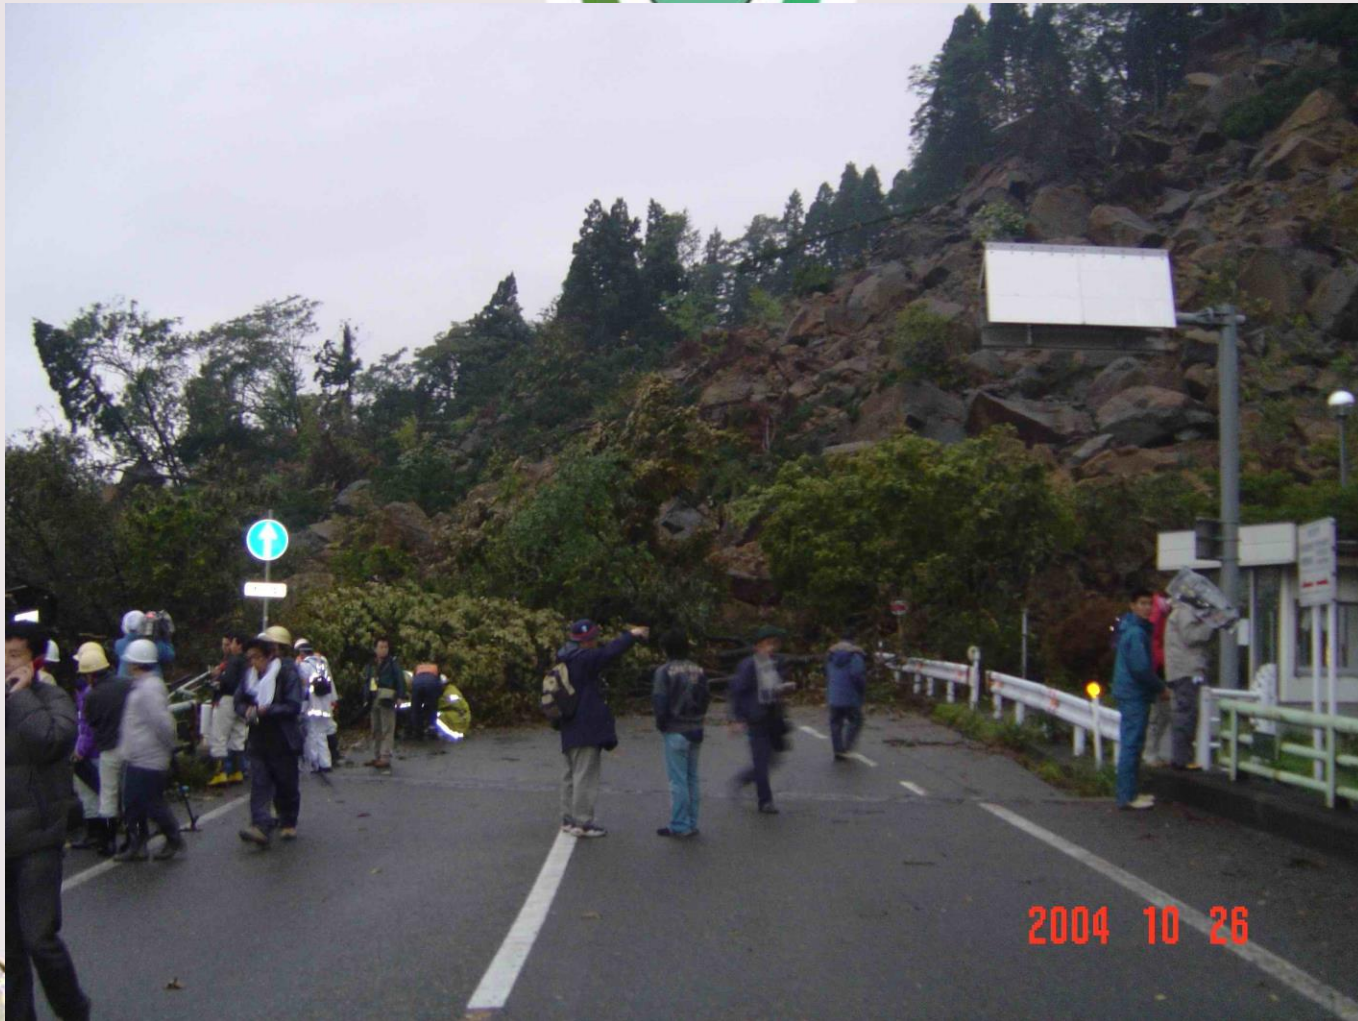
LANDSLIDE AT MYOKEN, OJIYA city

Huge rocks and mud stones completely blocked and destroyed the road in length of more than several hundreds meters

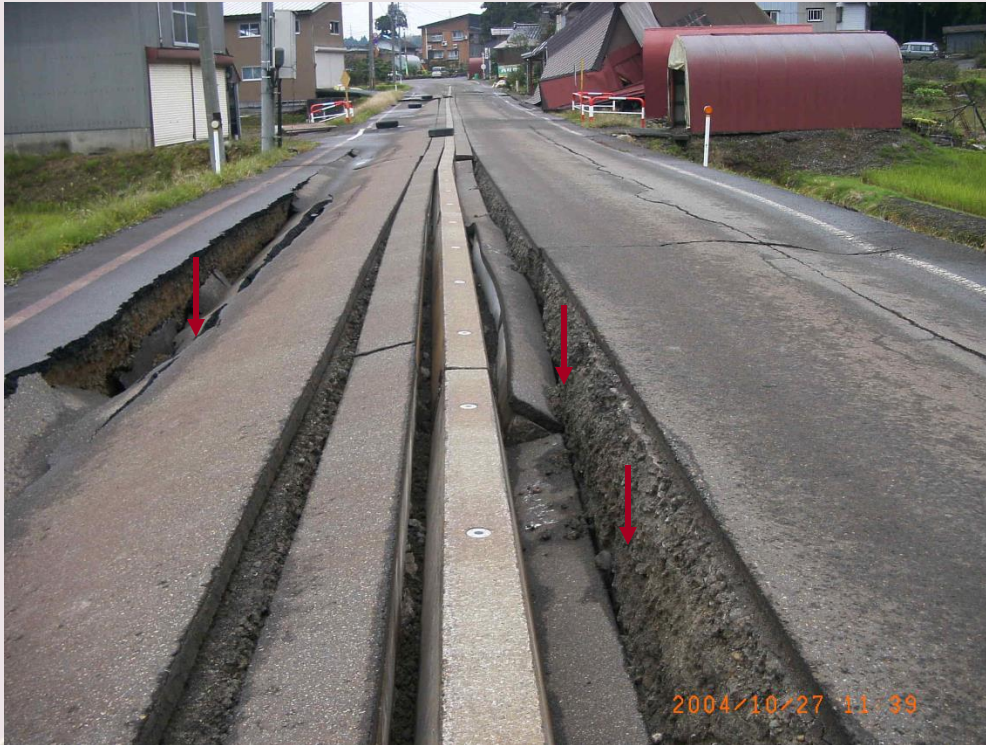
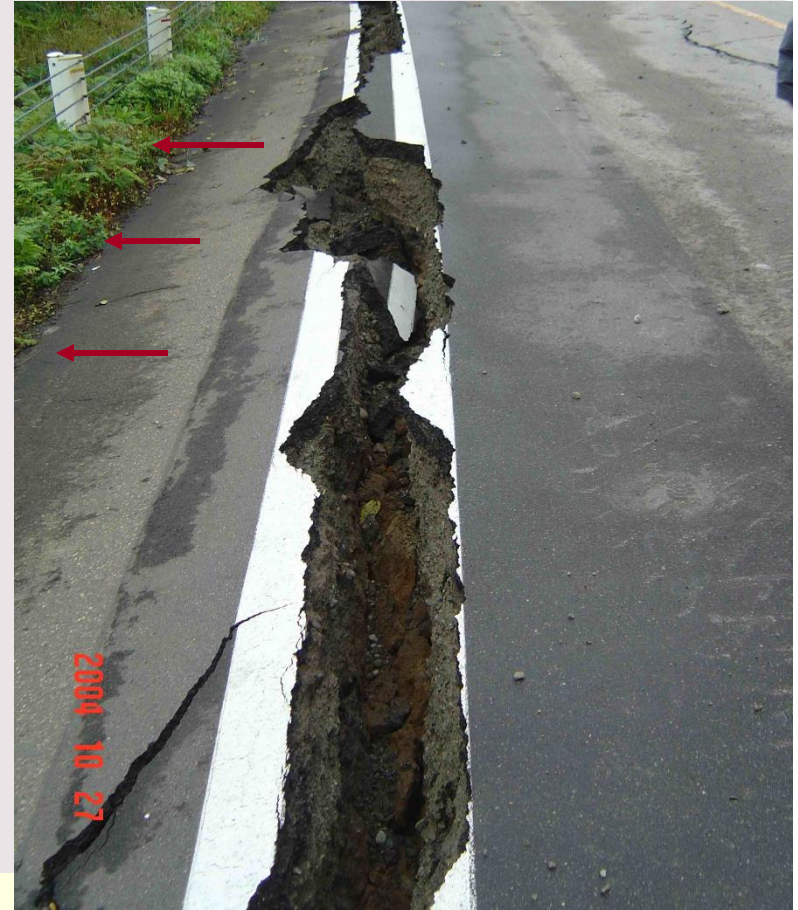
OBSERVED DAMAGES ON LOCAL ROADS

Cracks and subsidence of asphalt pavement.

cracks in asphalt pavement due to lateral displacement

The local roads suffer significant damages due to settlement of the road embankment causing numerous cracks and subsidence of asphalt pavement. Crest settlements of the road embankment frequently occurred with lateral movement of the fill material which produced damages on the retaining wall at the toe of the embankment. Also buried water pipelines located in the middle of the roads were separated from the asphalt pavements.

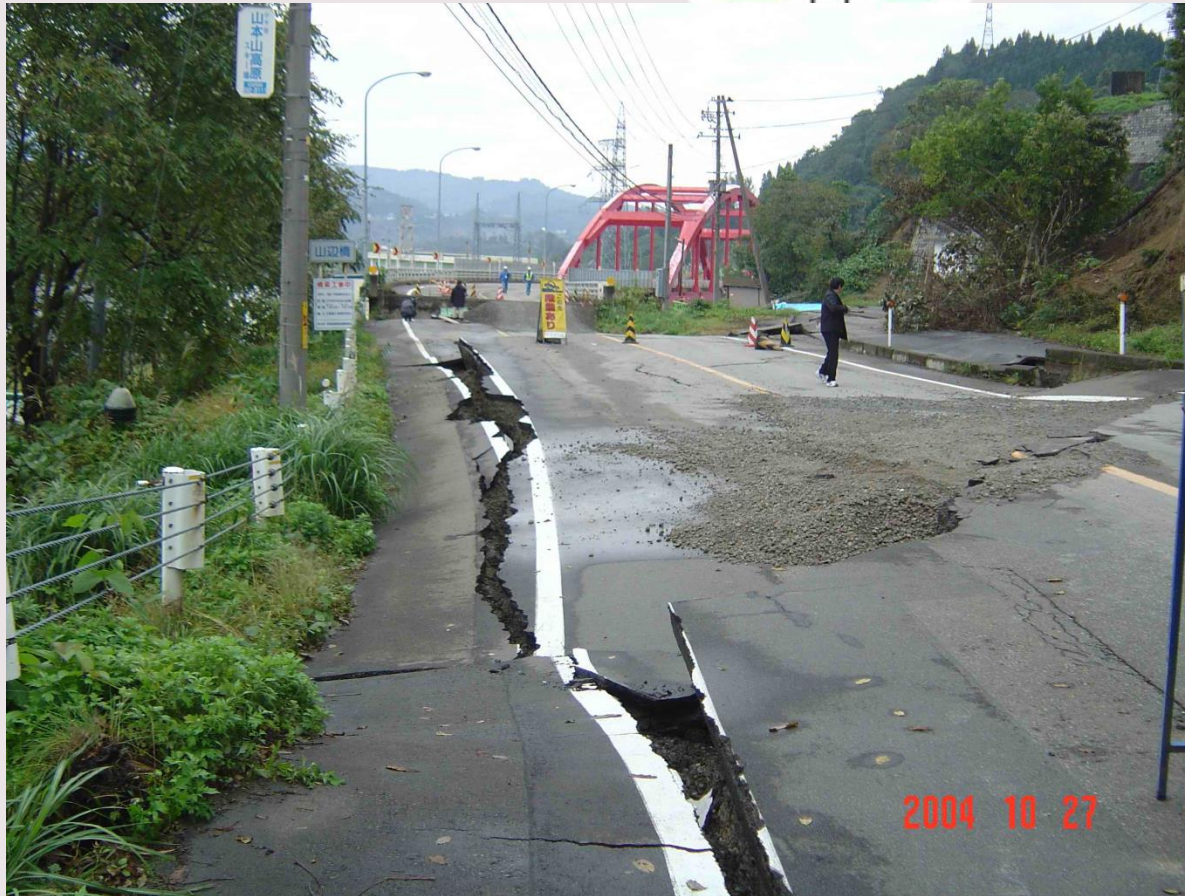
Approaching road to YAMABA bridge

Road was heavily damaged. Bridge steel structure performed well during the earthquake.

Connection between the roads and the culverts also between roads and the bridges were particularly damaged by the subsidence of fill material of the road embankment. We observed large crest subsidence on the road approaching the Yamabe bridge. The bridge itself performed well during the earthquake no visual damaged could be observe on the steel structure.
