Earthquake Geotechnical Risks

What we know, What we should know

Lessons learned

Prof. D-r Vlatko Sheshov

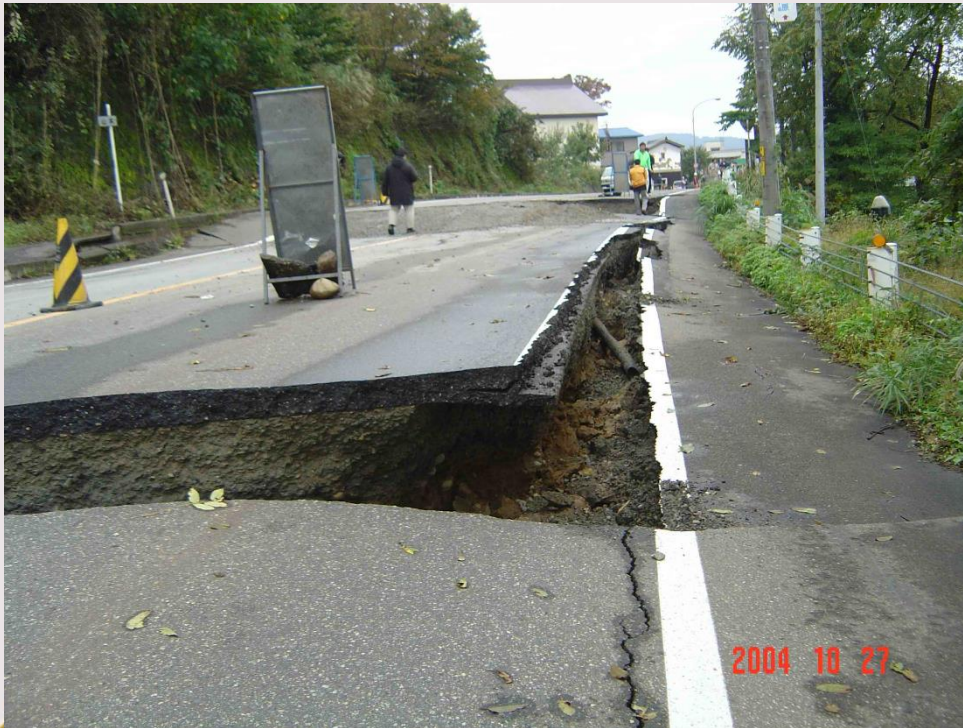
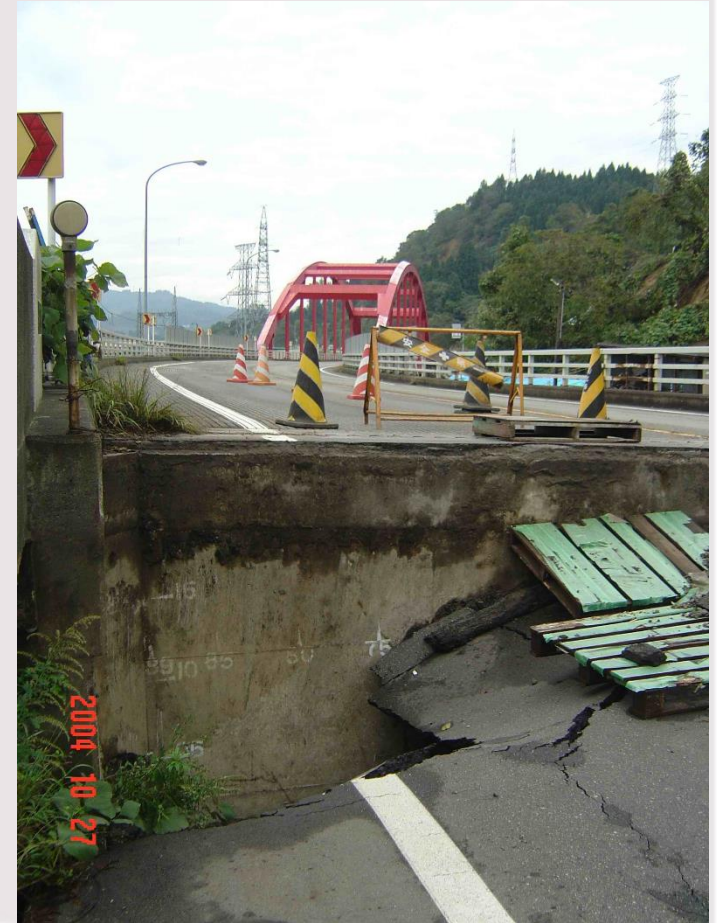
Approaching road to YAMABA bridge

Big subsidence were observed on the road approaching the Yamabe Bridge

Connection between the roads and the culverts also between roads and the bridges were particularly damaged by the subsidence of fill material of the road embankment. We observed large crest subsidence on the road approaching the Yamabe bridge. The bridge itself performed well during the earthquake no visual damaged could be observe on the steel structure.

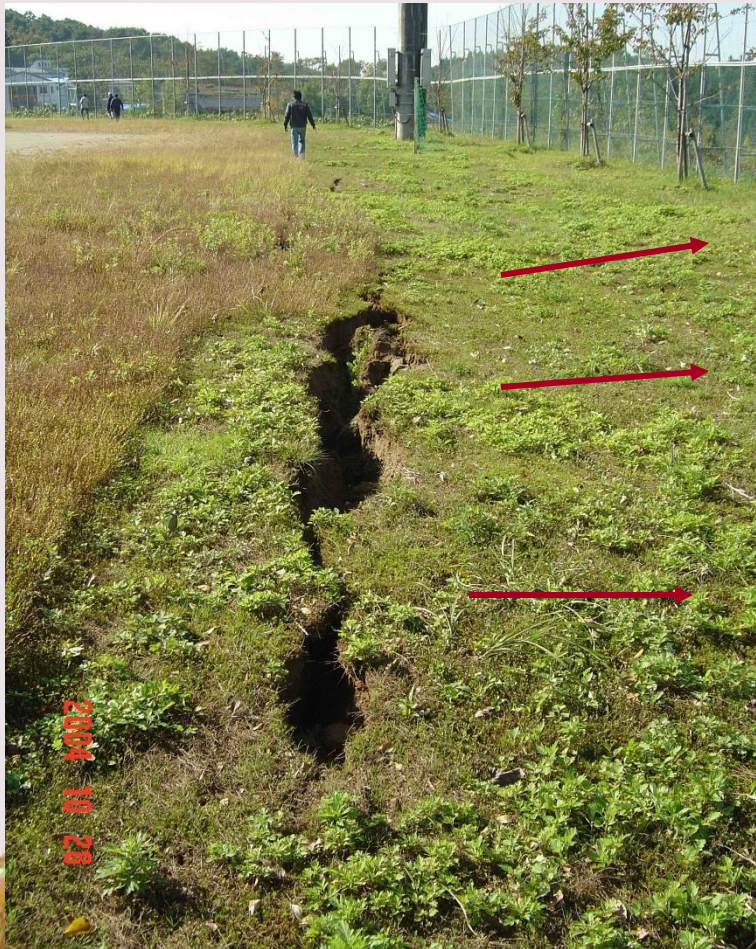
Soil moved toward the slope of the hill terrace and large cracks appeared.

Large lateral displacements and ground subsidence we observed at Nagaoka National College of Technology which is located on small hill terrace in Nagaoka city.

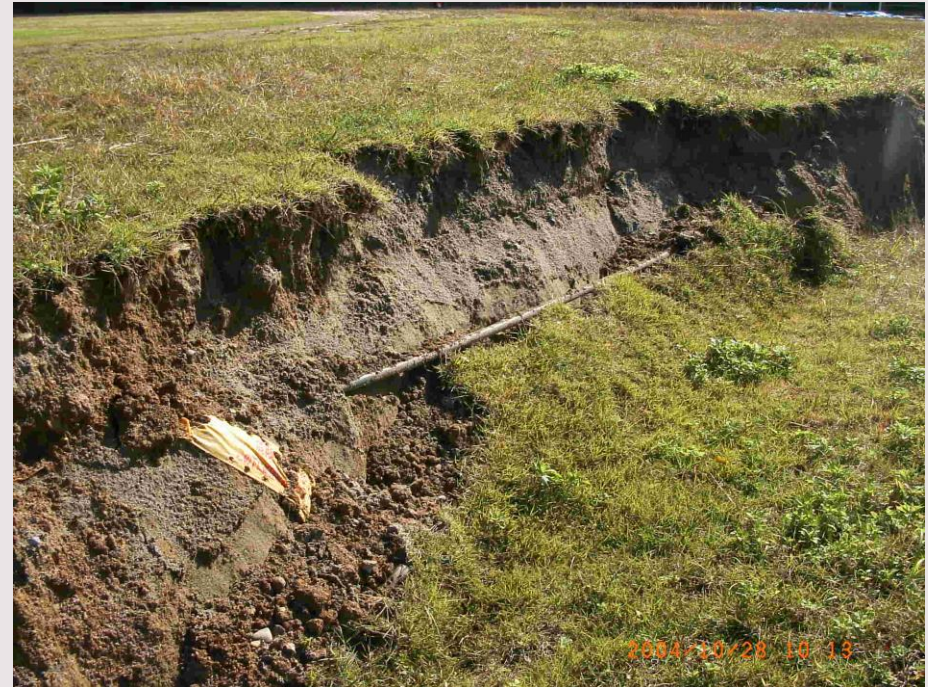
Ground subsidence of nearly 1 m at the college playground.

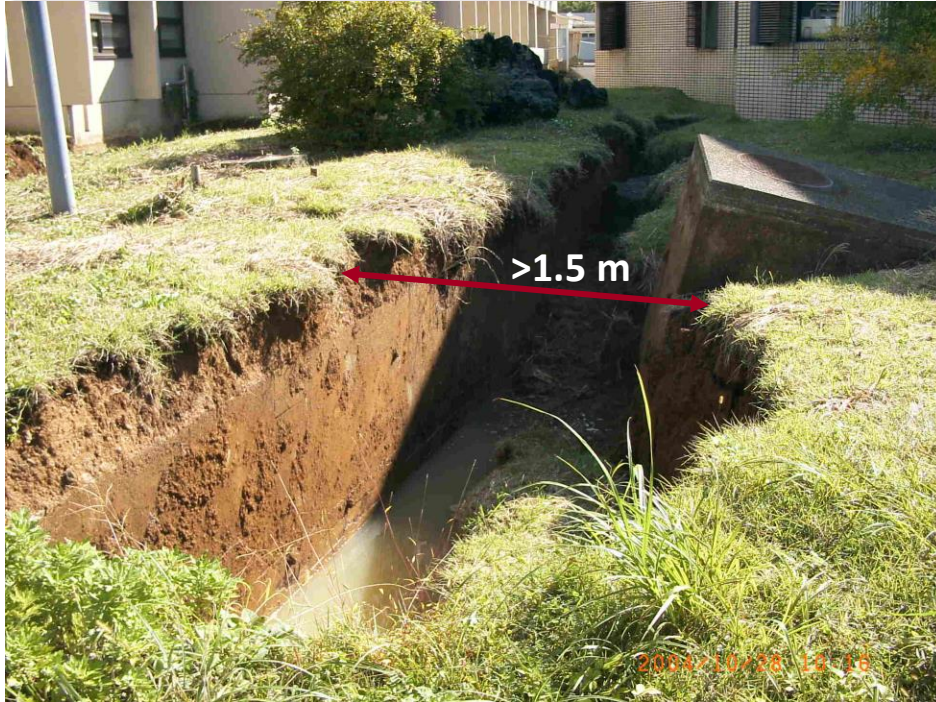
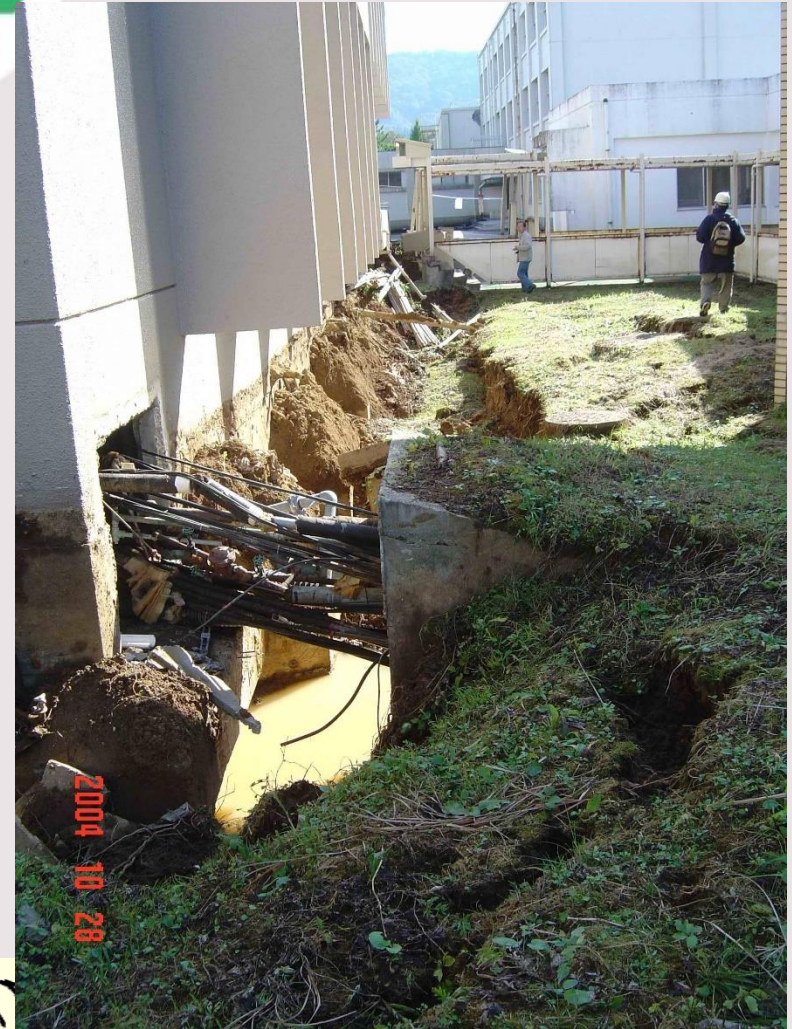
Fill material separated from underground concrete structure due to large permanent soil displacement

Large ground deformation was observed between two buildings

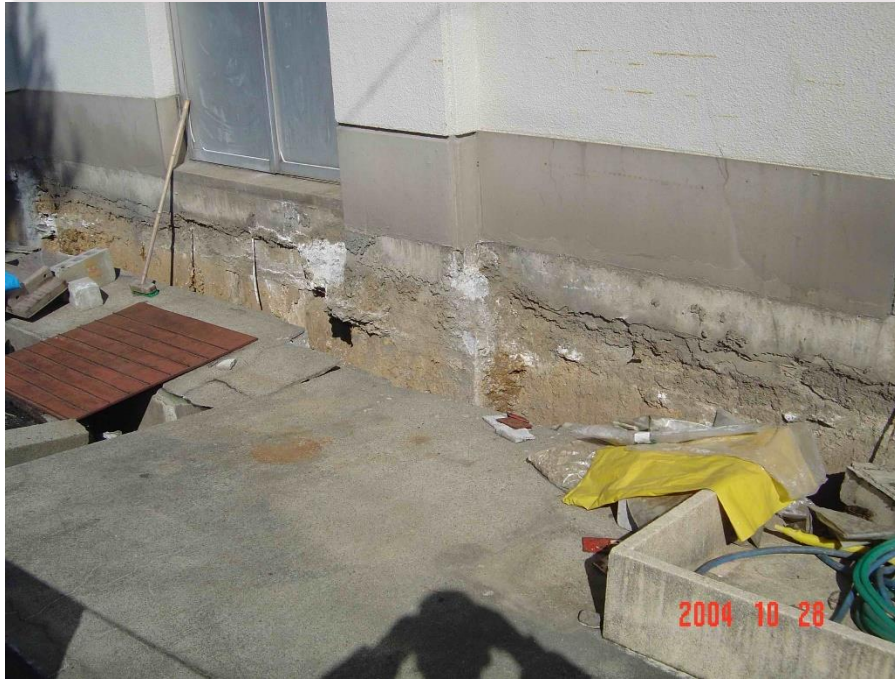
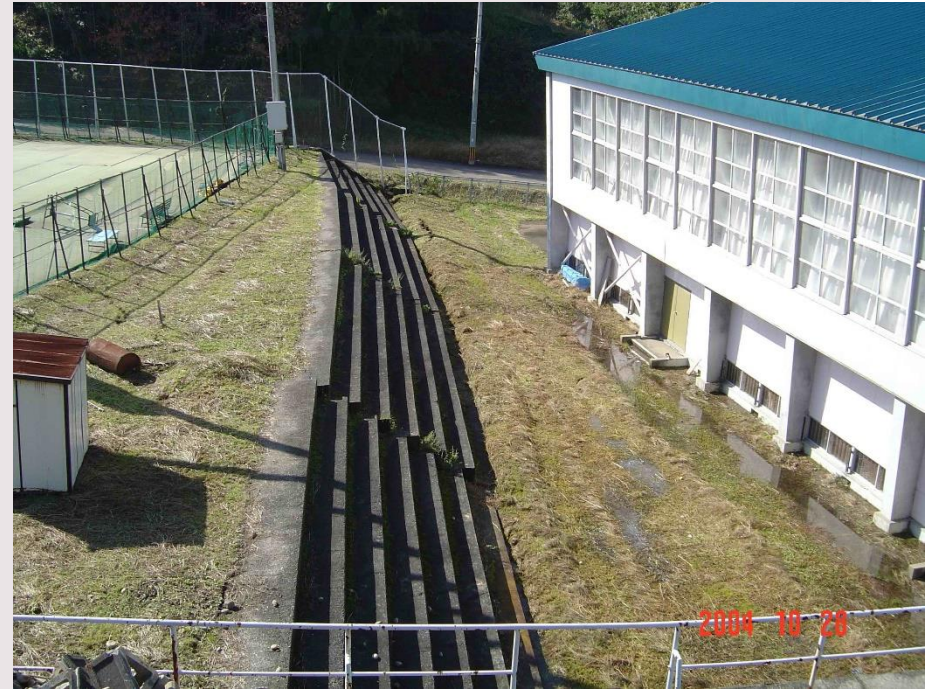
Soil settlements up to one meter were observed near to this three stories building which is founded on pile foundation

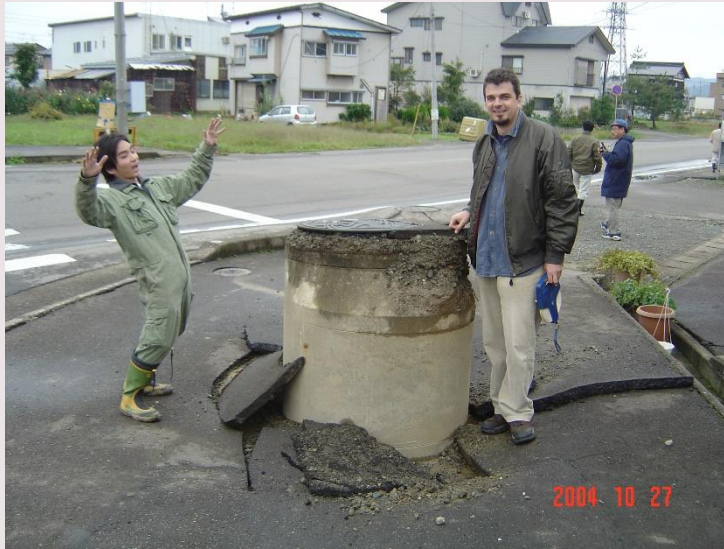
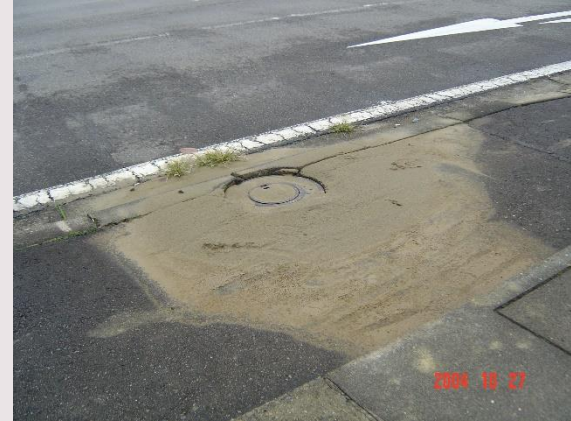
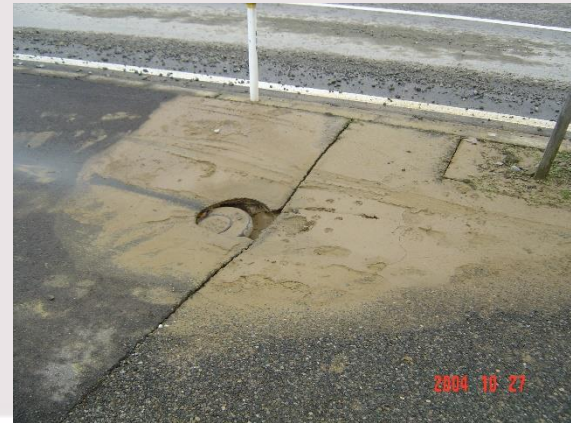
SOIL LIQUEFACTION AT OJIYA CITY

Up-lifted manholes in Ojiya city and small sand boils

- *Up-lifted manholes* in Ojiya city and *small sand boils* in their vicinity were the evidence that liquefaction took place. Also small sand boils could be observed in the rice fields.

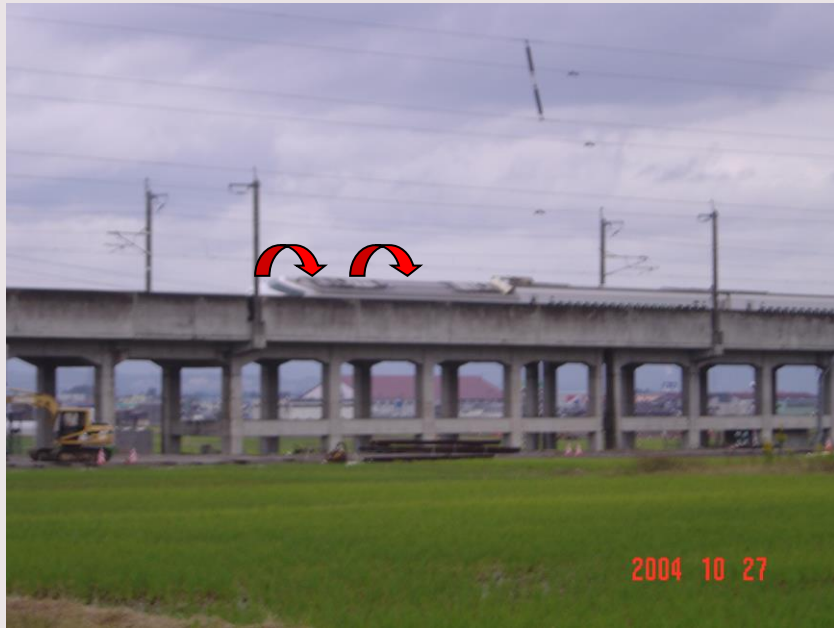
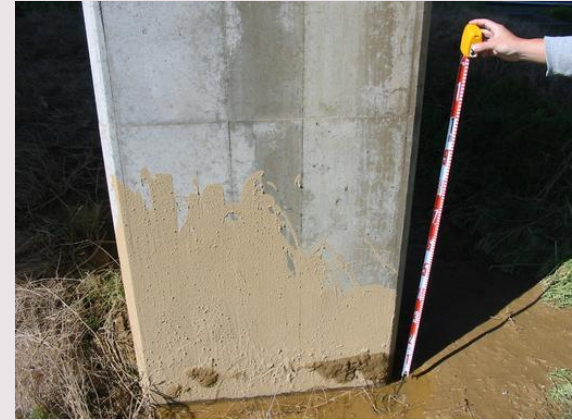
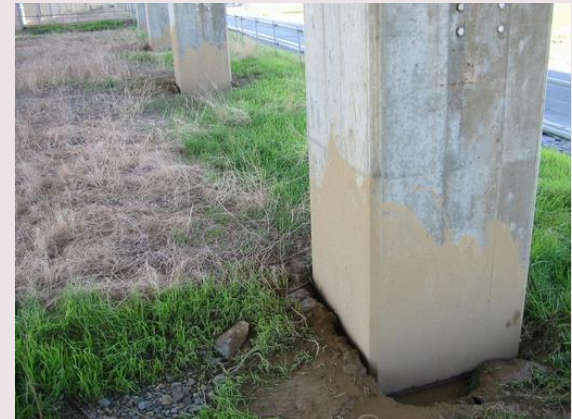
Derailment of Shinkansen

Liquefaction occurred at the foot of the piers the boiled sand reached 70 to 90cm. The gap between the pier and the ground indicates the large displacement the pier experienced. Strong motion sensors shut down the electric power supply and prevent bigger catastrophe.

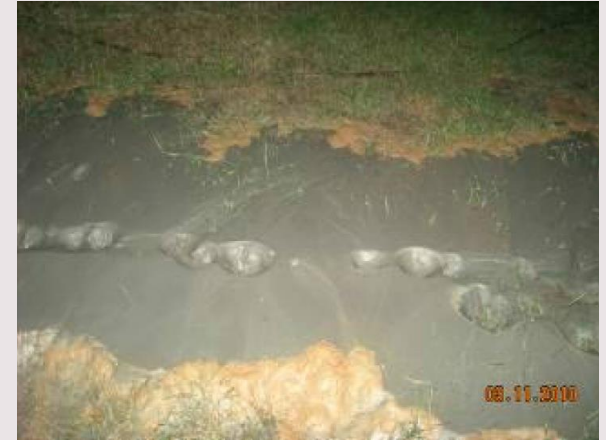
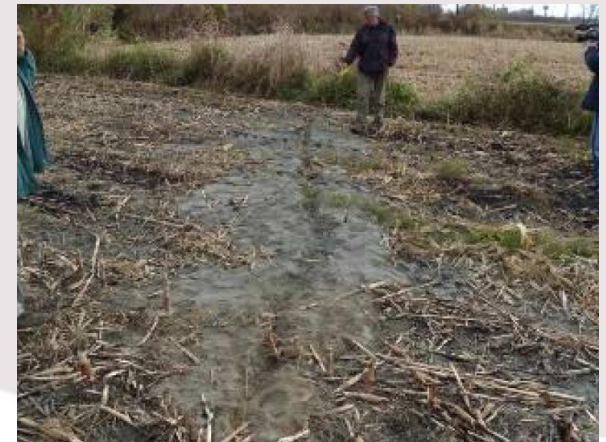
- Moderate earthquake with $M=5.4$, November 3, 2010 at 01:56:55 (local time).
- Typical liquefaction manifestations like: ground cracks, sand boils, ejected sand in wells (Seismological Survey of Serbia (2010)).
- Agriculture area in the vicinity of Zapadna Morava

Observed Liquefaction at epicentral area

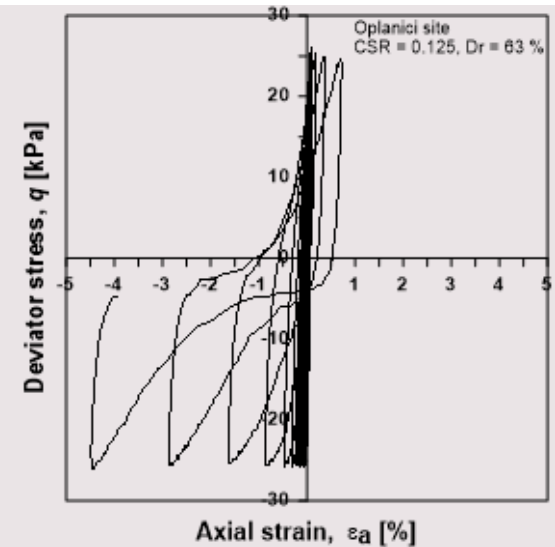
- Cyclic tests performed on Cyclic Simple Shear Apparatus (CSSA) and Dynamic Triaxial Apparatus (DTA) IZIIS, Skopje, Macedonia.
- Relatively **low magnitude M=5.4** produced few cases of liquefaction without any reported direct damages to building environment
- Investigated soil samples shows **potential for liquefaction** at low-moderate level of excitation

Stress strain paths during CTUT
