SEISMIC EXPOSURE OF BRIDGES IN BOSNIA AND HERZEGOVINA AND EVALUATION OF BRIDGES SEISMIC SAFETY

Damir Zenunovic
Novi Sad, April 2020

Procedure for evaluation of bridges safety in Bosnia and Herzegovina is presented through the case study of cable – stayed pedestrian and motorway overpass in Tuzla city urban environment.

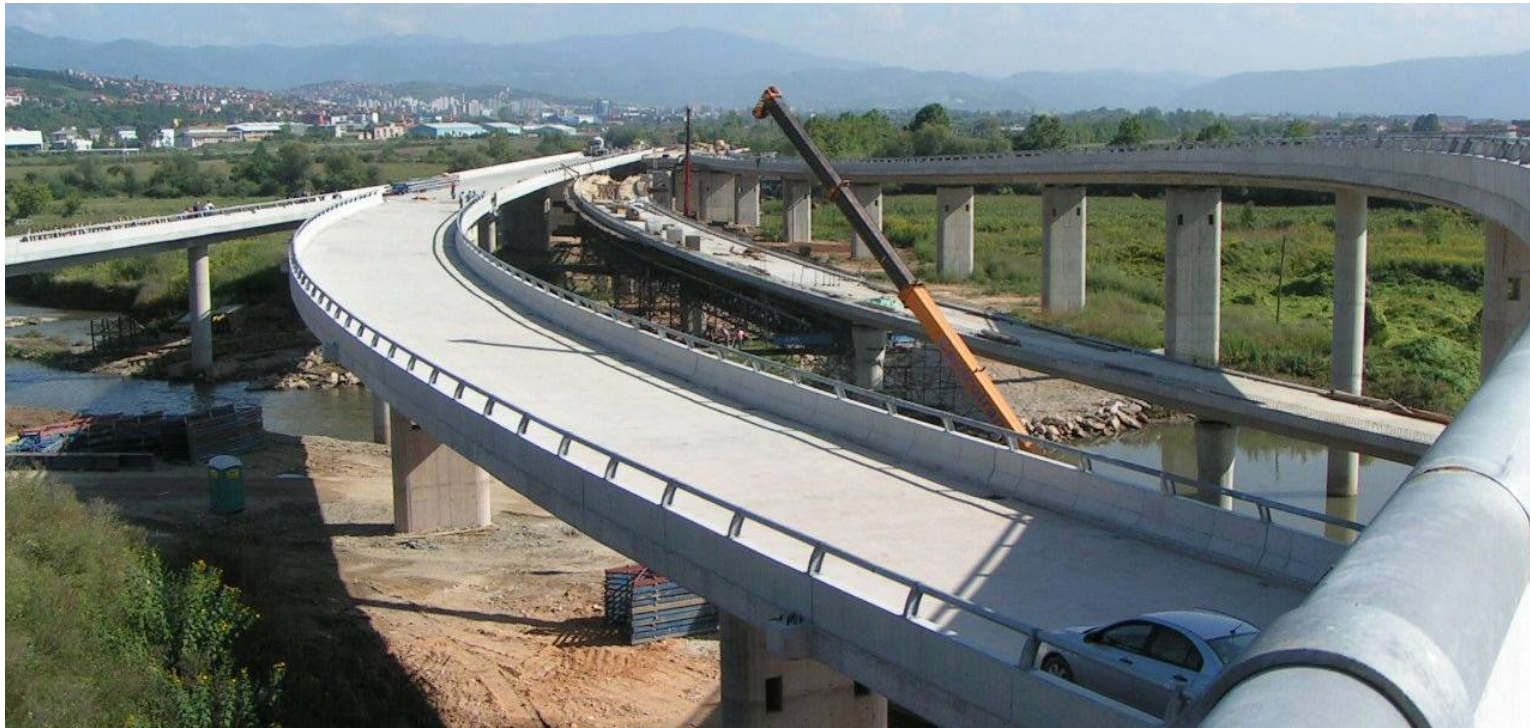
There are about 3000 bridges in Bosnia and Herzegovina, of which on the Federal Roads about 1000, and the rest to regional and local roads. Approximate value of all bridges is 1 billion EUR. Bridges are of different ages, shapes, and structural systems, mostly built of concrete, stone and steel. About 70% of the bridges were built in the period from 1955 to 1985, and 90% of bridges were constructed mainly of reinforced concrete and prestressed reinforced concrete. Other bridges are mostly composite steel-concrete.

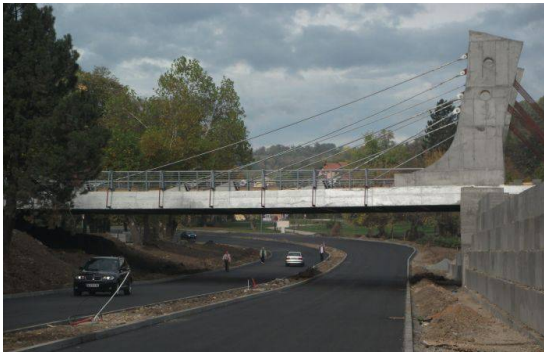
In order to ensure their reliability, and especially their stability and serviceability, it is important to analyze the bridge structure loaded by dynamic excitation. For both, newly constructed bridges and older existing bridges, it is desirable to measure the dynamic properties, resonant frequencies, mode shapes, and modal damping of the bridges to understand better their dynamic behaviour under normal traffic loads as well as extreme loads such as those caused by seismic events or high winds. According to existing regulations, compliance of structures performance in real with the design structure performance defines with bridge test load (static and dynamic test load).
