## STRUCTURAL FIRE SAFETY DESIGN: challenges and shortcomings

**Luisa Giuliani**  
**Novi Sad, 6<sup>th</sup> April 2020**

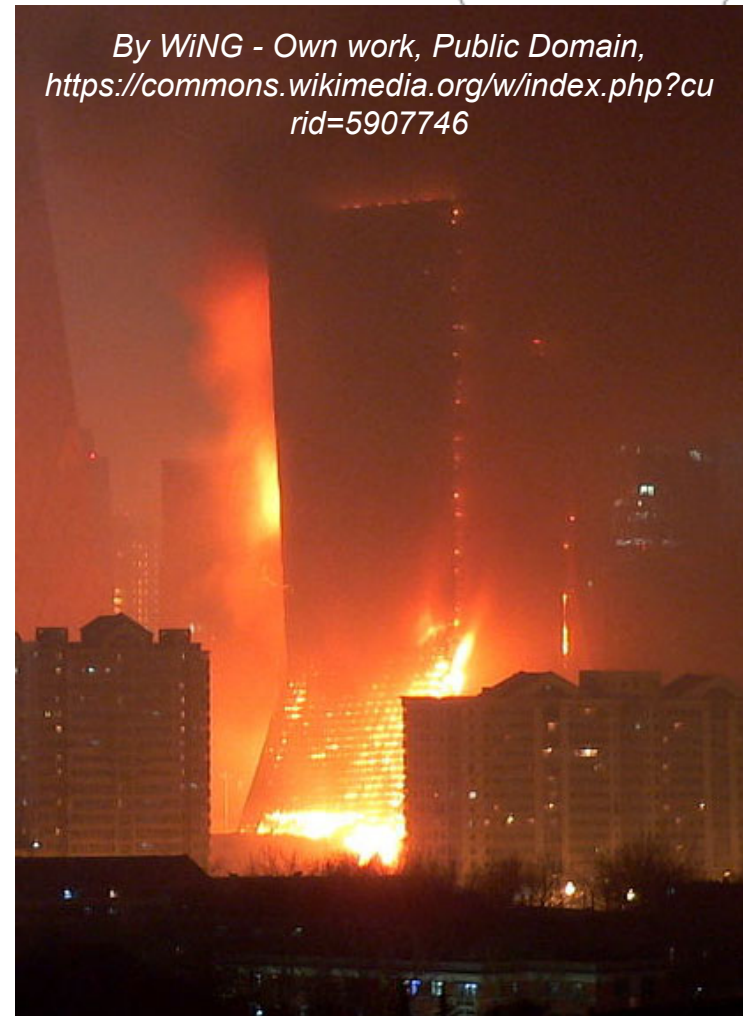
## TVCC HOTEL, Beijing, China, Feb. 2009

Built: under construction  
Height: 44 floors, 158 m  
Use: hotel, not occupied yet  
Structure: steel-framed with concrete core  
Fire: triggered at roof, spread downwards  
Cause: unauthorized firework  
Duration: 5 hours  
Injuries: 1 casualty (fireman), 7 injuries  
Damages: many floors, no frame, ca. \$100mil

*Fire triggers: firework*

*Fire spread: flammable facade*

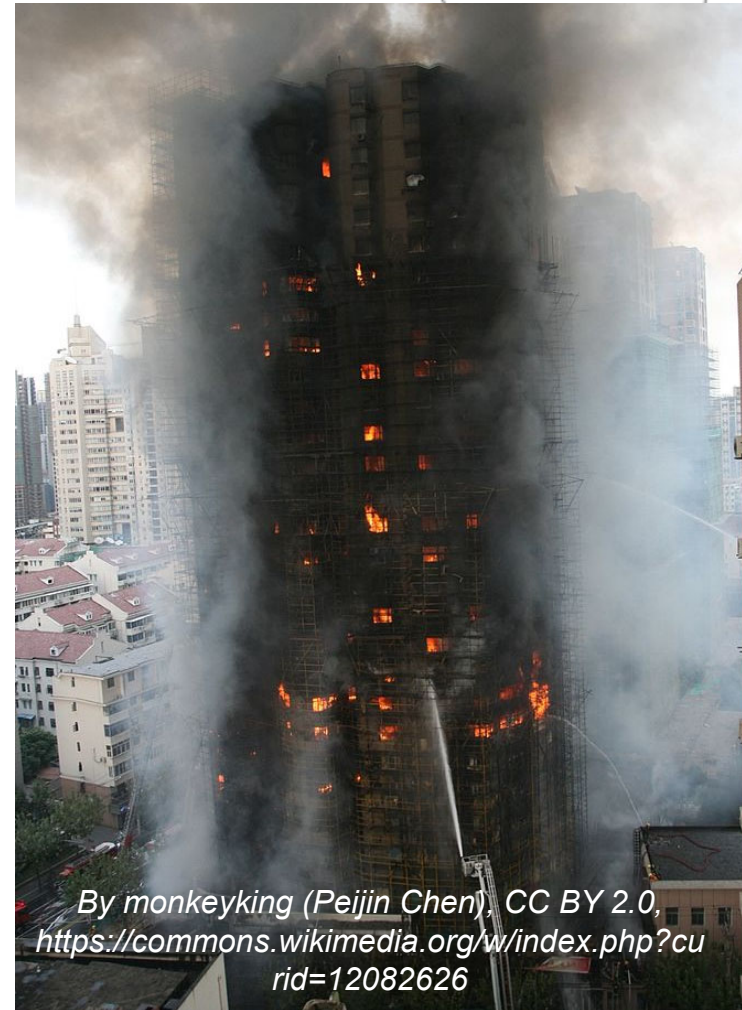
## SHANGHAI APARTMENT, China, Nov 2010

- Built: sprinkled  
Height: 28 stories, 85 m  
Use: residential  
Fire: started at 10<sup>th</sup> floor, spread to the roof through façade and then moved inside the building  
Cause: unauthorized welding work and polyurethane foam insulated façade  
Duration: several hours, but very rapid spread through facade (ca. 10 min)  
Casualties: 58 casualties, 70 injured

*Fire triggers: welding spark*

*Fire spread: flammable facade*

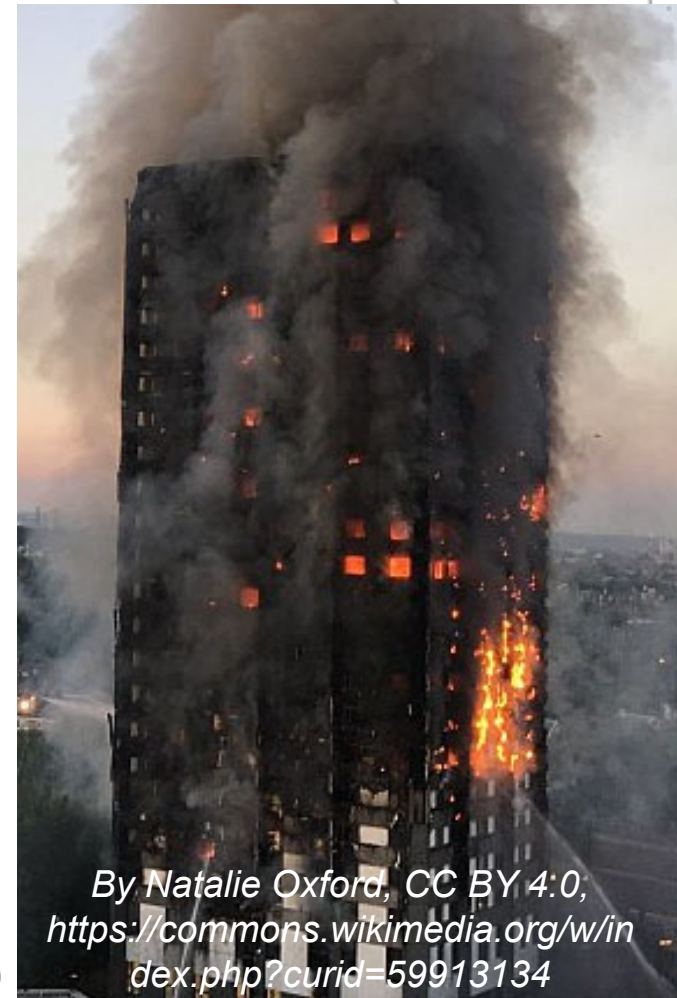
## GRENPELL TOWER, London, UK, 2017

Built: 1974  
Height: 24 stories  
Use: residential  
Fire cause: faulty freezer in one apartment,  
Spread: through newly installed composite cladding  
Duration: 60 h  
Injuries: 70 injured, 80 casualties  
Damages: to be demolished

### COMPOSITE CLADDING

Pre-fabricated concrete wall

PIR foam plate (150 mm)

Ventilation gap (50 mm)

Aluminium-polyethylene sandwich plates (3mm each)

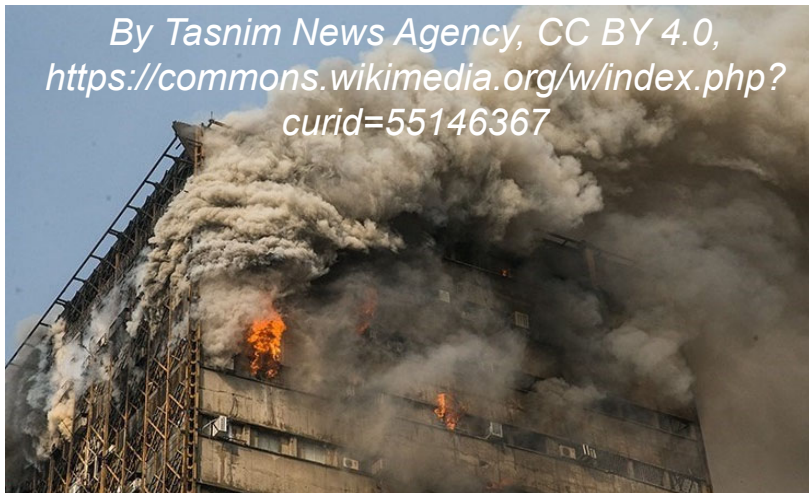
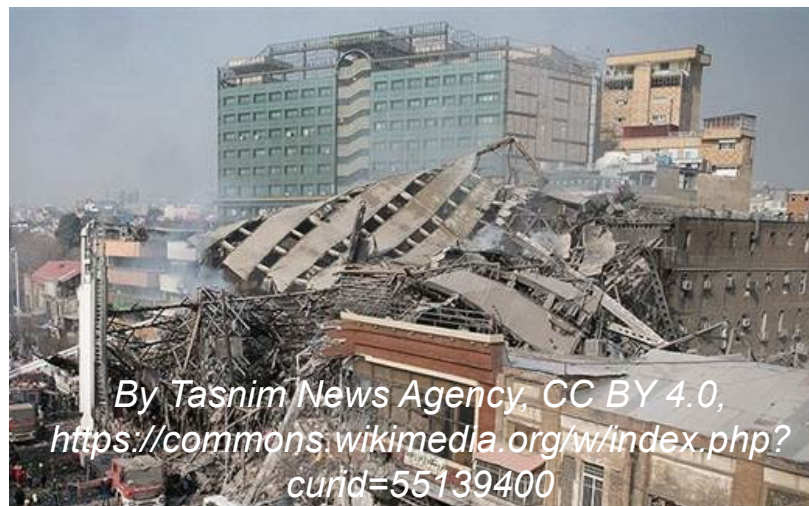
## PLASCO BUILDING, Theran, Iran, Jan 2017

- Height: 17 stories, 42 m
- Use: residential + shopping mall
- Structure: steel frame with bracing
- Fire: spread from 9<sup>th</sup> floor upwards
- Cause: faulty electrical connection
- Duration: collapse after 4 hours
- Injuries: 26 casualties (16 firemen),  
230 injured (70 by collapse)
- Damages: complete collapse

*Structure: steel*

*Collapse: after 4 h fire – fire fighter safety*

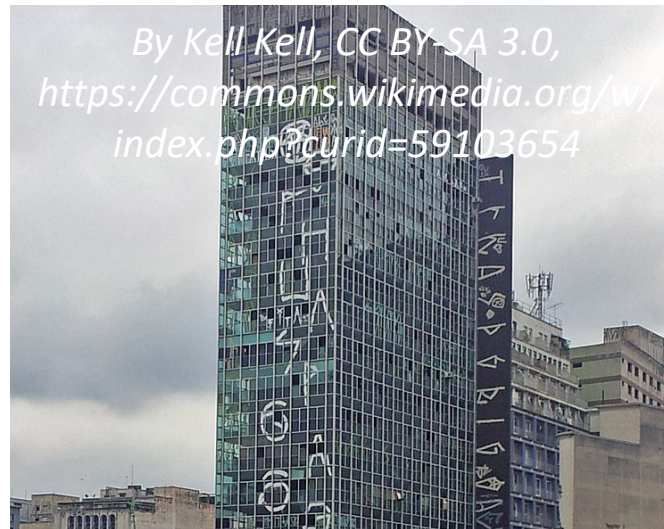
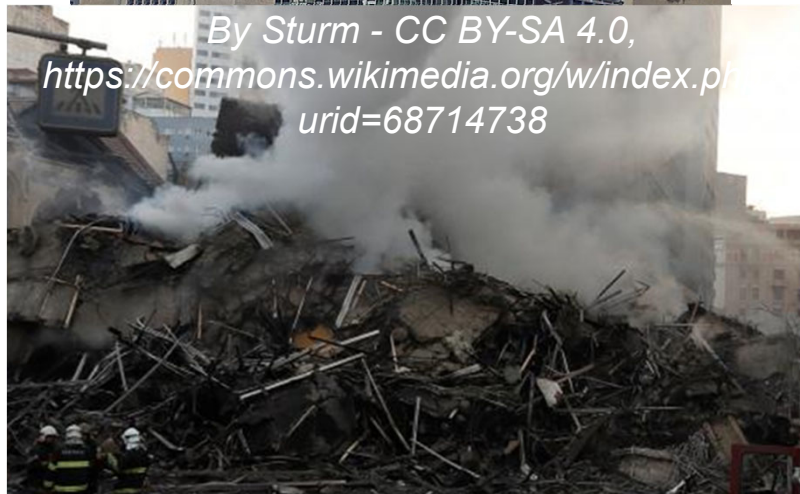
## **WILTON PAES DE ALMEIDA, Sao Paulo, Brazil, May 2018**

Built:	1968, 85 m
Height:	26 stories (24 above ground)
Use:	residential + shopping mall
Structure:	steel frame with concrete floors
Fire:	spread from 5 <sup>th</sup> floor spread also to adjacent buildings
Cause:	short circuit
Duration:	90 min
Injuries:	7 casualties + 2 missing
Damages:	complete collapse; damages from debris to adjacent church

*Fire spread: to adjacent building*

*Structure: steel*

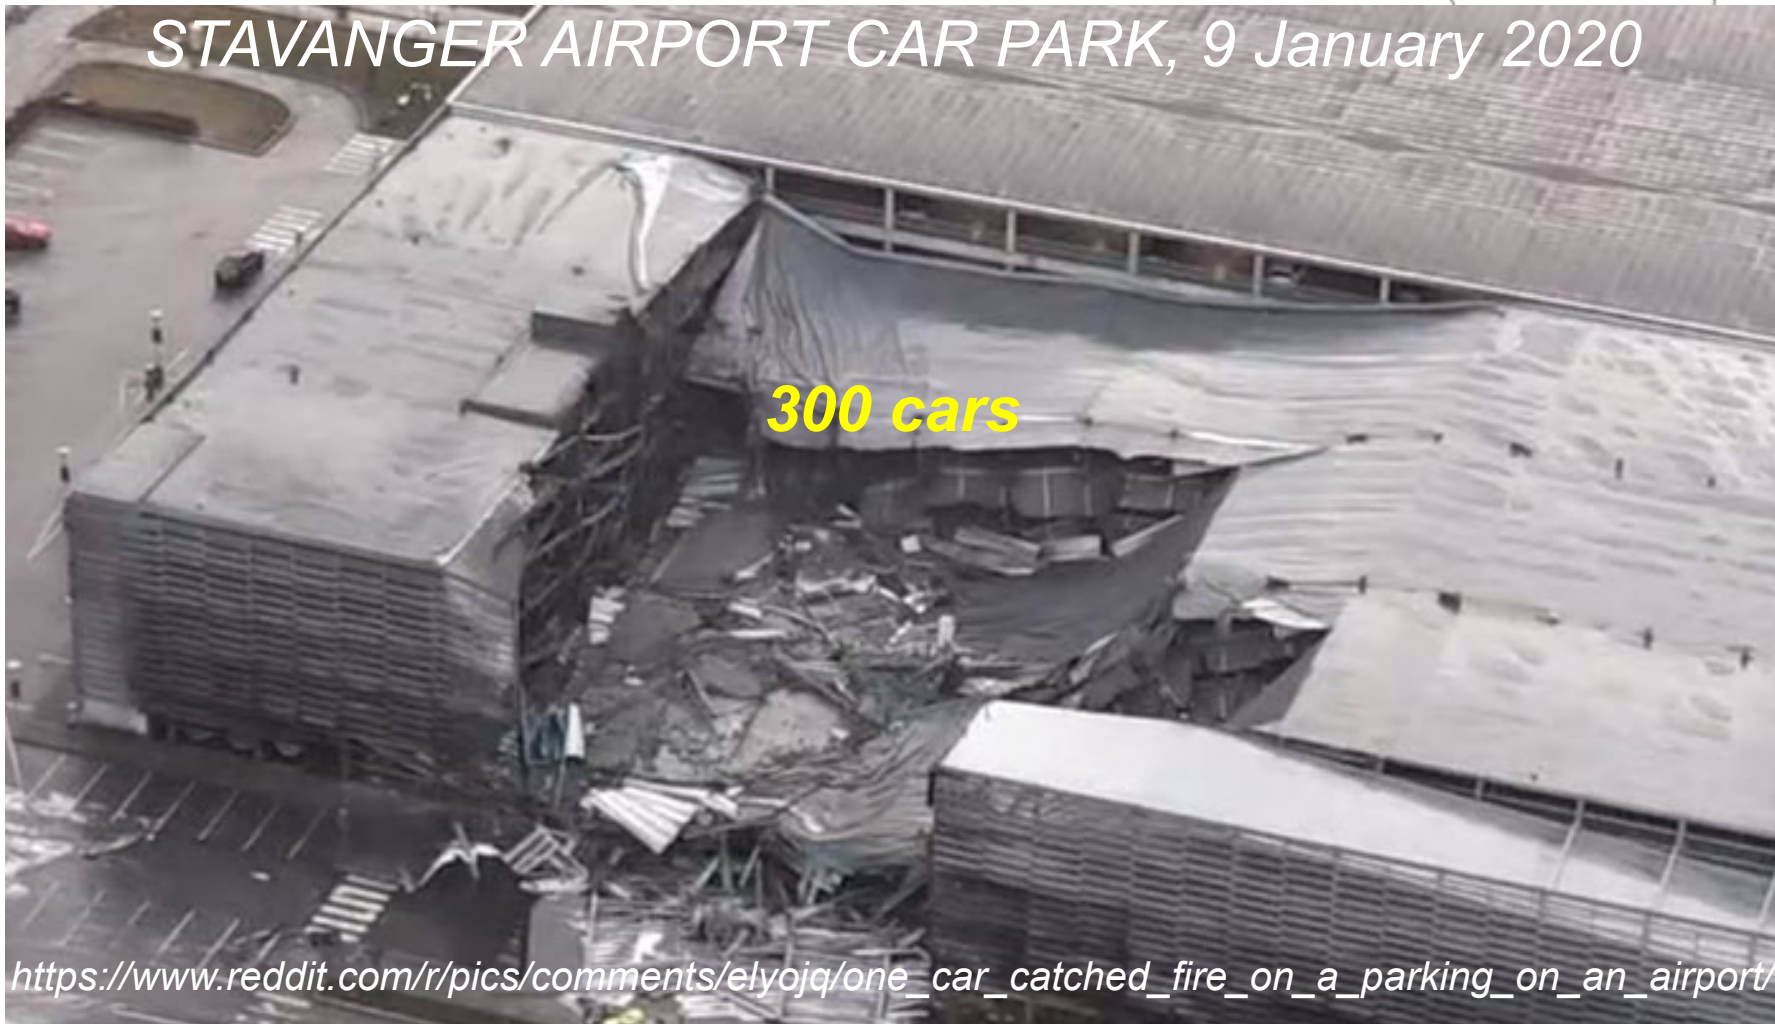
*STAVANGER AIRPORT CAR PARK, 9 January 2020*

## CAR PARK FIRE-INDUCED COLLAPSE

Date	Location	Burned cars	Construction type	Notes
2016-03-25	Nygaards Plads Brøndby, Denmark	19	Open	
2016-08-03	Dance Festival Andanças, Portugal	422	Open air	
2016-08-15	West Car Park at Boomtown Fair Festival, Winchester, Hampshire, UK	82	Open air	
2017-04-16	Von Lingens Väg Malmö, Sweden	30	Closed	
2018-01-01	Echo Arena, Liverpool, UK	1400	Open	to be demolished
2018-09-17	Kings Plaza Shopping Center, Brooklyn, NY, US	120	Closed	
2019-01-31	Newark Liberty airport, New Jersey, US	17	Open air	
2019-09-02	Douglas Village Shopping Mall, Cork, IE	60	Open	
09-01-2020	Stavanger airport, Norway	300	Open	steel structure collapsed

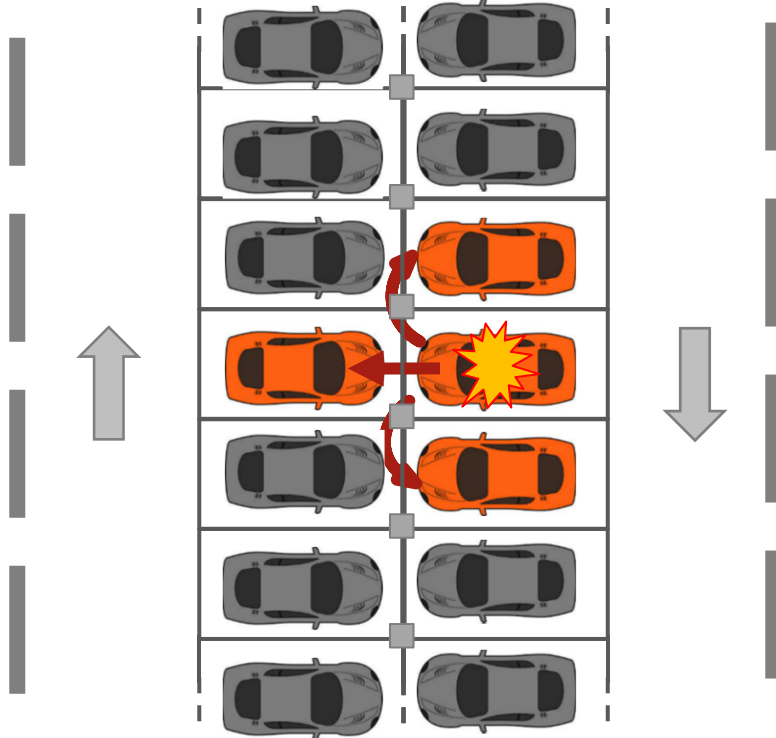
CTICM LARGE SCALE TEST

Fire scenario: local fire

3-4 cars, 12 min one car to another

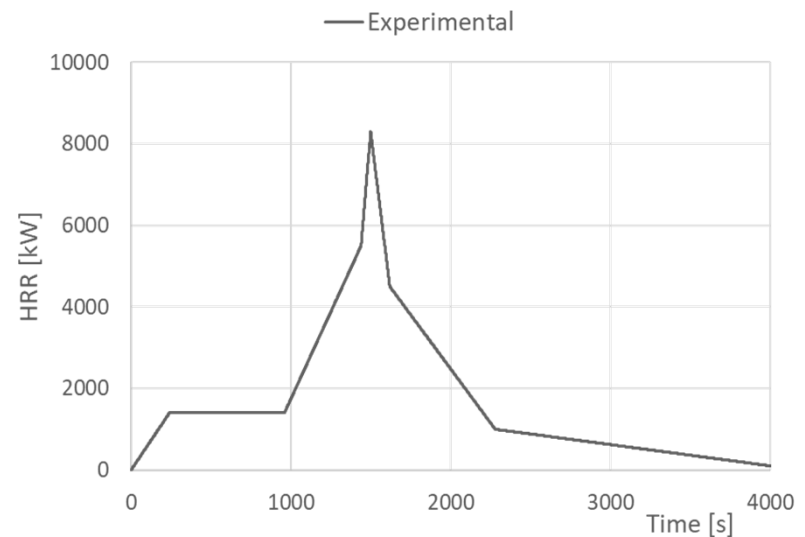
CALORIMETRIC HOOD TEST

Fire load: experimental HRR

- Lower ventilation & thermal feedback from ceiling
- New cars (higher energy content)
- Alternative fuels (batteries, hydrogen)

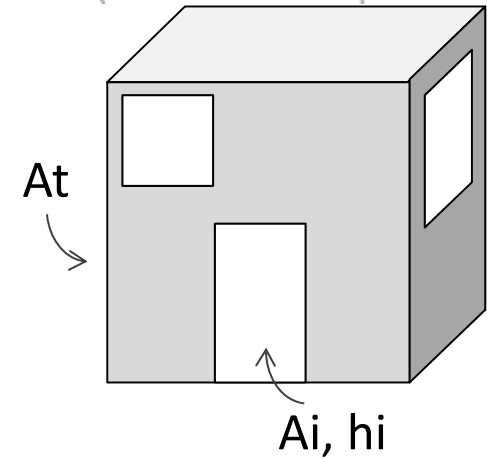
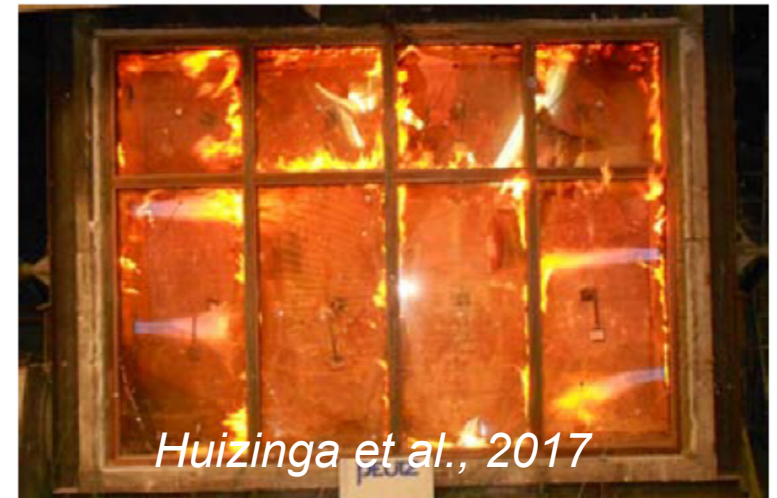
## DESIGN FIRES: ventilation

Opening factor:  $O = A \sqrt{h_{av}} / A_t$  [ $m^{1/2}$ ]

$$A = \sum_i A_i \quad \leftarrow \quad \begin{array}{l} \downarrow \\ \downarrow \end{array} \quad \begin{array}{l} \downarrow \\ \downarrow \end{array} \quad h_{av} = \sum_i A_i h_i / A$$

*BREAK BEFORE FO*

*MAY NOT BREAK*

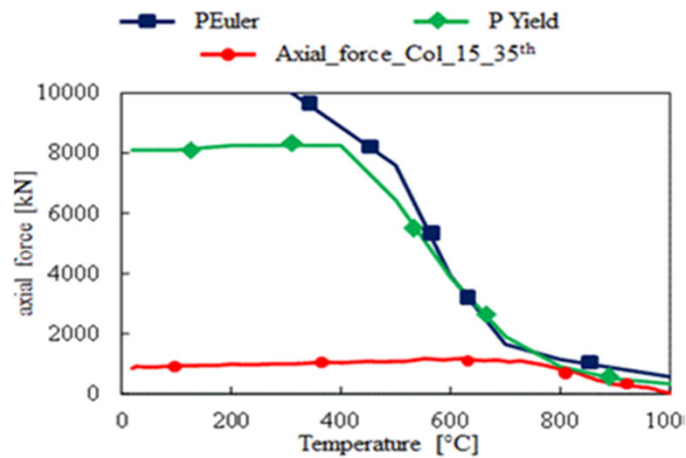
Fire at 35<sup>th</sup>  
floor

## DESIGN FIRES: vertical fire spread in buildings

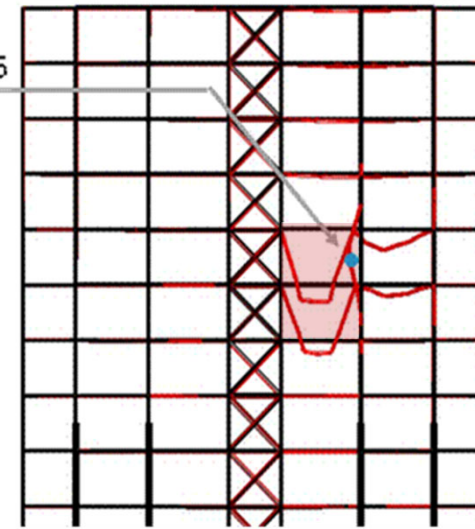
Fire at  
35&36<sup>th</sup> floor

Col 15

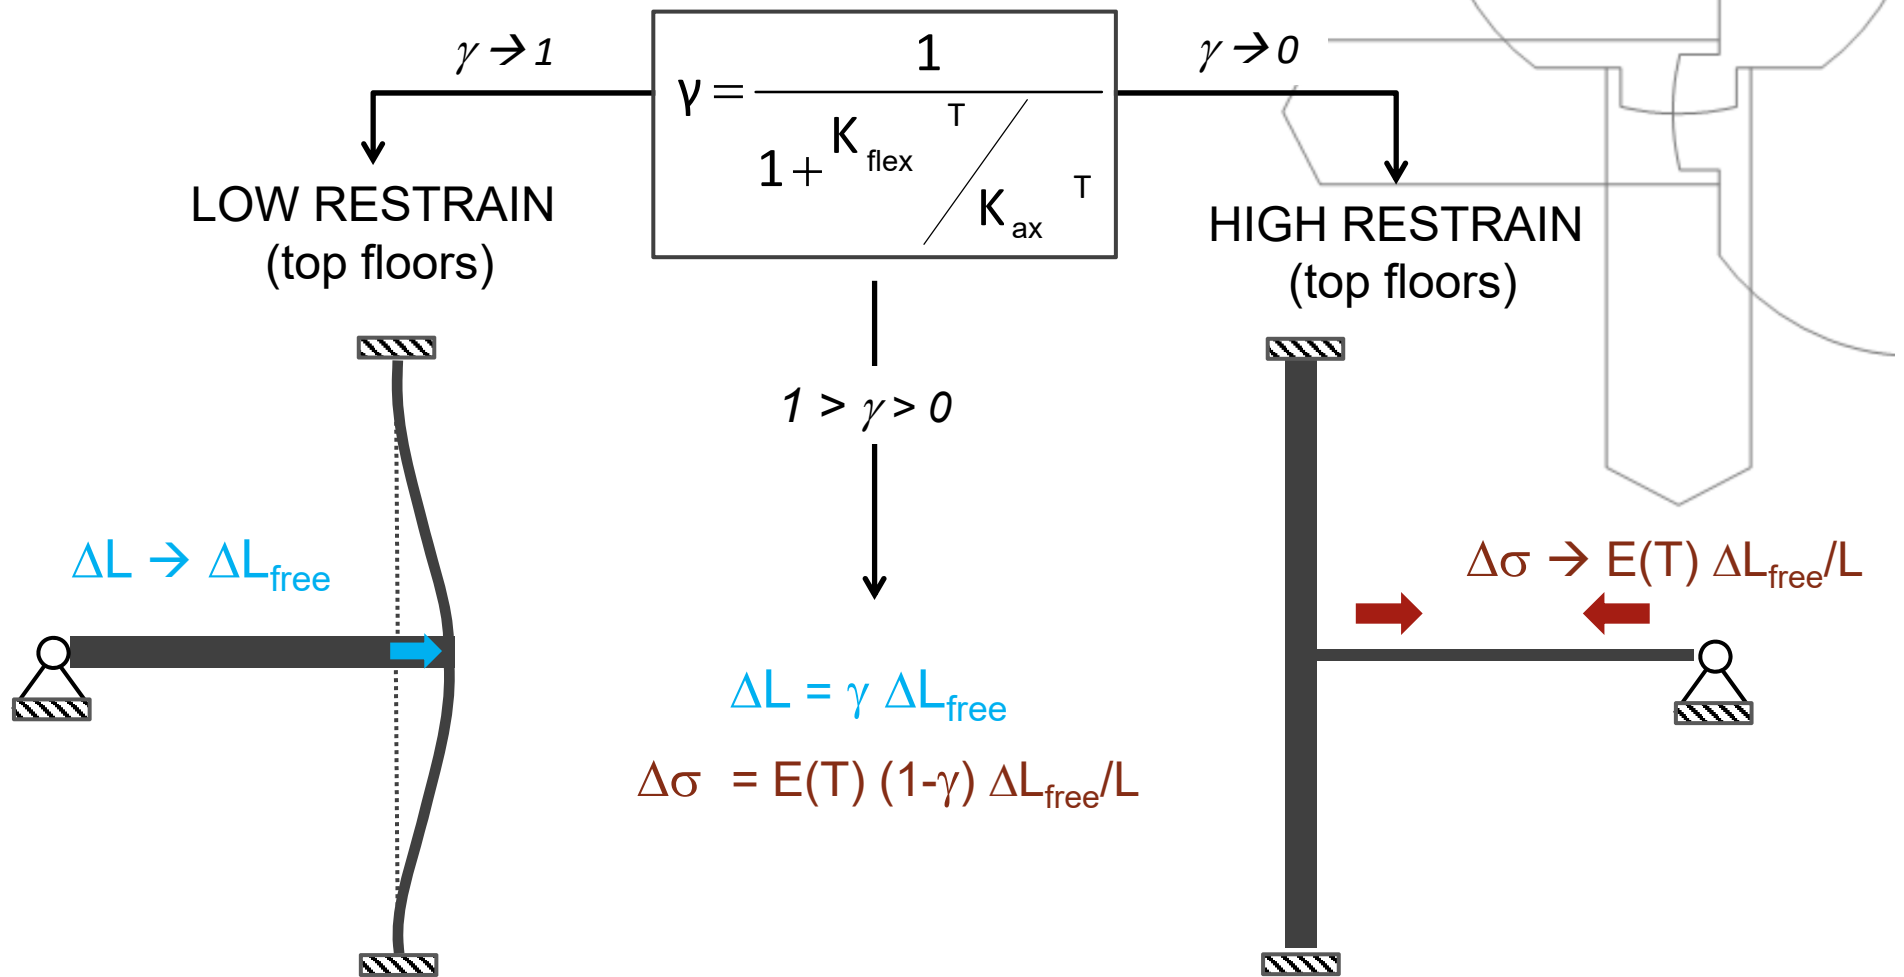
# STRUCTURAL DESIGN: degree of expansion

Source: EN1991-1-2: Actions on structures exposed to fire, Brussels, Belgium, 2002

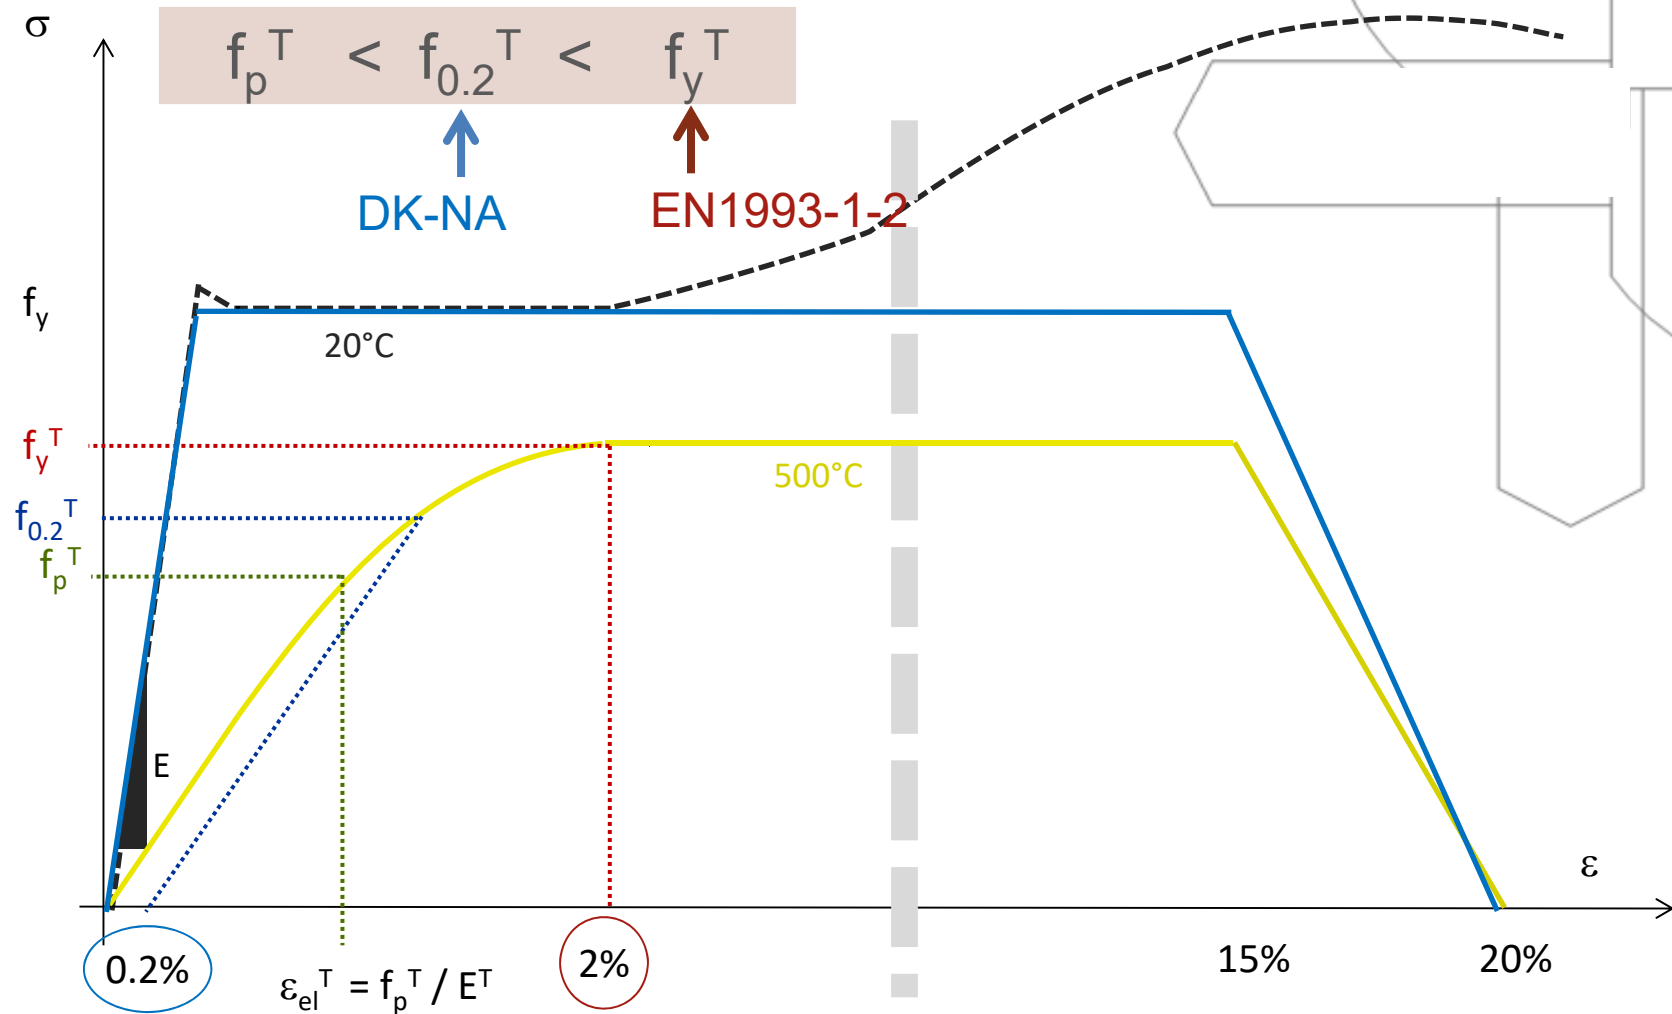
## STRUCTURAL DESIGN: mechanical properties

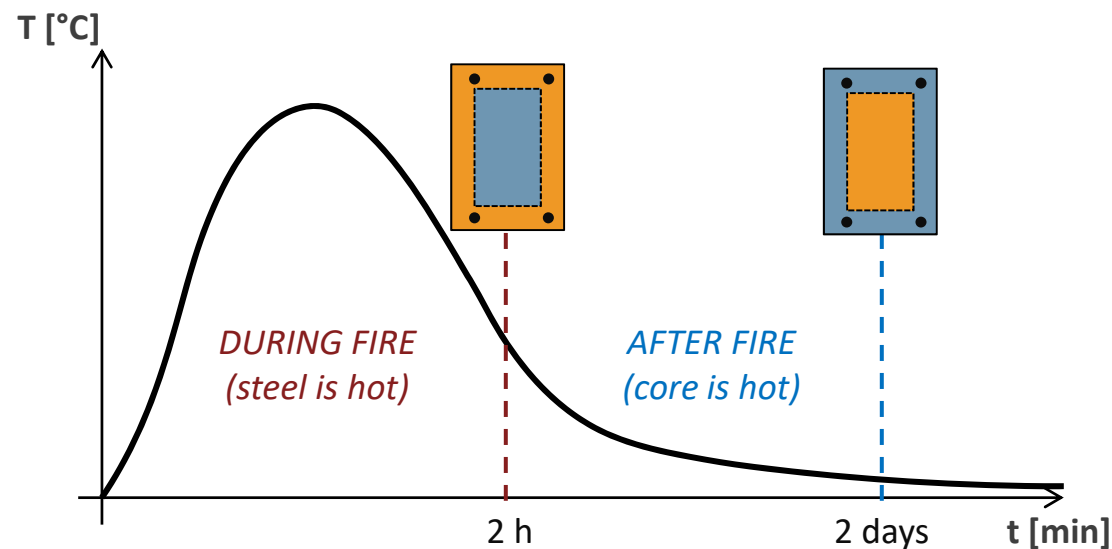
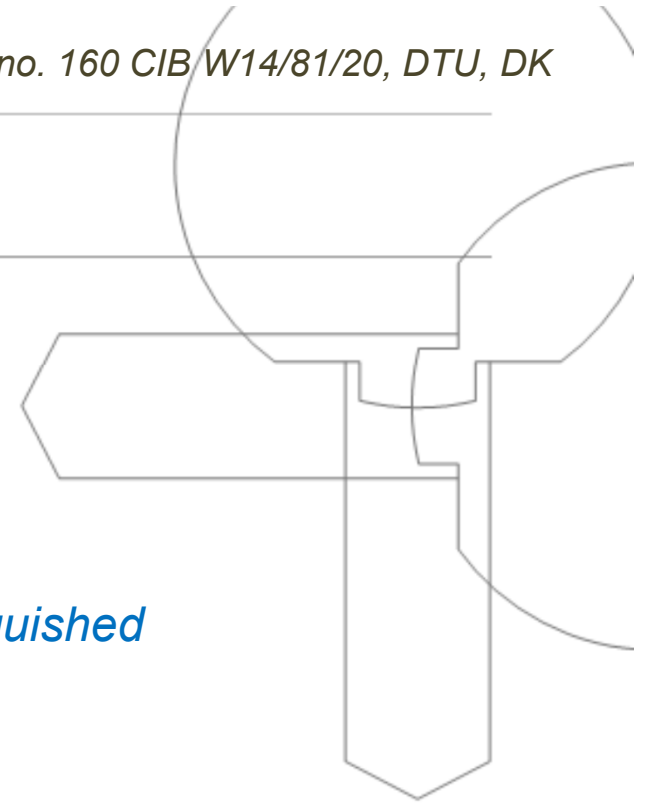
## STRUCTURAL DESIGN: cold condition

### I. DURING FIRE

Outer concrete and reinforcing bars are heated

### II. AFTER FIRE

Concrete core is heated, outer bars are cooled down

→ *risk of collapse after the fire is extinguished*

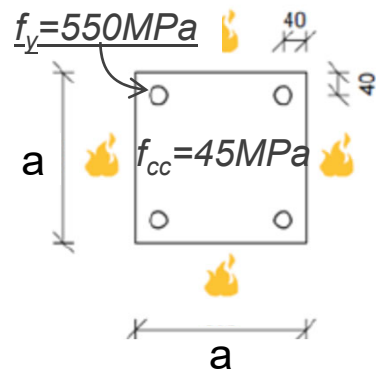
## STRUCTURAL DESIGN: cold condition

FIRE $q=200$ [MJ/m <sup>2</sup> ]		OLD COMPARTMENT $O=0.04$ [m <sup>-1</sup> ] $b=1160$ [Ws <sup>0.5</sup> m <sup>-2</sup> K <sup>-1</sup> ]		NEW COMPARTMENT $O=0.02$ [m <sup>-1</sup> ] $b=600$ [Ws <sup>0.5</sup> m <sup>-2</sup> K <sup>-1</sup> ]	
a [mm]	Ø [mm]	$N_{cr,HOT}$ [kN]	$N_{cr,COLD}$ [kN]	$N_{cr,HOT}$ [kN]	$N_{cr,COLD}$ [kN]
200	10	550	350	190	150
300	15	2'220	1'650	1'410	1'060
400	20	4'950	3'910	3'680	2'870
500	20	11'070	9'140	9'150	7'410

$N_{cr,HOT} \rightarrow 36\%$  overestimation

+ old comp.  $\rightarrow > 100\%$  overestimation

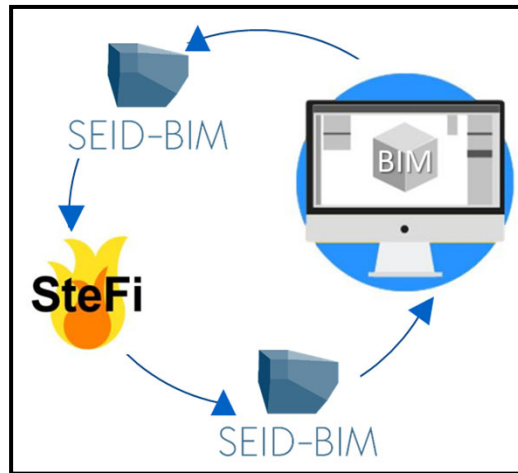
**Steel in Fire**

- Standard and Parametric fire
- 0.2% and 2.0% strength
- Libraries for steel profiles and insulation materials
- Calculation of load capacity
- Design of required insulation

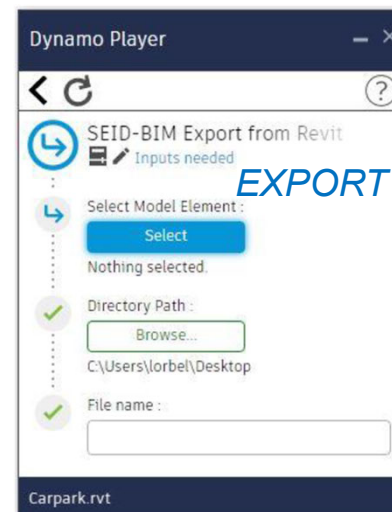
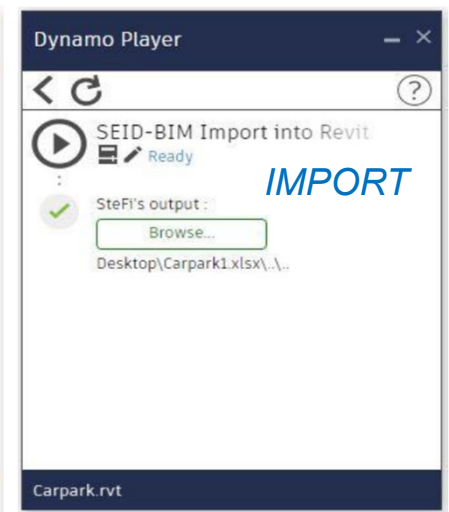
**Struct. Exp./Imp.  
of Data for BIM**

SEID-BIM

- Export geometry and material propert. of a steel element from Revit
- Import geometry and material properties of the insulation into Revit
- Compatible with the IFC format
